Tina Cohen, Certified Arborist

Arborist Services: Review of Tree Retention Plan

Re: Nouri Short Plat, 7502 NE 132nd St, Redmond, WA 98052
Site visit: October 5, 2015

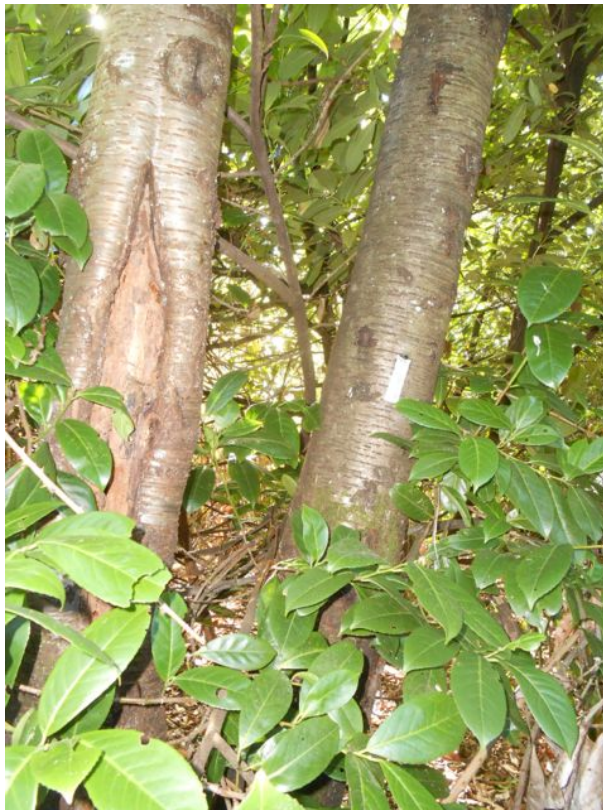
2. Wild cherry trees #15 and 17 have cavities (hollows) in their trunks, and are not viable for the long term. The species is susceptible to decay and short lived. See the attached photos. Therefore I deleted them from the total number of trees.

Above: Both trunks are part of Wild cherry #15 (per tag). Note the large wound on the left trunk.

Error: #15 and 17 should be omitted. There are seventeen trees on the site.

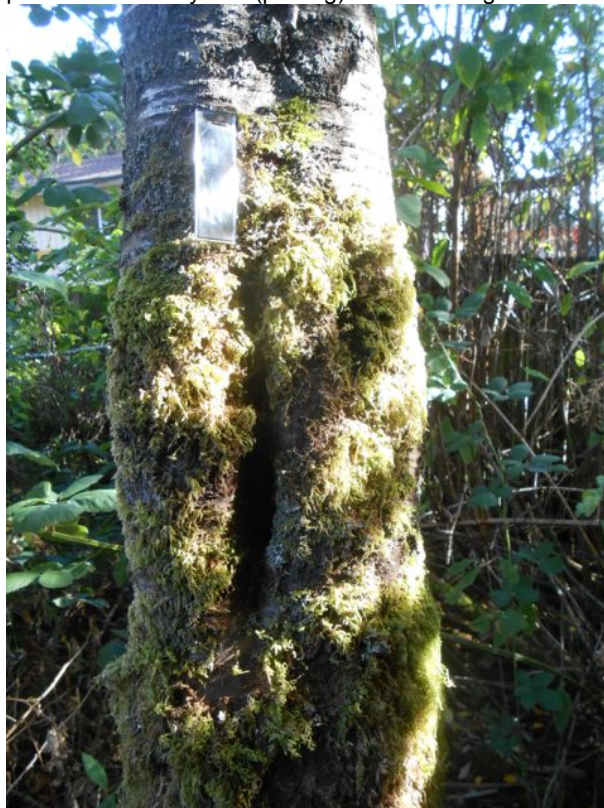
Above: The large cavity on Cherry #17 (per tag) seriously impacts its health and long term viability. Thus #15 and #17 are not healthy and should be omitted from the tree inventory.
