August 10, 2015

Site: TPN #0325059100  
13400 NE 100<sup>th</sup> St (approx.)  
Kirkland, WA98033

At your request I performed a Visual Risk Assessment (VRA) of the Kirkland site noted above on March 4<sup>th</sup> and 7<sup>th</sup>, 2014. The VRA is a systematic process that reviews risk factors and ranks them into risk categories. It is a standard used by the International Society of Arboriculture (ISA) to ascertain tree health.

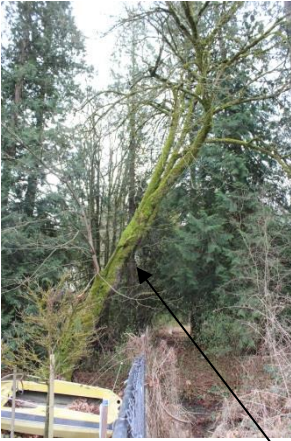
"A" Maple falling onto subject site

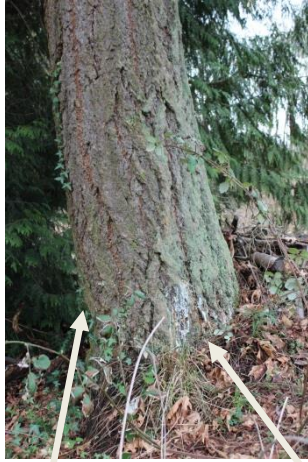
1553 Lean, decay in plane of lean, free running sap from crown

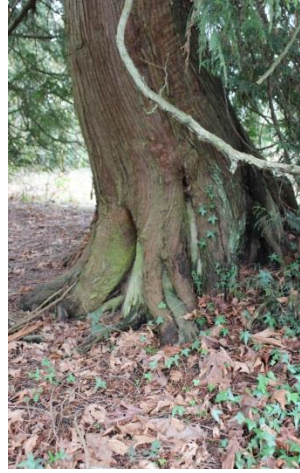
33	1551	Douglas fir	52	52	-	Poor	Decay, non-self-corrected lean, falling HAZARDOUS				1								Not significant Landmark
34	1552	Western red cedar	33	33	-	Fair	Decay in buttress roots, shedding bark				1								Not significant Landmark

#1552 Decay in buttress roots, and trunk carpenter ants

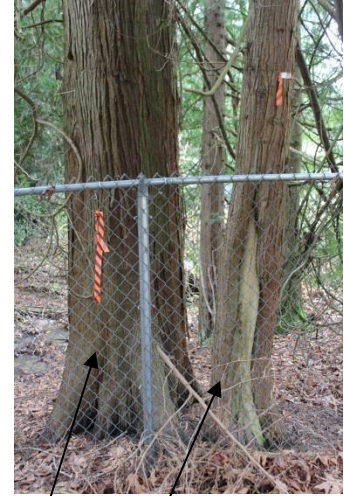
#1556 1557 Trunk and root crown decay

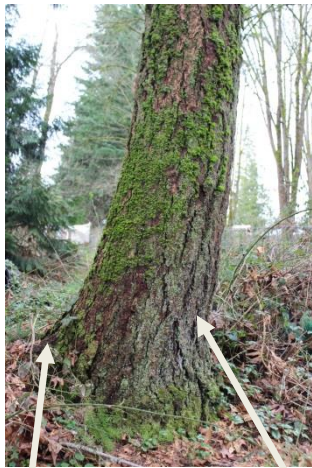
1529, lean, heaved soil, abnormal bark, decay in root and trunk

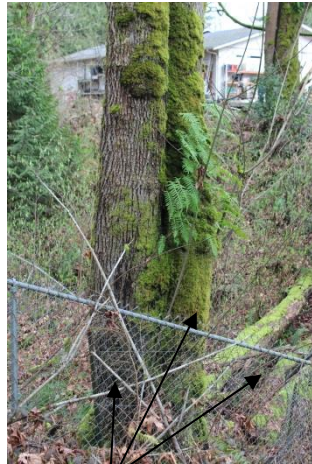
#1584 3 trunks one failed, co-dom leaders with included bark decay

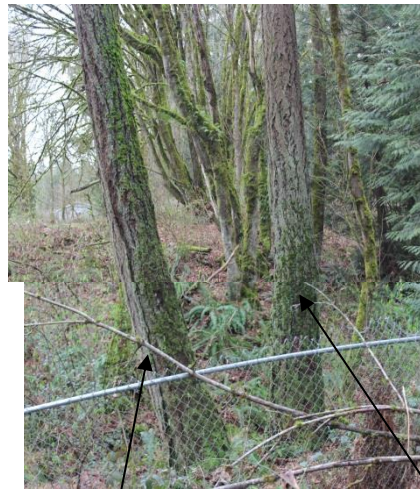
#1499 split bark

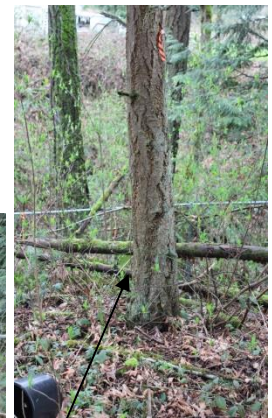
1527, abnormal shedding bark, no taper, prob Laminated root rot

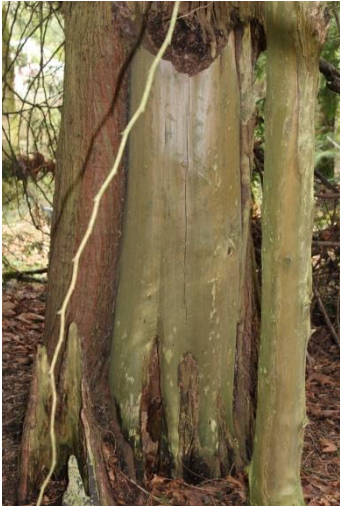
1525: Cedar split with .70% trunk decay, carpenter ants

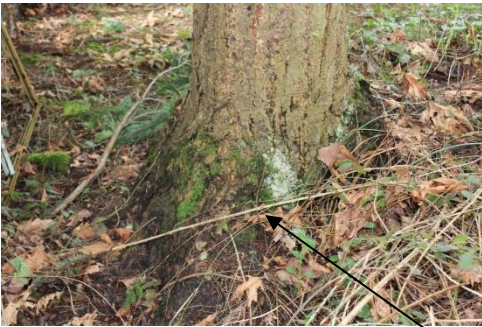
#1524 epicormic roots, decay at root crown and trunk

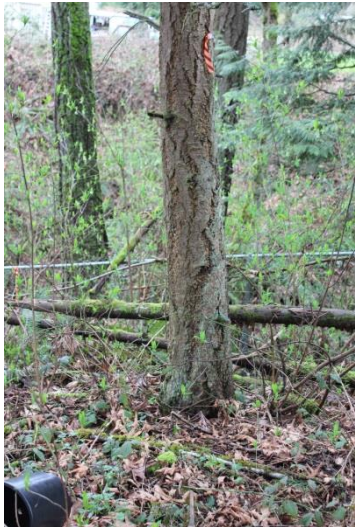
1497 1527 1496 All with laminated root rot

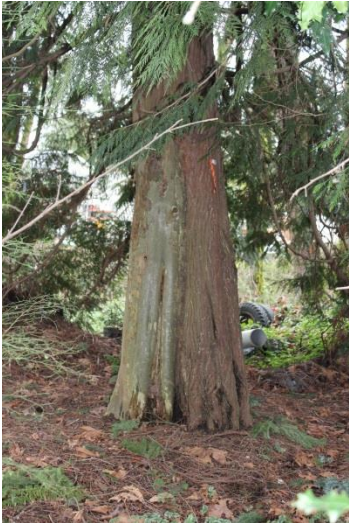
#1523 Roots decayed through

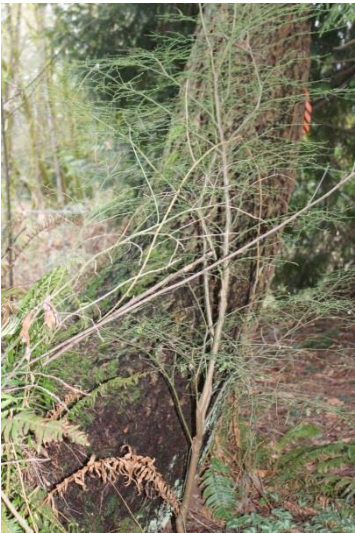
#1522 self-corrected lean on nurse log

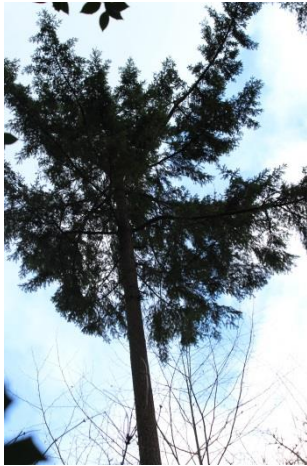
#1520 previous large top failure

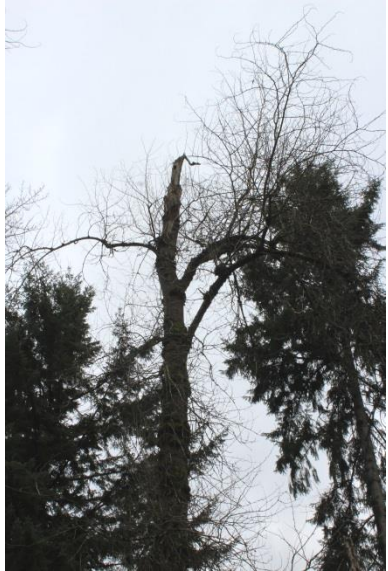
#1515 Dead top, dead branches

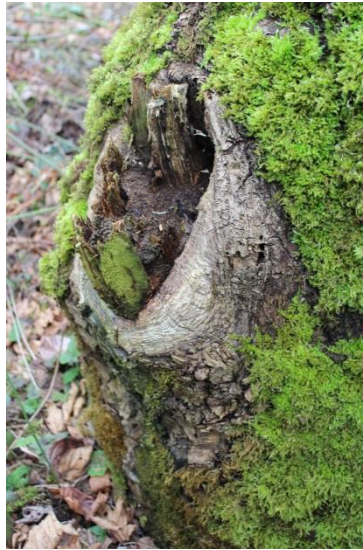
1589: Cottonwood with Co-dominant leader

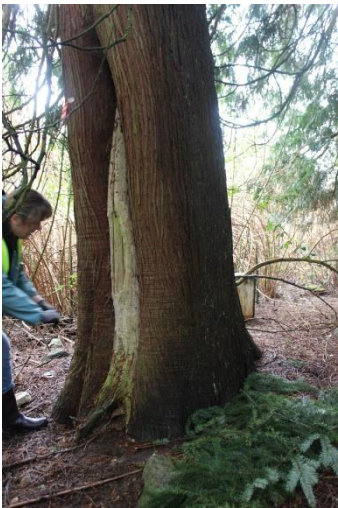
#1545 Large column of decay, with carpenter ants, woodpecker activity, sparse canopy

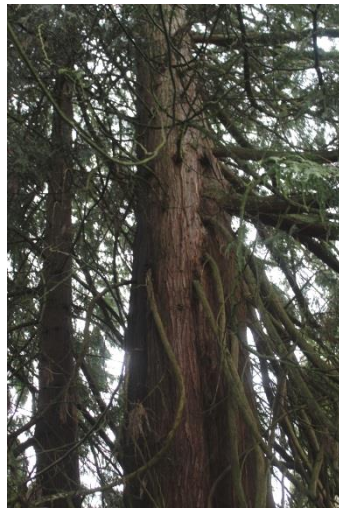
#1550 exposed roots with decay, large column of dead wood, carpenter ants and woodpecker

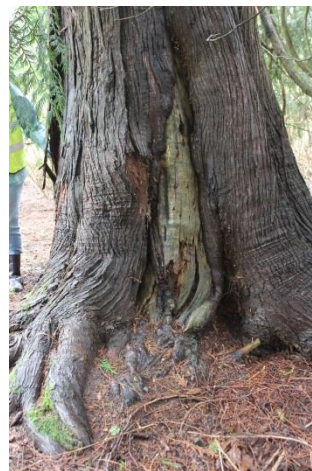
#1549; red ring rot canker and conk

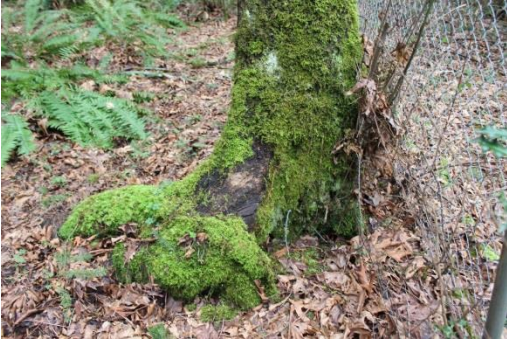
#1502 Maple with decay in buttress roots

Many of the trees located offsite are in poor health, I recommend that the owners be notified of those trees and that they can be snagged.

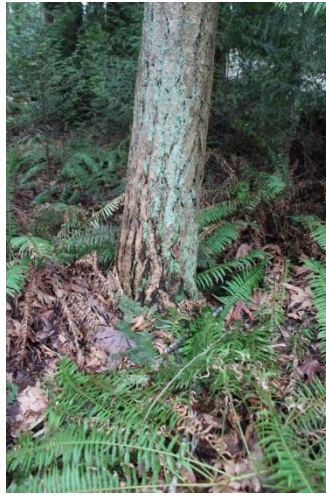
10	1503	<i>Douglas fir</i>	Est. 14	14	10	Poor	Suppressed canopy, butt, rot, abnormal bar, thin canopy		x		14				
11	1504	<i>Western red cedar</i>	22	22	20	Fair	Abnormal bark, base swell, wound, thin canopy		x		22				
12	1505	<i>Western red cedar</i>	Est. 12	12	12	Good	Remove dying spur	x			12				
13	1506	<i>Douglas fir</i>	26	26	18	Fair	Typical of species		x		18				
14	1507	<i>Douglas fir</i>	13"	13	-	Poor	Tree broken off at base and fallen onto 1506		x		-

#1503 abnormal bark, no taper, decay at root crown

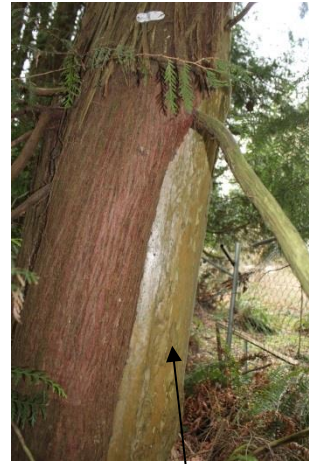
1504: decay

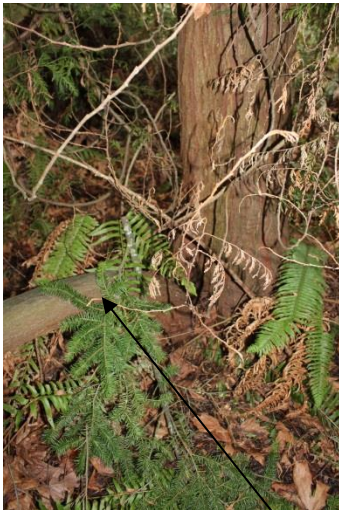
#1505, OK, remove dead spur

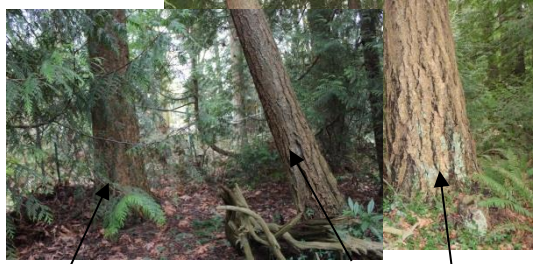
#1506 abnormal bark #1507 (Fallen) #1508

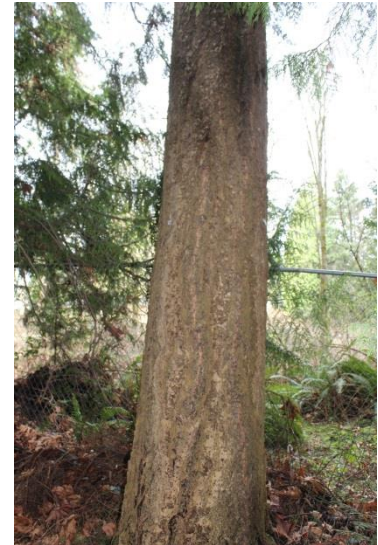
#1506, abnormal bark, popping and shedding

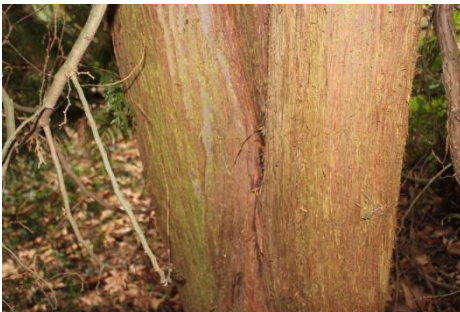
#1509 Cedar, co-dom leaders w split
