August 10, 2015

Site: TPN #0325059100
13400 NE 100th St (approx.)
Kirkland, WA98033

At your request I performed a Visual Risk Assessment (VRA) of the Kirkland site noted above on March 4th and 7th, 2014. The VRA is a systematic process that reviews risk factors and ranks them into risk categories. It is a standard used by the International Society of Arboriculture (ISA) to ascertain tree health.

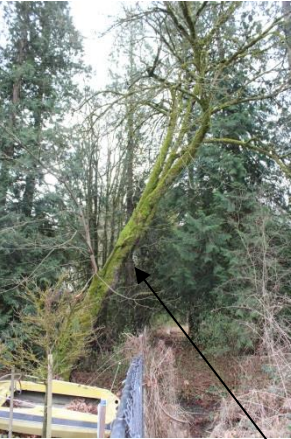
"A" Maple falling onto subject site

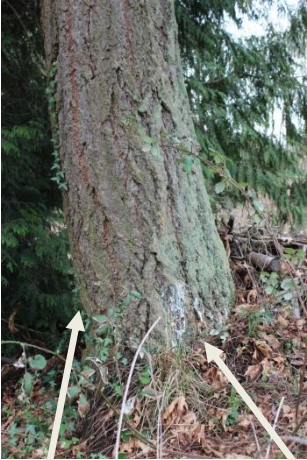
1553 Lean, decay in plane of lean, free running sap from crown

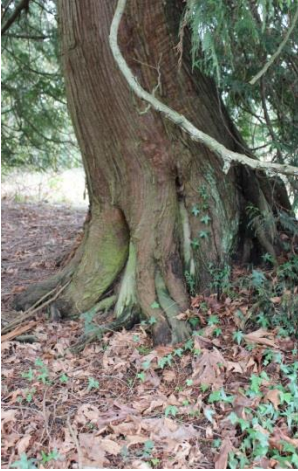
#1552 Decay in buttress roots, and trunk carpenter ants

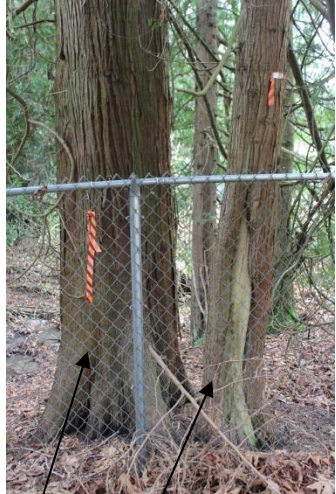
#1556 1557 Trunk and root crown decay

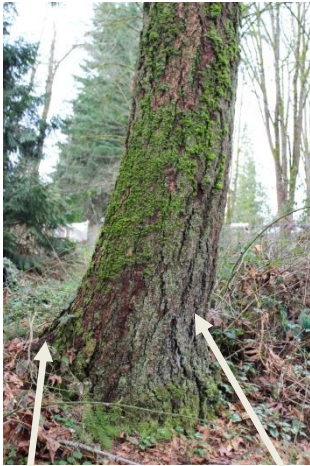
1529, lean, heaved soil, abnormal bark, decay in root and trunk

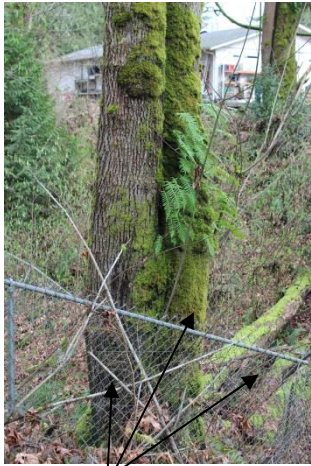
#1584 3 trunks one failed, co-dom leaders with included bark decay

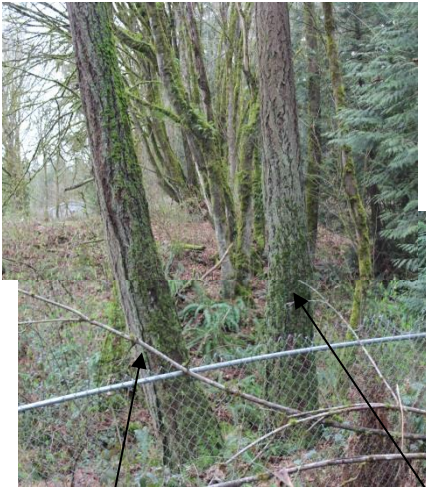
#1499 split

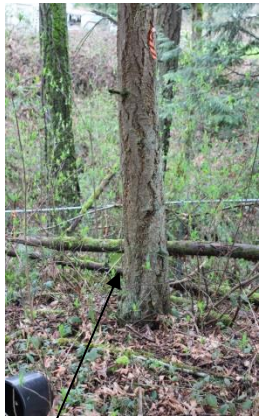
1527, abnormal shedding bark, no taper, prob Laminated root rot

#1500 abnormal bark

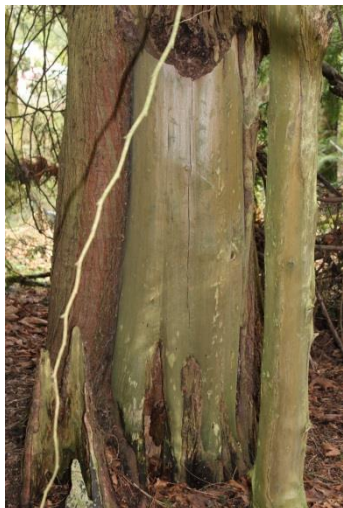
1525: Cedar split with .70% trunk decay, carpenter ants

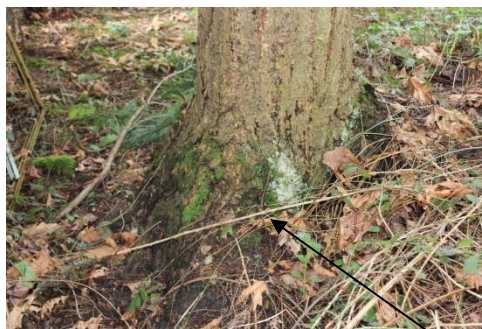
#1524 epicormic roots, decay at root crown and trunk

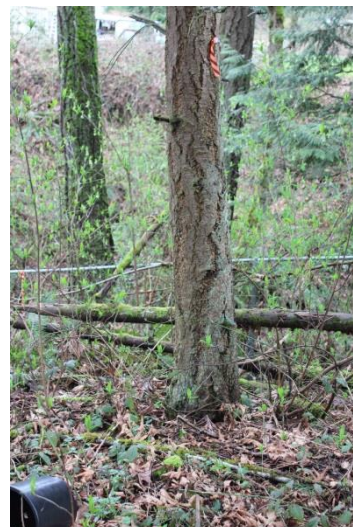
1497 1527 1496 All with laminated root rot

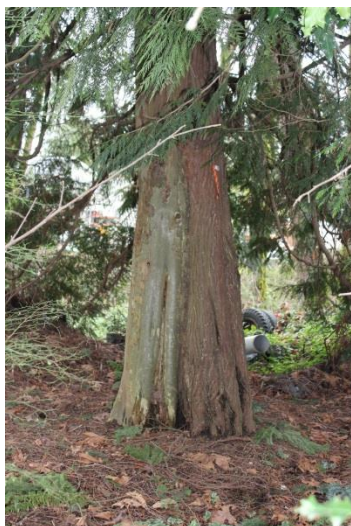
#1523 Roots decayed through

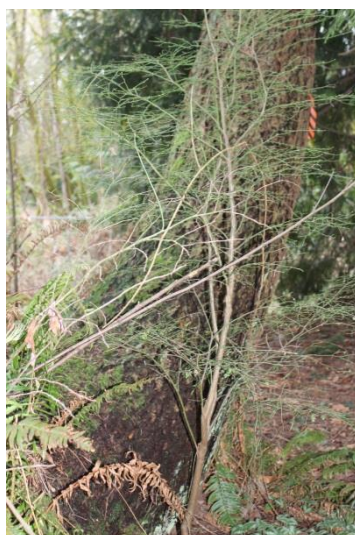
#1522 self-corrected lean on nurse log

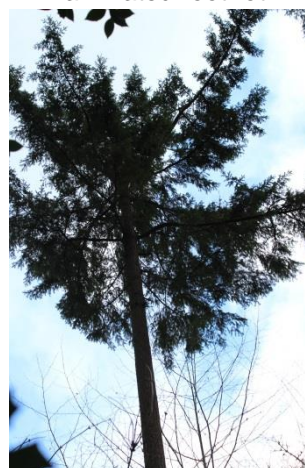
#1520 previous large top failure

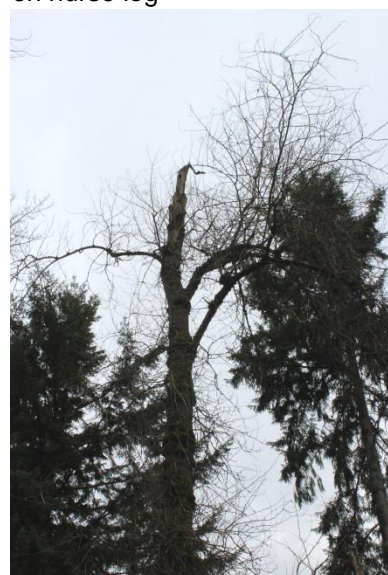
#1515 Dead top, dead branches

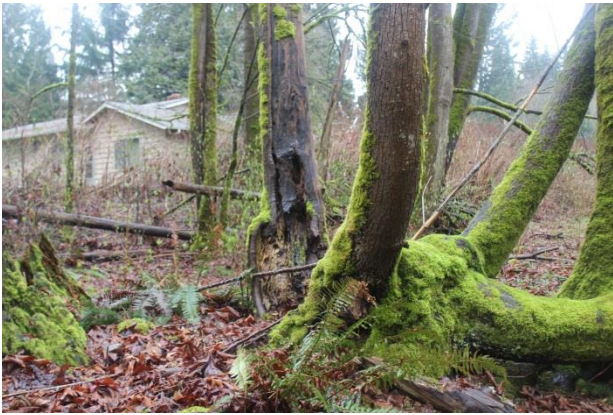
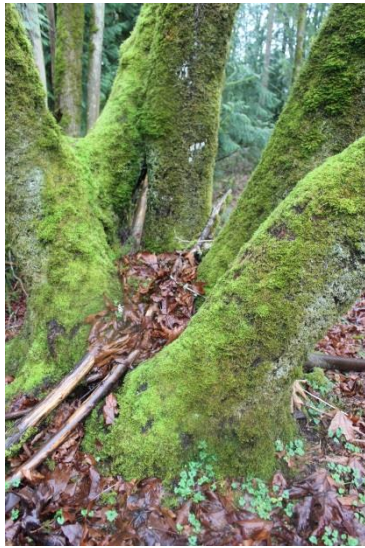
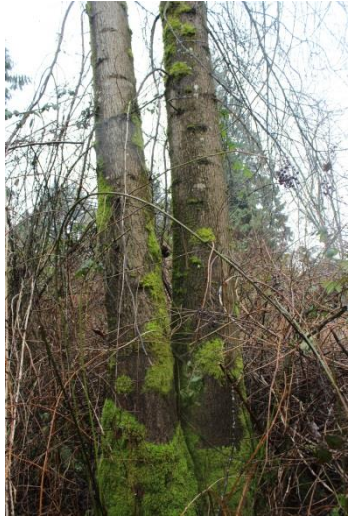
1589: Cottonwood with Co-dominant leader

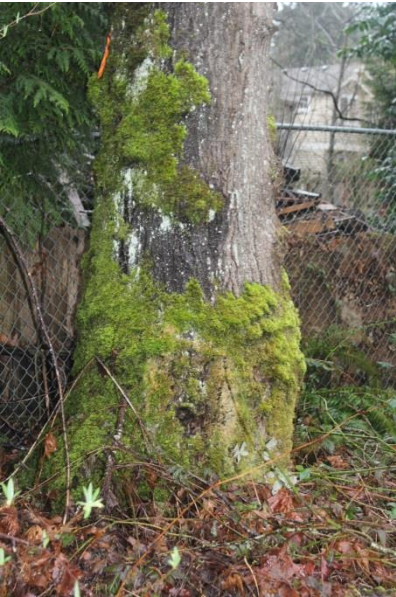
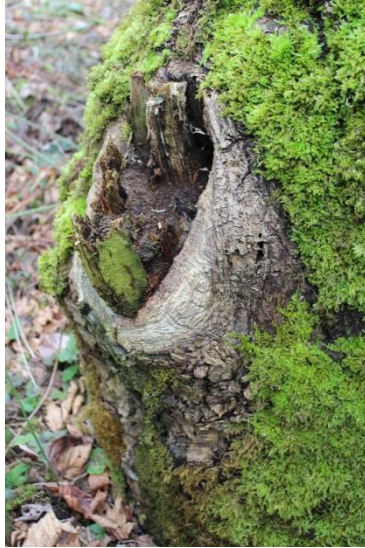
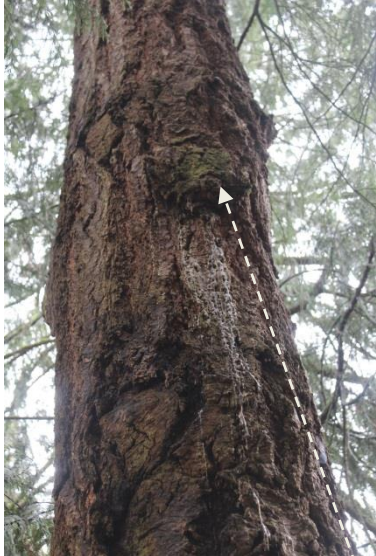
#1549; red ring rot canker and conk

Sample of typical site maples, dead wood, decay, exposed roots, Hypoxylon canker

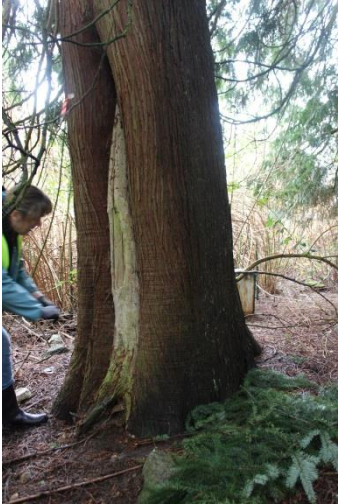
#1545 Large column of decay, with carpenter ants, woodpecker activity, sparse canopy

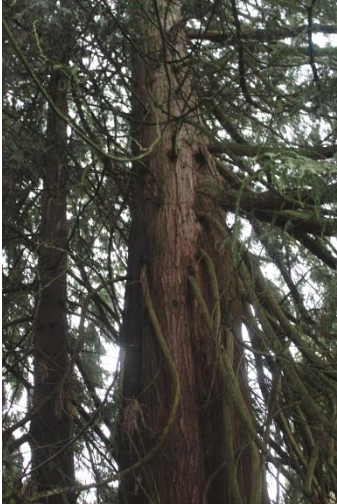
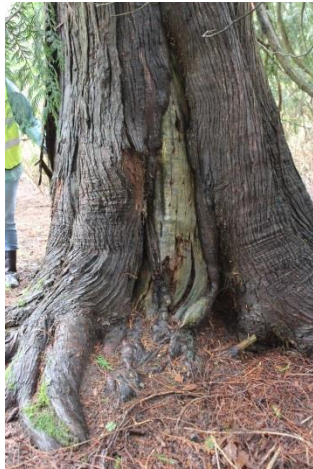
#1550 exposed roots with decay, large column of dead wood, carpenter ants and woodpecker

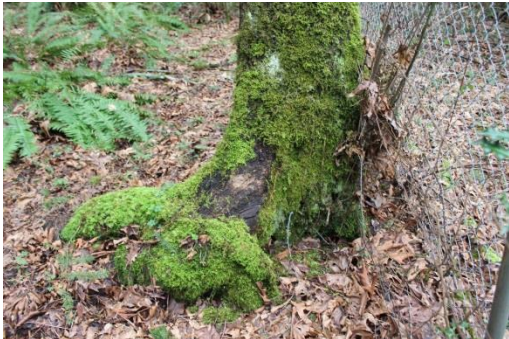
#1502 Maple with decay in buttress roots

Many of the trees located offsite are in poor health, I recommend that the owners be notified of those trees and that they can be snagged.

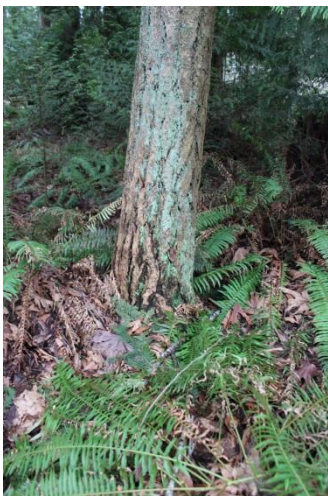
#1503 abnormal bark, no taper, decay at root crown

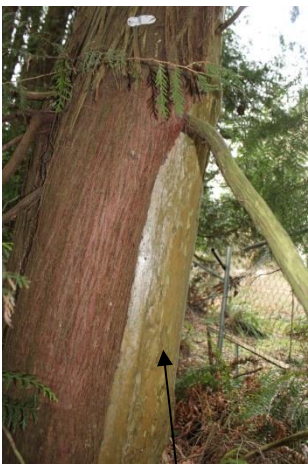
1504: decay

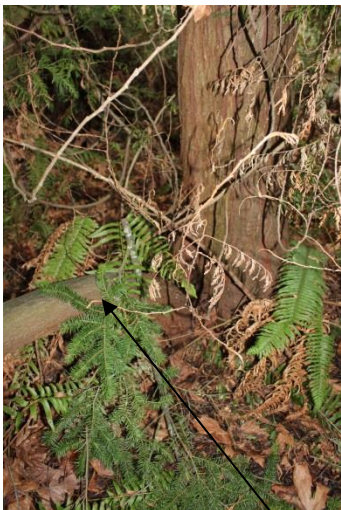
#1505, OK, remove dead spur

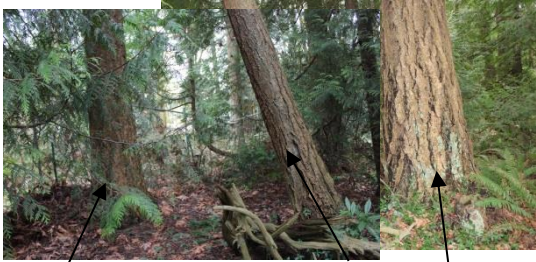
#1506 abnormal bark #1507 (Fallen) #1508

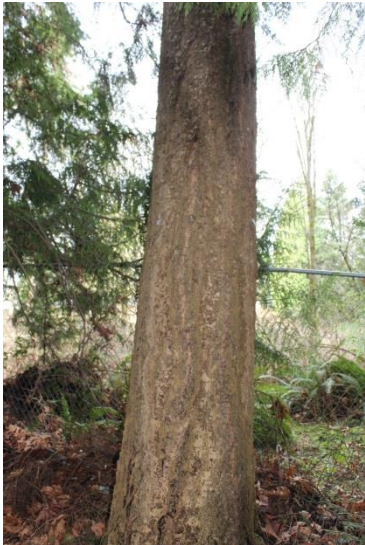
#1506, abnormal bark, popping and shedding

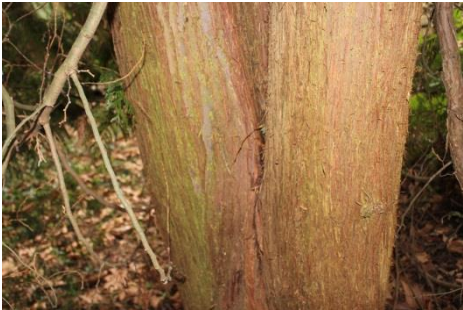
#1509 Cedar, co-dom leaders w split
