May 11, 2015

Re: TPN: 252605-9023; 6.89 acres

EDGEWOOD EAST TREE PRESERVATION PLAN

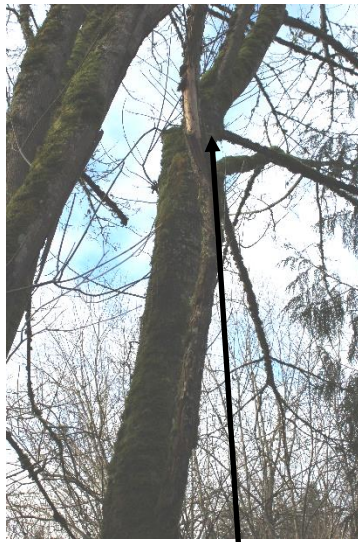
2

7252 Dead scaffold, dead wood, Decay in root crown,

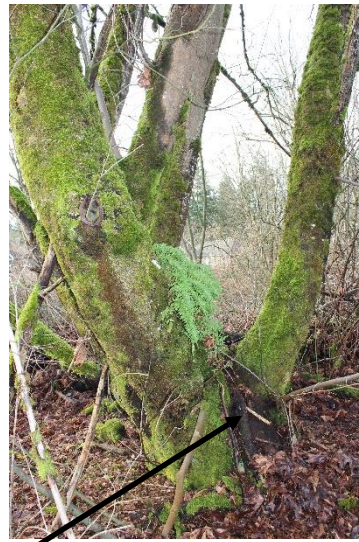
7228 Cherry falling onto and supported by 7227 Red alder, exposed roots, moss from wet soil and low air circulation

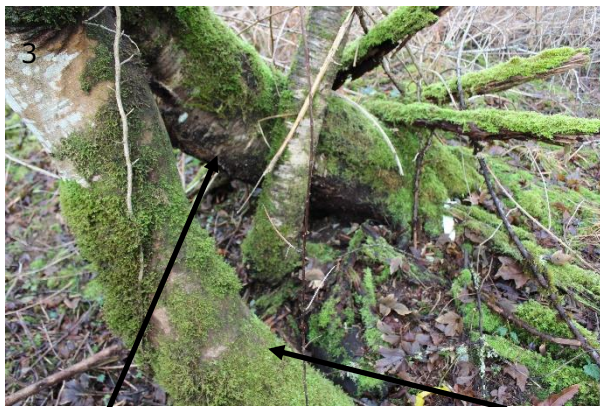
#7224 Red alder, previous dead leader, falling to west

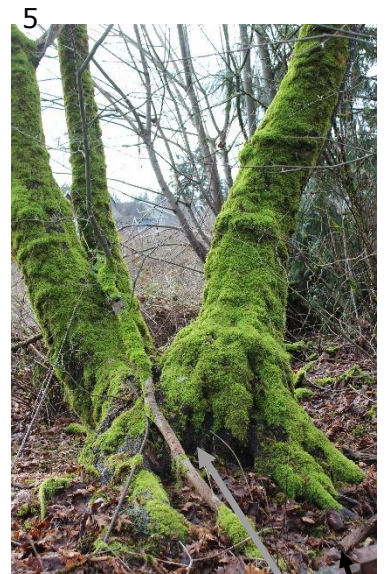
7251 Bigleaf maple; Decay @ root crown, exposed roots, wet soil, leaning

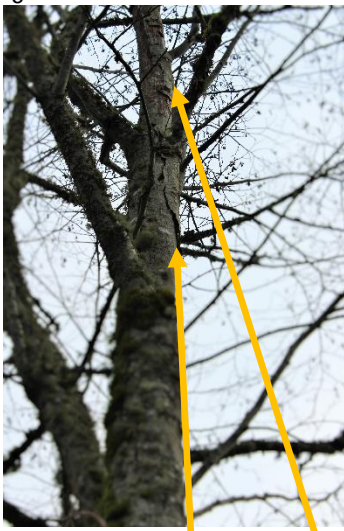
6

7376 Red alder, crack, decay pileated woodpecker

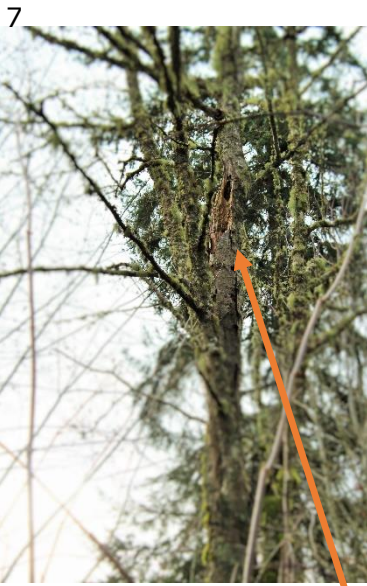
7375 Red alder, decay, carpenter ants, pileated

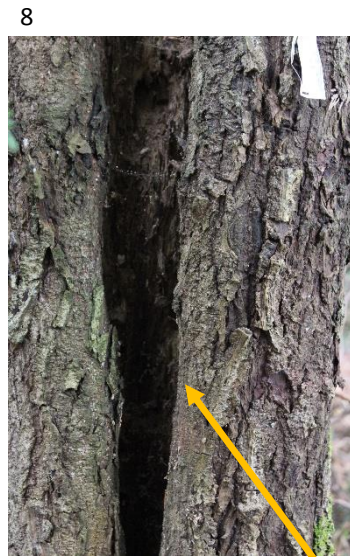
7368 Bigleaf crack with decay, mostly dead

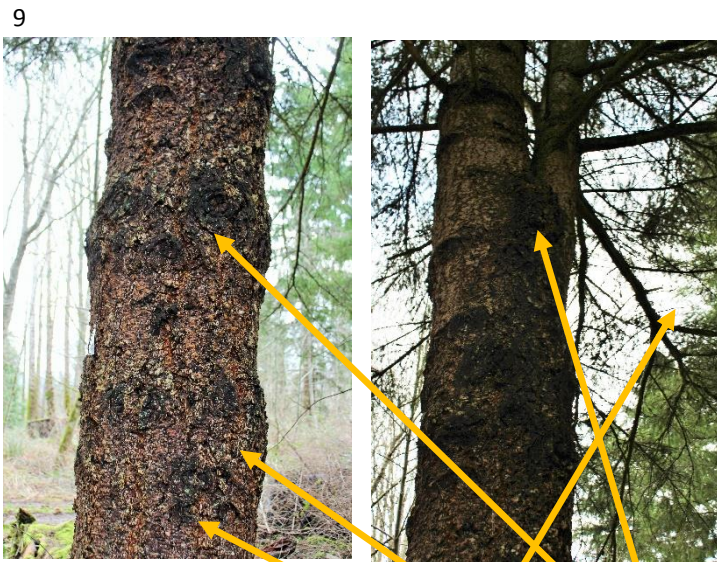
7382 Douglas fir, abnormal bark, headed wound, canker, co-dominant leaders with included bark, dead branches

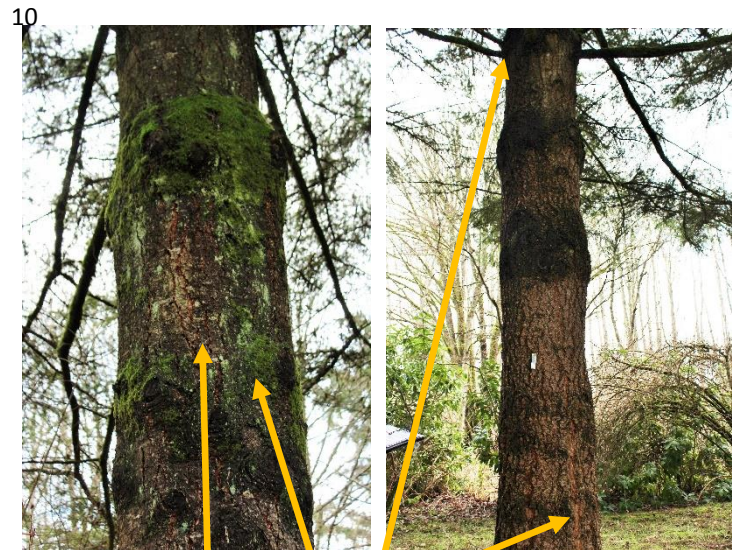
7384 Douglas fir abnormal bark, epicormic branch's, low live crown ratio, column of decay, vertical crack

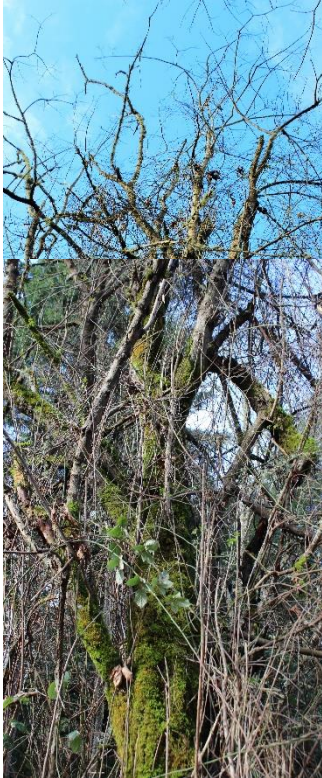
10

7533 P. willow mostly dead

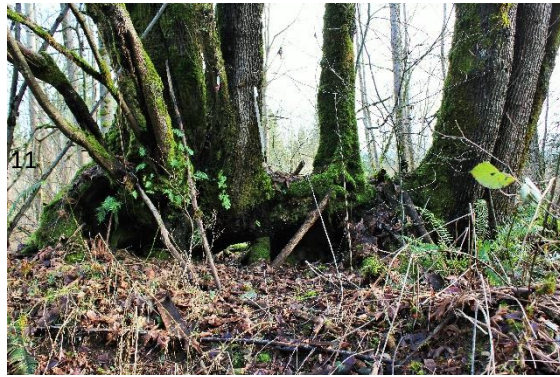
7530 Very large multi trunked maple, nurse tree, less decay than normal exposed roots, etc. but healthy

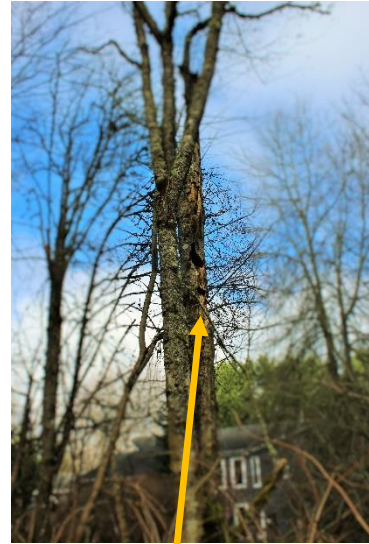
12

7458 Red alder, Pileated woodpecker (carpenter ants, decay)

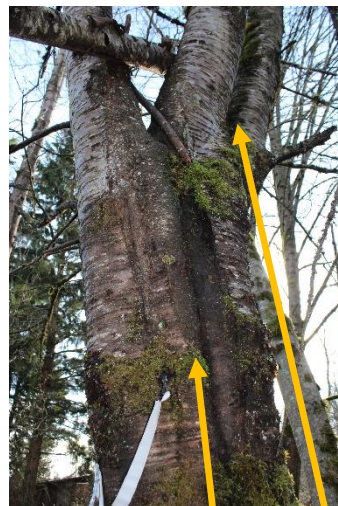
14

7521 Cherry, Cracks w decay

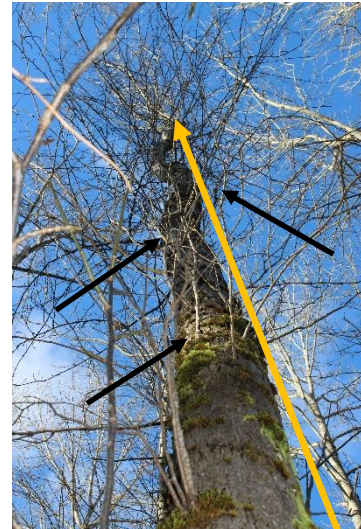
15

7505 Cottonwood, top failure, multiple weak doglegs

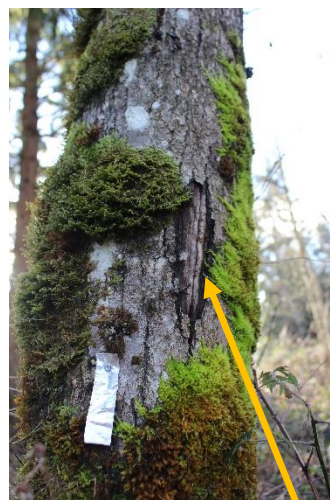
17

7352 Red alder, large area of decay, cracks

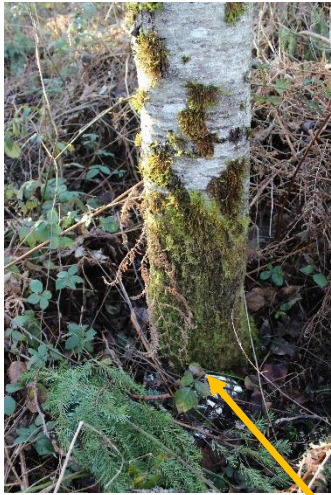
18

7353 Cottonwood, lean to west, (poor photo) Column of decay @ root crown (indent) 21

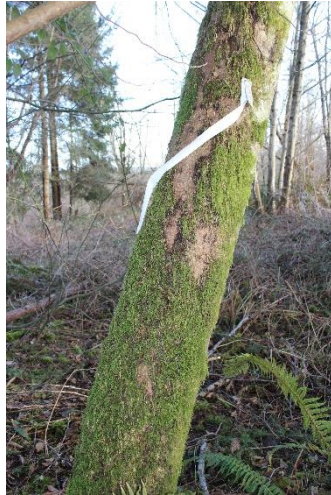
19

7537 Red alder, soil failure—falling to south

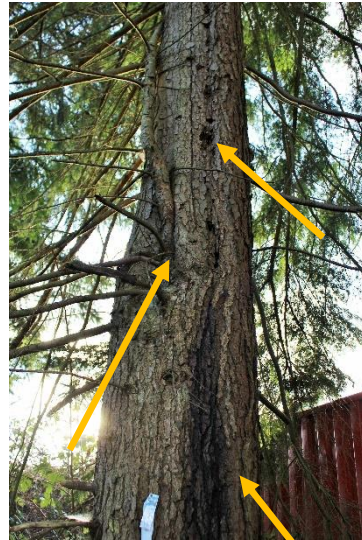
20

7536 Hemlock, perennial canker, torques crack with decay and pileated woodpecker

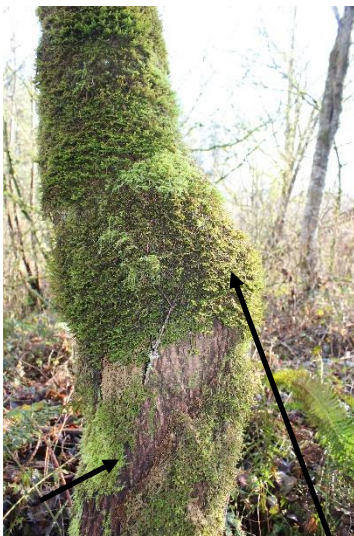
7553 Cottonwood, previous failure, left dogleg with decay

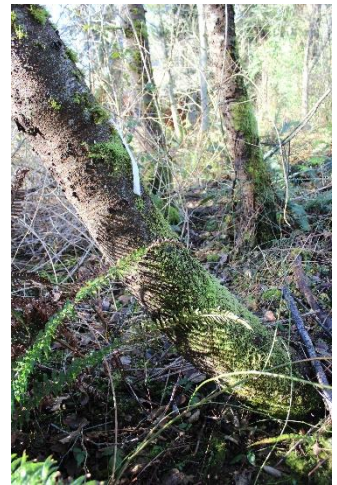
23

7590 Cherry: falling to south (soil failure)

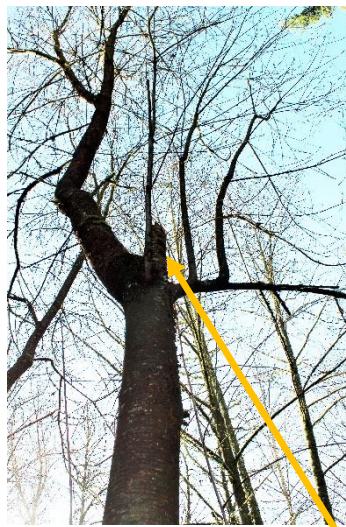
24

7589 Cherry: Co-dom failure, decay throughout

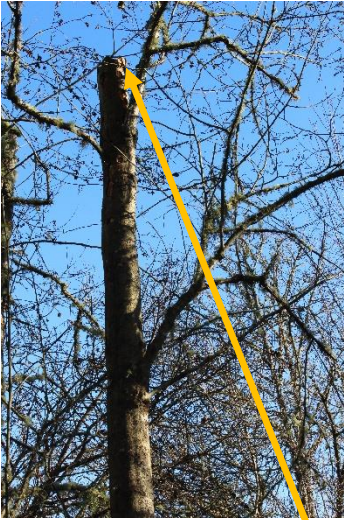
25

7597 Red alder, Previous top failure, mostly dead

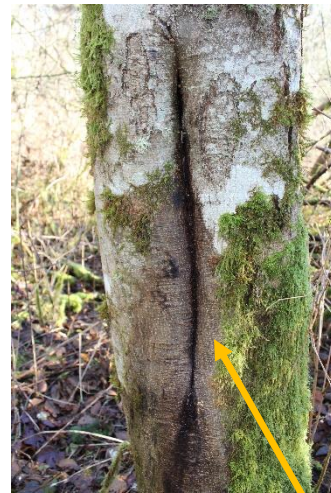
27

7558 Red alder: Multiple trunks, fused, cracked, decay

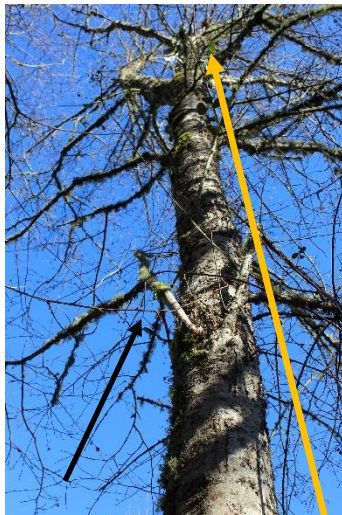
29

7652 Red alder: Multiple top failure, decay throughout, dead, broken branches

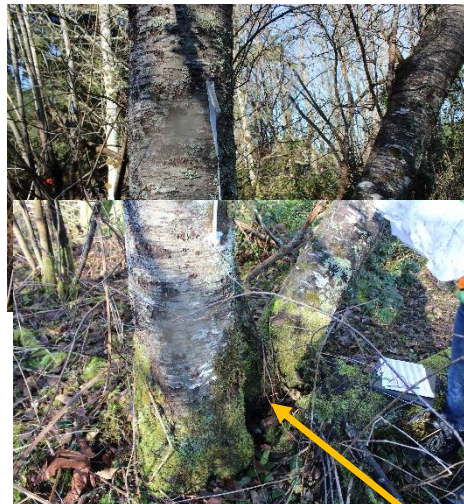
31

7583 Cherry: Co-dom w included bark, 1/2 failed, decay @ root crown

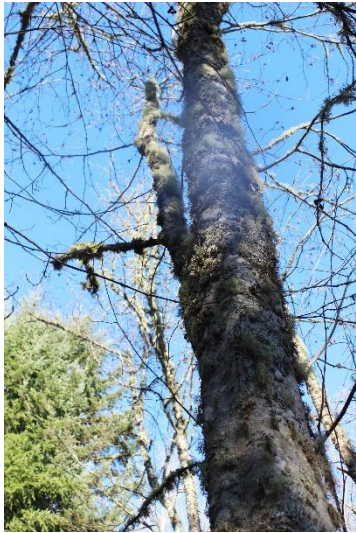
32

7581 Red alder: mostly dead

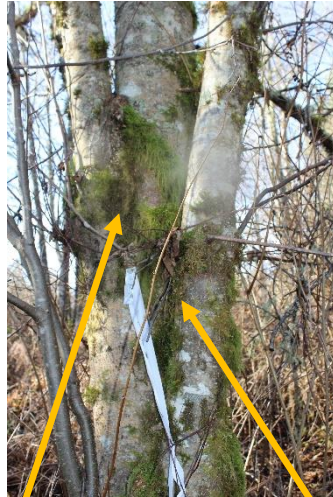
33

7582 Red alder: Co-dom X3
Poor attachments, decay

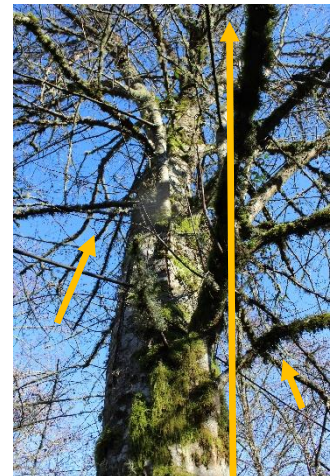
37

7578 Red alder: dead wood, dead scaffold, hanger

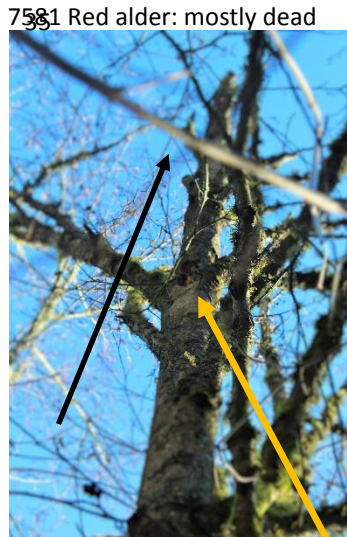
7580 Red alder: multiple top failures, large pileated woodpecker holes @30'

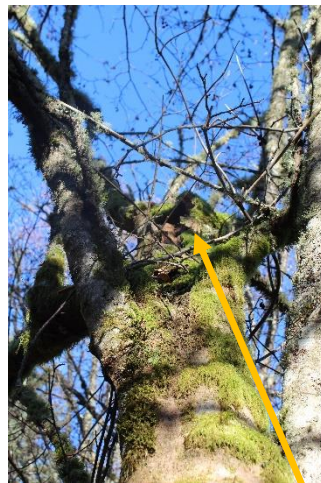
36

7579 Red alder: previous failure of a large portion of top, decay throughout

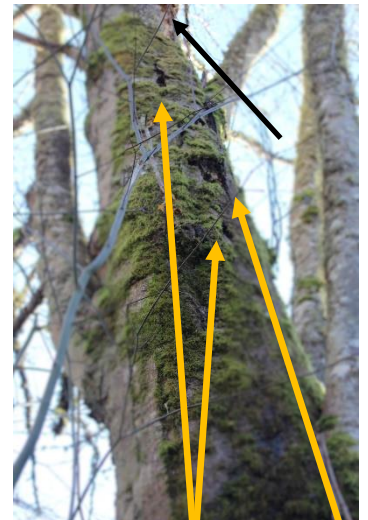
39

7314 Red alder: cracks, decay, pileated woodpecker

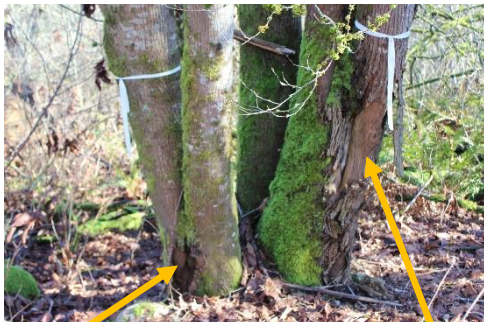
38

8045/8046 Bigleaf maple, multi trunk, decay at co-dom leaders, decay in major leaders

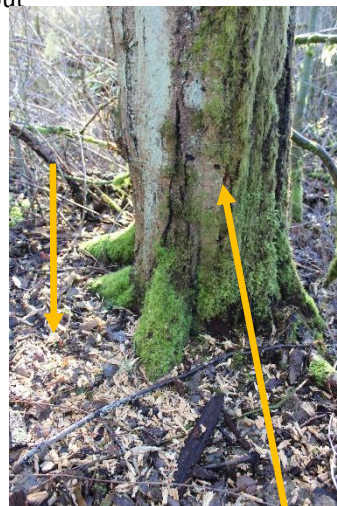
7310 Red alder, fresh wood chips from pileated woodpecker, carpenter ants

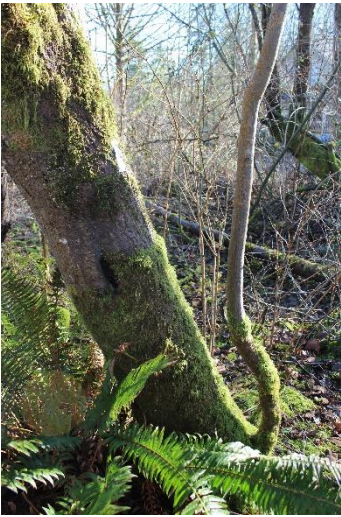
40

7314 Red alder: failing to north (decay at root crown)

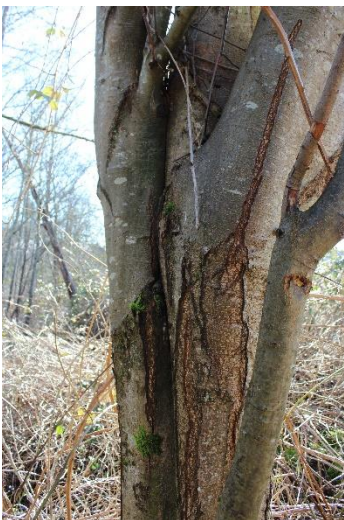
42

7331: Bigleaf: multiple co-dom trunks with included bark and decay

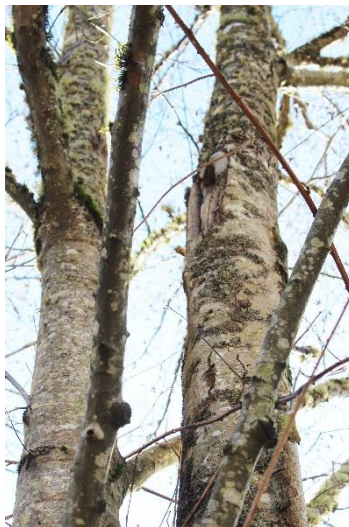
42

7331 Bigleaf: pileated wood pecker, vertical cracks

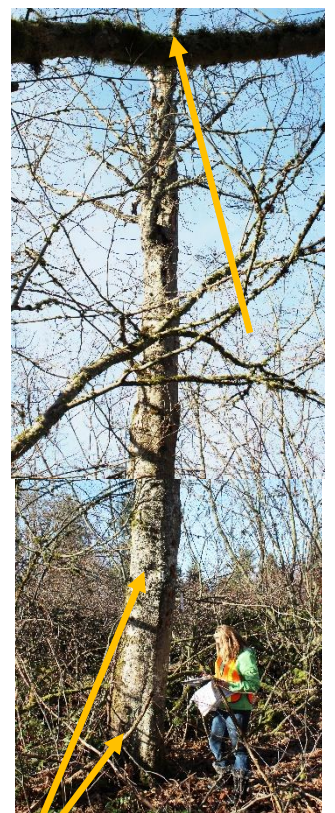
43

7489 Cottonwood, Previous top failure, column of decay, cavities of decay, dead branch's,

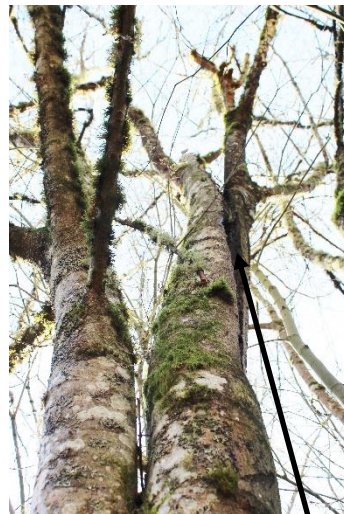
7331, 7330 Red alder, decay, dead wood, hangers, decay at rot crown

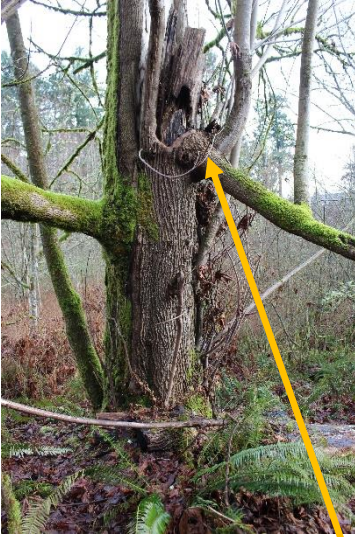
46

7562 Bigleaf maple: large fracture, decay, carpenter ants

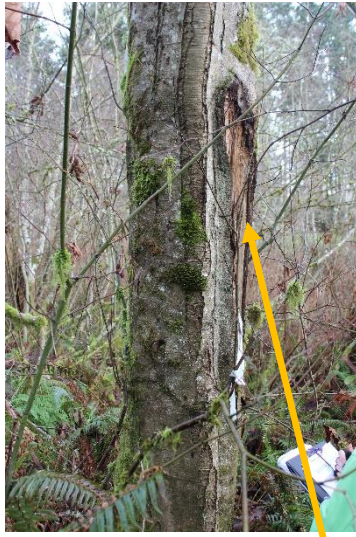
47

7727 Red alder: 1/2 tree failed, carpenter ants, decay

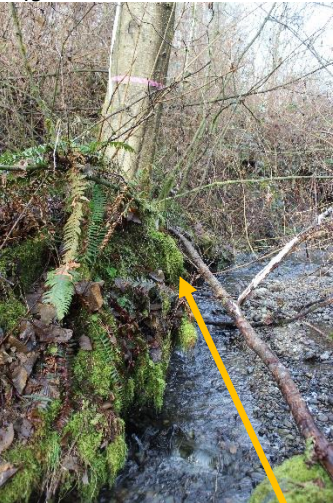
49

7668 Red alder: undermined roots, lean to east

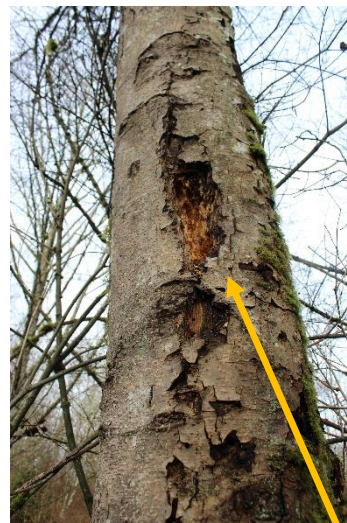
51

7688 Red alder: mostly dead, pileated woodpecker, decay, carpenter ants

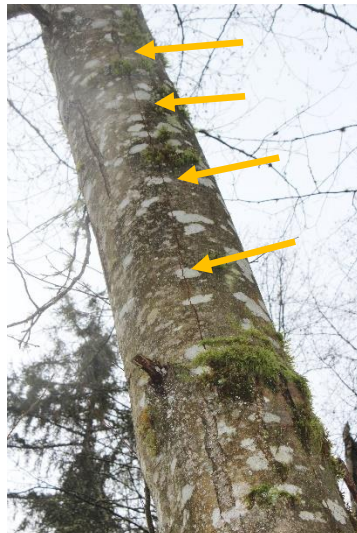
52

8211 Red alder: vertical crack 10 degree lean to east, deadwood

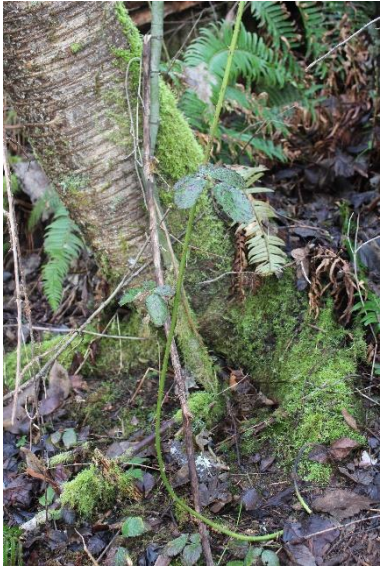
54

7681" Cherry: Failing to west,

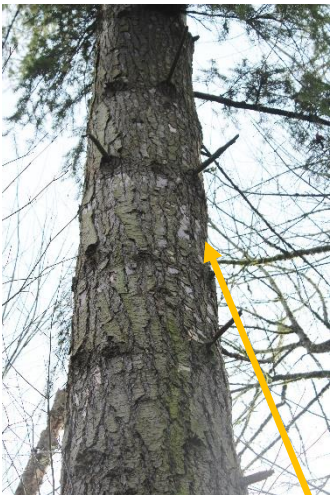
57

7707 Douglas fir, abnormal popping bark

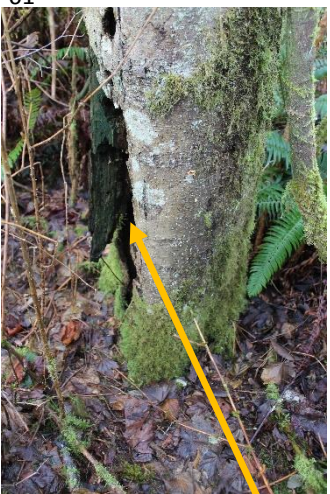
61

7416 Red alder: decay @ root crown

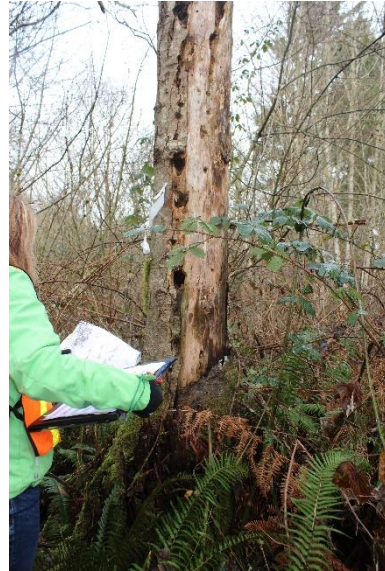
55

7680 Red alder: Dead, carpenter ants, pileated woodpecker

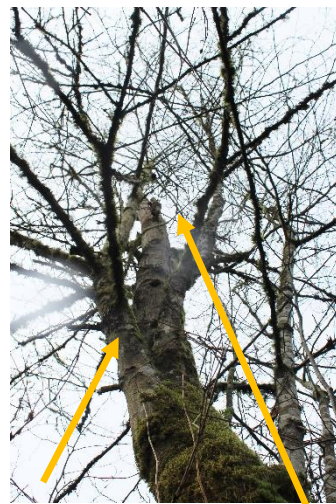
58

7715 Red alder, filled with decay, top loss, lean to west

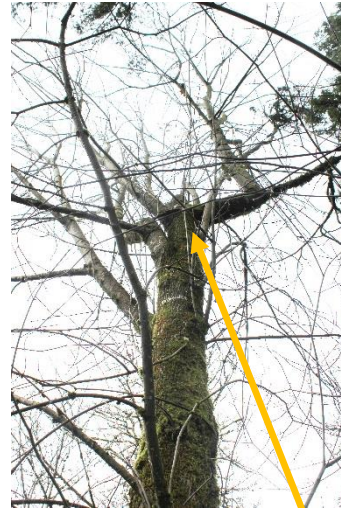
56

7706 Bigleaf maple, previous top loss, dead wood, carpenter ants

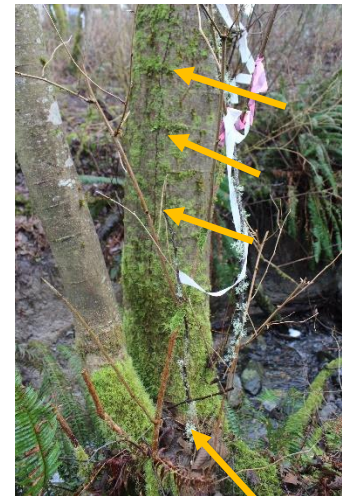
60

7626 Red alder: co dom, undermined roots, decay @ root crown, vertical crack

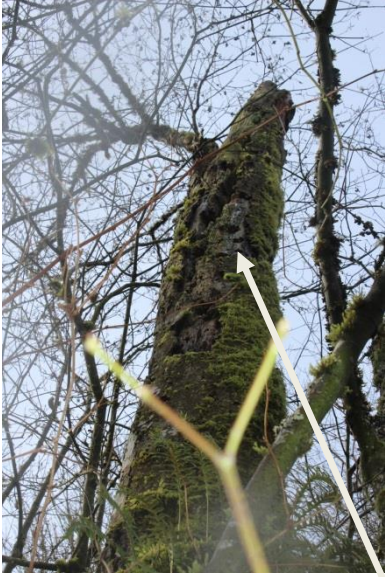
62

7614 Previous top loss, decay, carpenter ants, pileated woodpecker holes

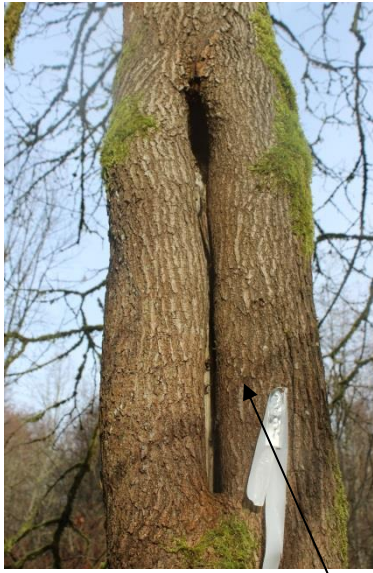
63

7601 Bigleaf maple, large column of decay, carpenter ants

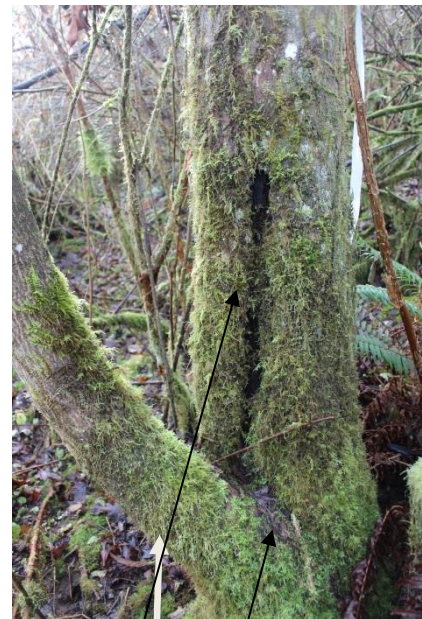
64

7748 Red alder, co-dominant leaders' one failing, decay @ root crown, large cavity of decay

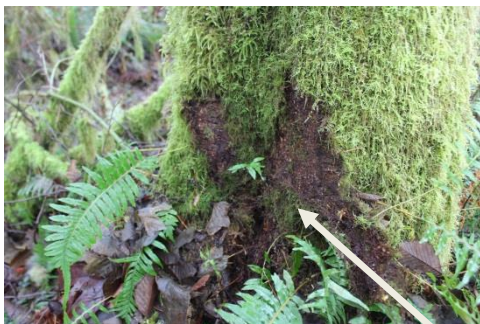
65

8225 Red alder: decay at root crown, carpenter ants

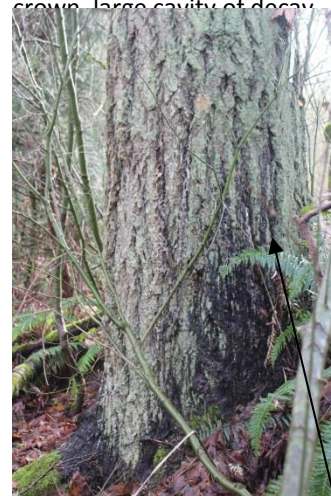
8100 Douglas fir: sap circumventing trunk at 4' - probable armillaria root rot

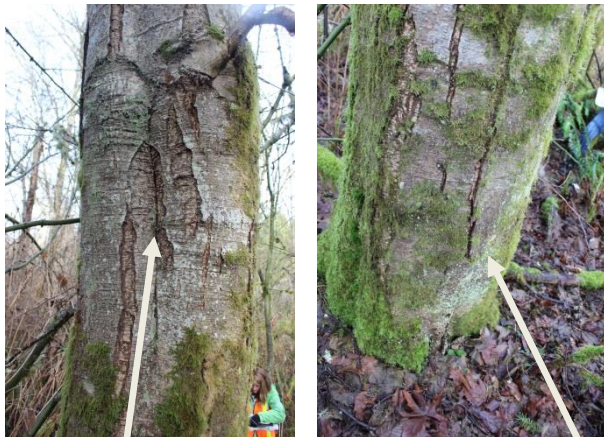
67

8103 Red alder: cavity of decay, vertical crack with decay

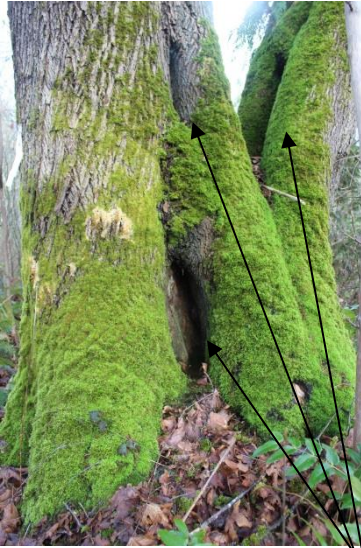
69

8098 Bigleaf maple: cavities of decay, filled with water, dead scaffolds, previous failures

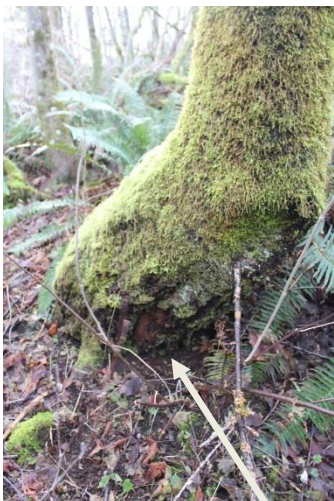
73

8060 Cherry: self-corrected lean, decay at root crown

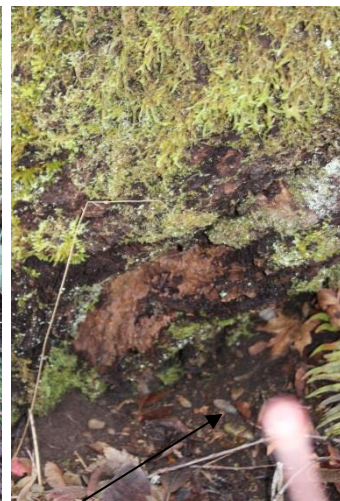
8232 Bigleaf maple: Hypoxylon Canker, decay at root crown, previous failure @ root crown

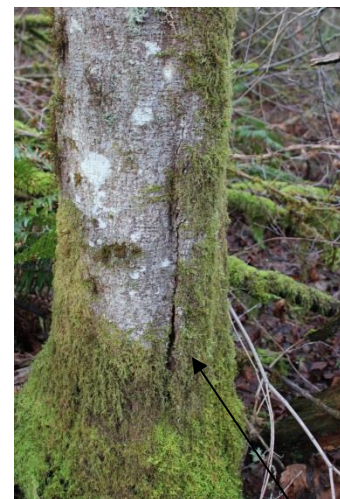
8090 Red alder: Vertical crack

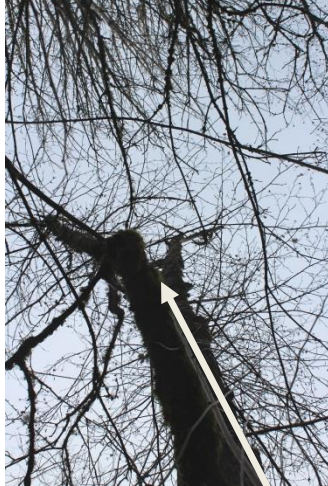
75

7732 Red alder: Previous top loss, mostly dead

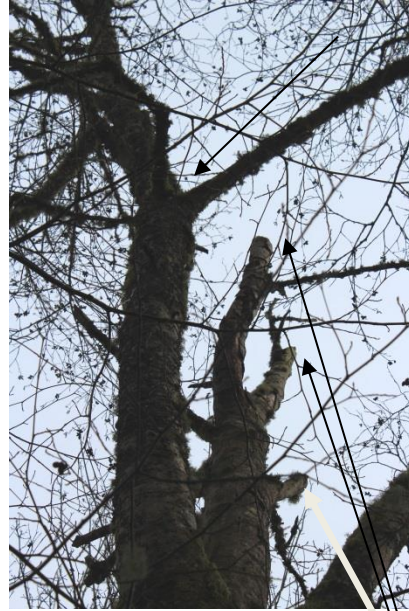
76

7734 Red alder: Dead scaffolds, dead top, large column of decay on north scaffold

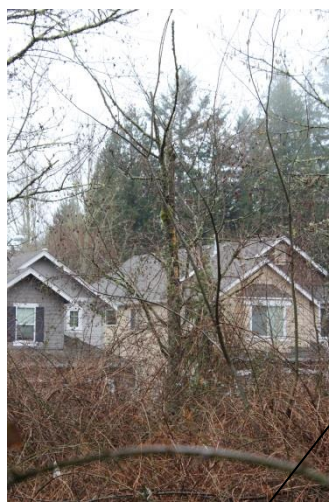
78

7218 Red alder: dead top, decay, pileated woodpecker

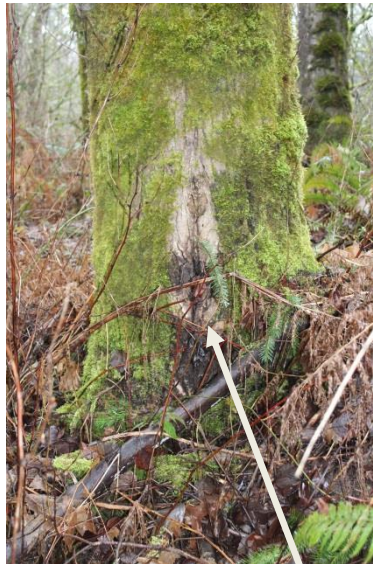
80

7550 Cottonwood: Crack at base, decay, carpenter ants

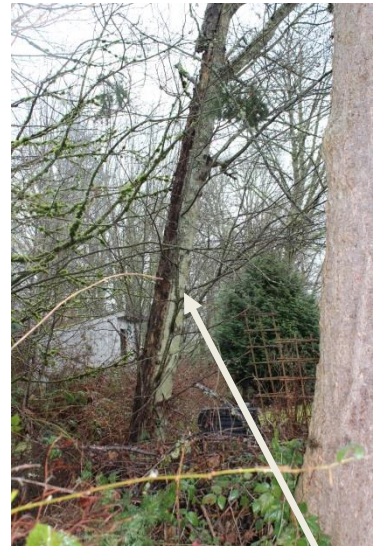
81

7004 Red Alder: Dead, falling to south

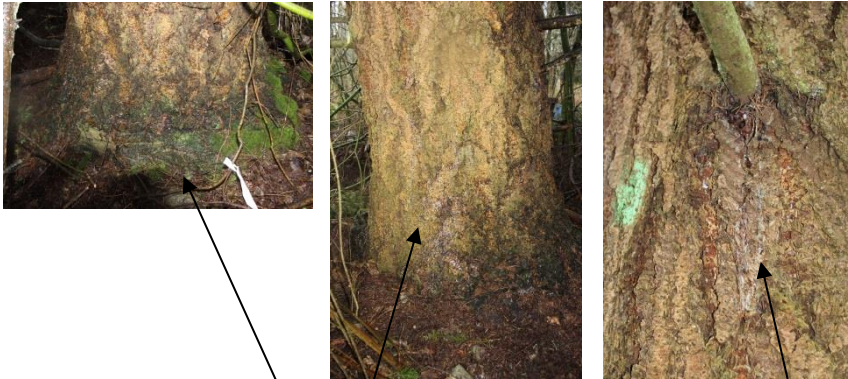
83

9348 Douglas fir: Girdling root, sap flow from lower trunk and branch collars, probable early fungal root infection, previous to failure
