- Tree Protection Plan -

## DUKES LANDING

16410 NE 47<sup>th</sup> Street  
Redmond, WA

Date: March 11, 2015

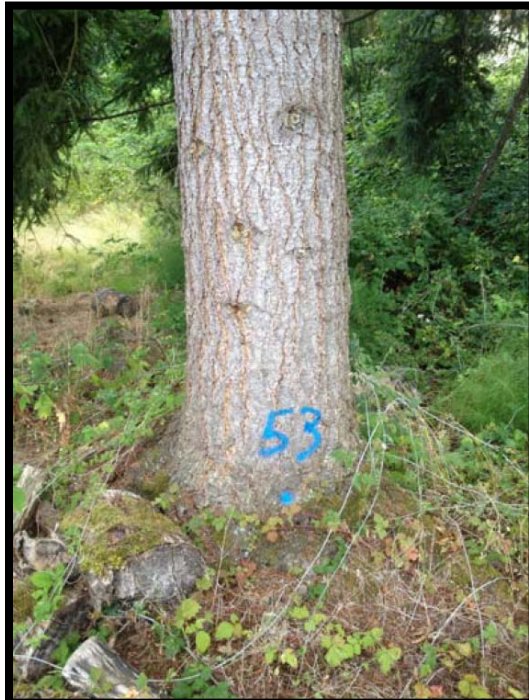
| Tree # | Species | DBH (in.) | Crown Position | Live Crown Ratio (LCR) | Condition | Notes | Minimum Root Protection Zone (RPZ) ft | Project Plan Save / Remove |
|---|---|---|---|---|---|--|---|---|
| 53 | Douglas-fir | 23 | Co-dominant | 65 | Fair | sound and healthy | | Remove |

**Photo A. View of tree numbering on tree # 53.**

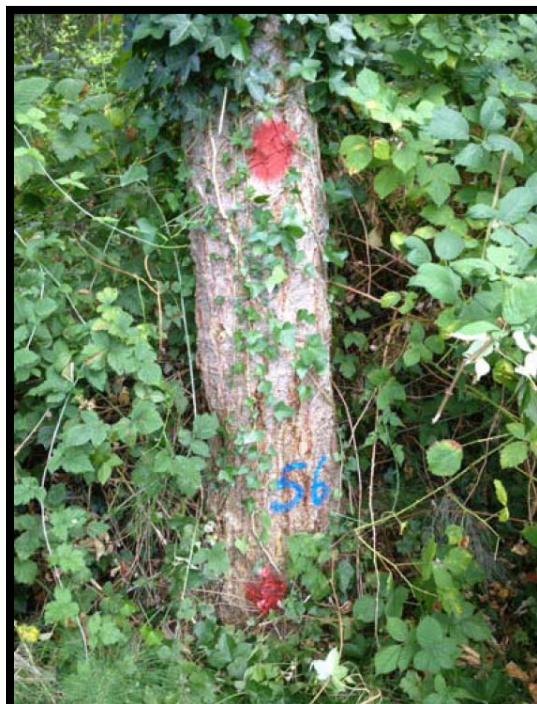
**Photo B. View of marking on a tree recommended for removal.**

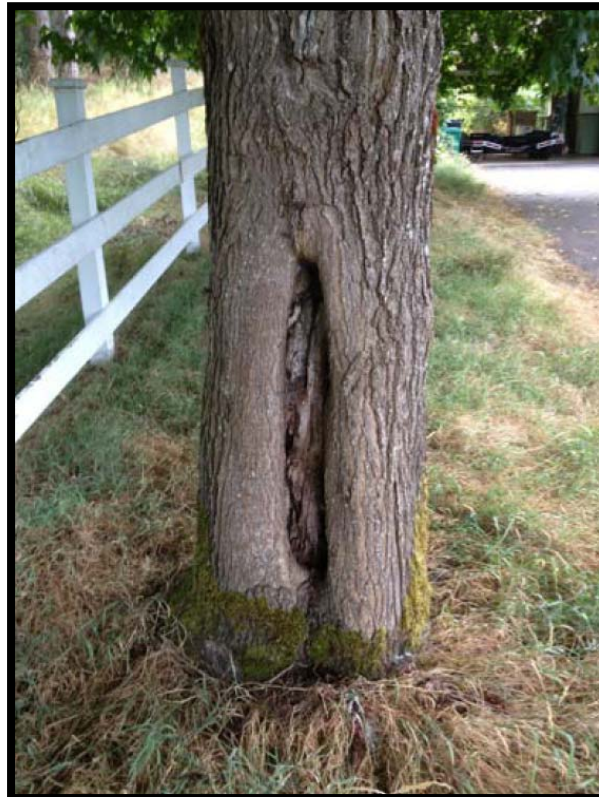
| Tree # | Species | DBH (in.) | Crown Position | Live Crown Ratio (LCR) | Condition | Notes | Minimum Root Protection Zone (RPZ) ft | Project Plan Save / Remove |
|---|---|---|---|---|---|---|---|---|
| 29 | Sweetgum | 17 | Co-dominant | 70 | Very Poor | hollow | | Remove |

**Photo C. View of decayed stem on #29, a 17" DBH Sweetgum.**

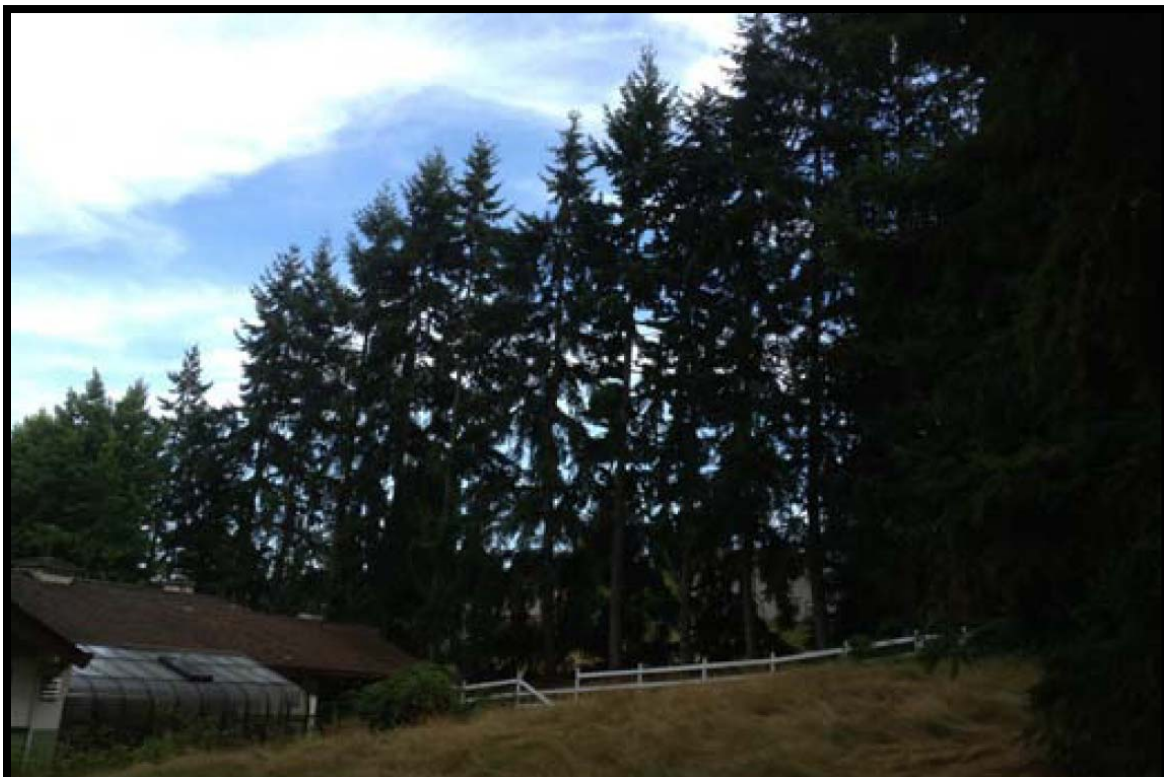
**Photo D. View of the row of Douglas-fir in the central portion of the parcel.**

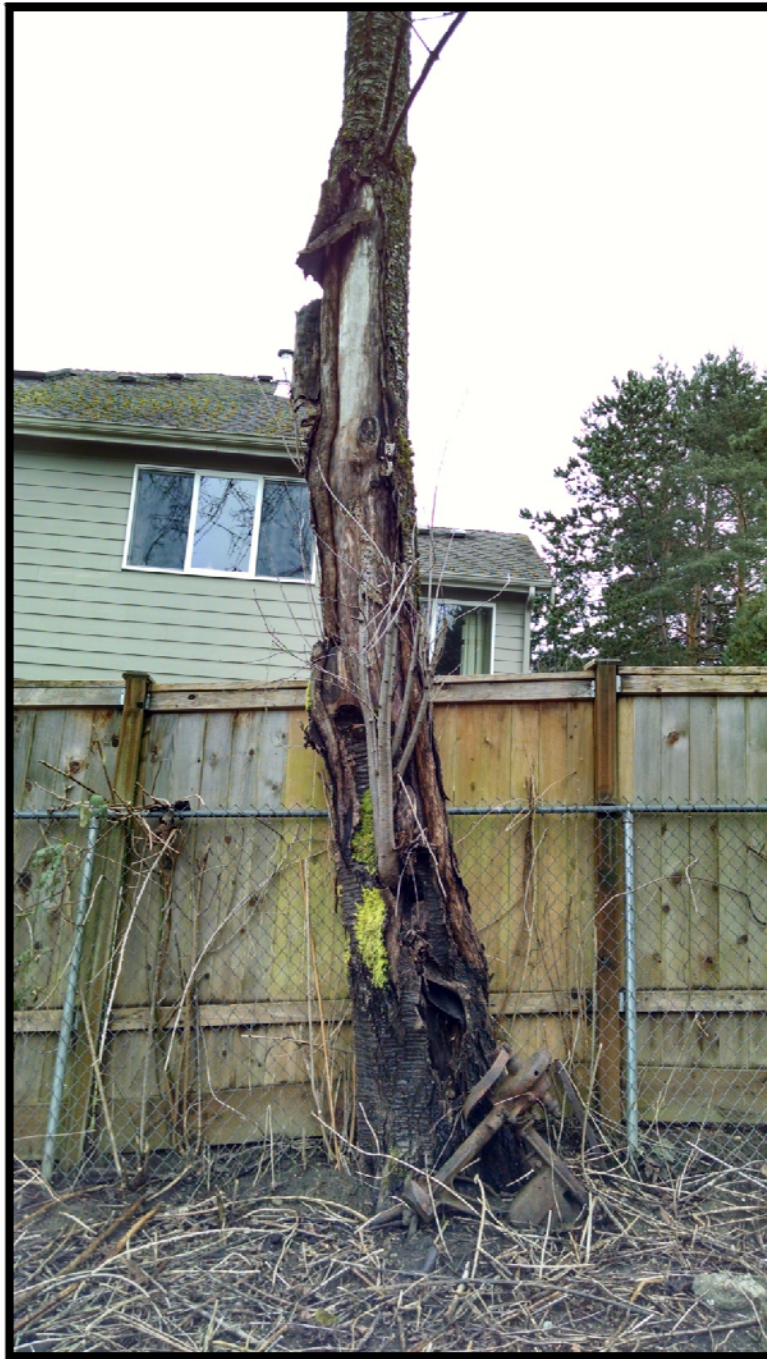
| Tree # | Species | DBH (in.) | Crown Position | Live Crown Ratio (LCR) | Condition | Notes | Minimum Root Protection Zone (RPZ) ft | Project Plan Save / Remove |
|---|---|---|---|---|---|--|---|---|
| 54 | Cherry | 14 | Dominant | 60 | Very Poor | Large scar/stem decay | | Remove |

**Photo E. Severely damaged cherry tree on eastern property line.**
