**WETLAND REPORT  
FOR THE  
BETROZOFF JONES SUBDIVISION**

11818 and 11845 Red-Wood Road  
Redmond, WA 98052

December 3, 2012

Mark Rigos, P.E.  
Certified Wetland Biologist  
440 SE Darst Street  
Issaquah, WA 98027  
(425) 652-6013  
markrigos@hotmail.com

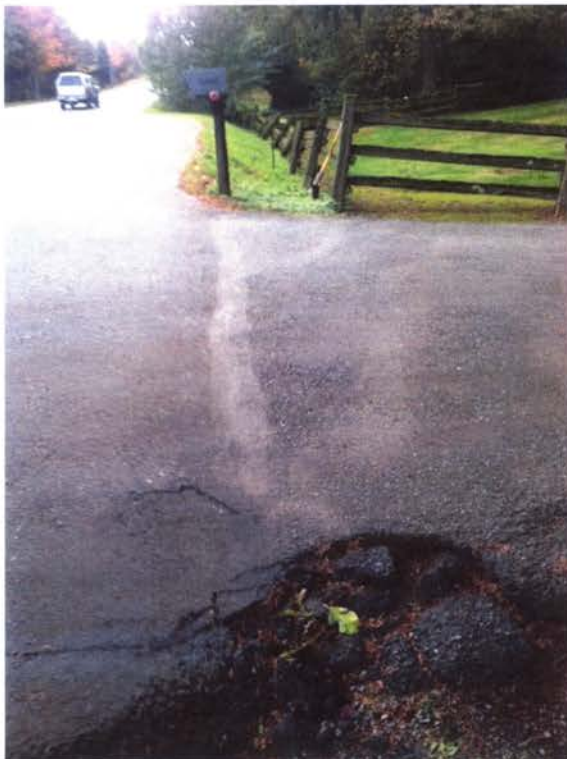
Photo B: Looking south at paved driveway entrance into the North (Jones) Parcel. Pavement is stained and showing watermarks from water overtopping pavement. 12-inch corrugated metal pipe outlet not found.

- A. Buried Culvert: The 12-inch diameter corrugated metal pipe (cmp) outlet somewhere near the Jones's paved driveway entrance was not found. The outlet is likely buried north of the driveway. The culvert should be video cameraed to determine if the culvert is clogged. The outlet should be found and removed of debris. If the culvert is crushed under the driveway, then a properly sized culvert should be installed.

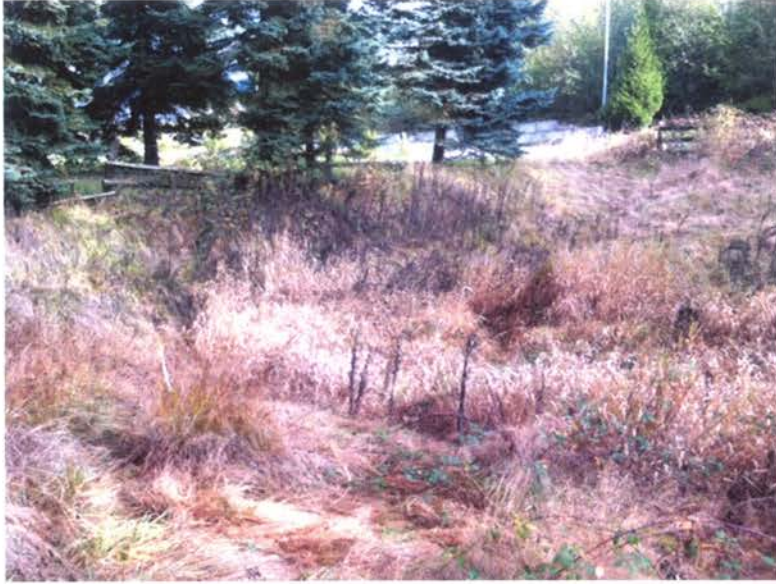
Photo C: Looking northeast at former farm pond / current drainage ditch on the North (Jones) Parcel. Sample Location 3 is on the left side of the photo and SL-4 is at the low point in the center of the photo.

In the very northeast corner of the Jones Parcel is a depression and man-made drainage ditch. SL-3 is on the a side slope of the drainage ditch, likely close to the shoreline of the former farm pond. SL-4 is placed at the bottom of the depression. The depression and drainage ditch both contain all three wetland criteria and thus would normally be considered wetland. However, these areas do not meet Redmond’s wetland definition for the following two reasons:

1. The depression is at the north terminus of an existing man-made drainage ditch and former farm pond. The depression terminates at a 12-inch diameter (inner) concrete culvert inlet. In November 2012, property owner Adam Jones told me that he purchased this property in 1986. Before 1986, at that time and for 13 years later, horses and livestock would drink water from the farm pond in this depression. Apparently, during the rainy season, there was so much stormwater runoff flowing into the depression that it was used as a farm pond. On occasions, the depression would fill with up to three feet deep of water. Apparently, the concrete culvert would periodically plug, which helped allow the farm pond to fill with water. As of 2012, the farm pond no longer exists because there is decreased stormwater runoff being directed to the drainage ditch than there used to be, there are no longer horses or livestock onsite, and the system has not been plugged. In approximately 2005, a storm drainage collection and conveyance system was constructed on the east side of Red-Wood Road in conjunction with pavement improvements. This fairly recent system conveys natural stream water from tributary areas to the southeast. So what effectively has happened was that stream water has been diverted into the new conveyance system under the east side of Red-Wood Road. I

observed stream flow in this new stream culvert system on my first site investigation. There is no longer enough tributary water to create the farm pond effect on the subject site. However, because this area was a farm pond, it is not considered a wetland, because a farm pond is exempt from Redmond's wetland definition (see above).

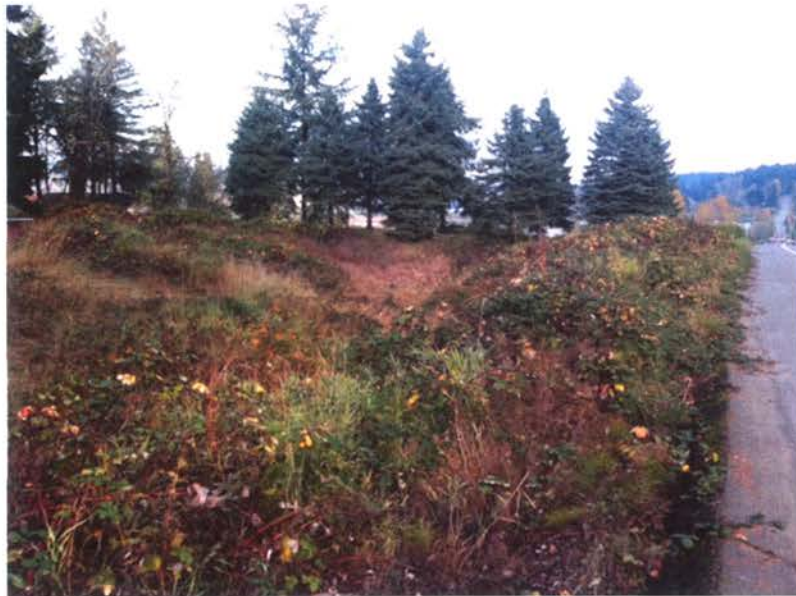
Photo D: Looking north at unmaintained roadside drainage ditch choked full of Himalayan blackberry and reed canarygrass. Drainage ditch located partly in public right-of-way and partly on the North (Jones) Parcel.

- B. Ditch Maintenance: Along the Jones frontage, the drainage ditch has not been maintained very well by either the property owner or the City. On the north segment, Himalayan blackberry has completely overgrown the side slopes. At the base of the ditch, reed canarygrass has completely invaded. Rip-rap pads should be placed every 100 feet in the ditch to reduce erosion potential.

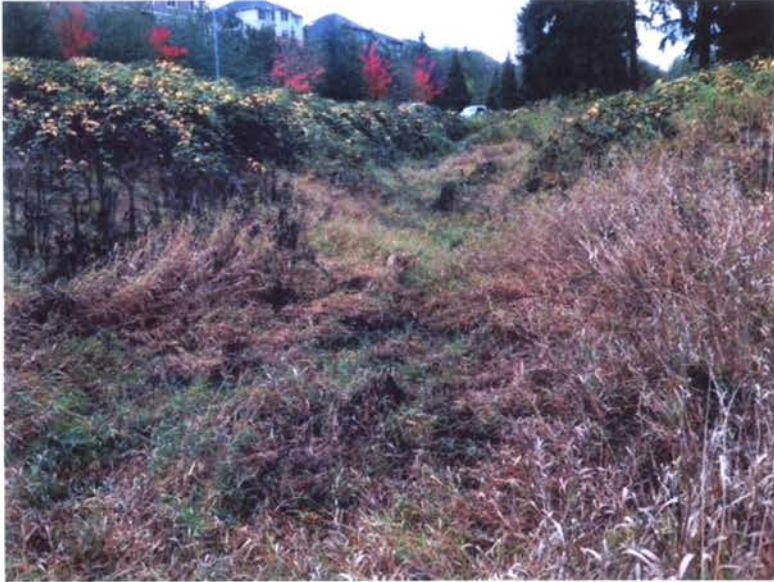
Photo E: Looking south-southeast up the drainage ditch on the North (Jones) Parcel. Vehicle in foreground is driving on Red-Wood Road.

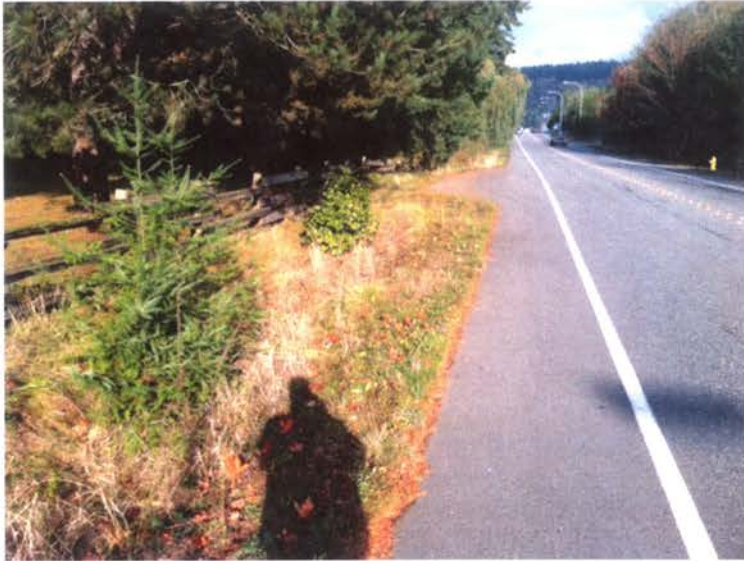
Photo G: Looking north at the roadside drainage ditch sloping down to the north along the South (Betrozoff) Parcel.

- C. Ditch Maintenance: Between SL-6 and SL-5, along the Betrozoff frontage, the drainage ditch has not been maintained. Cattails have been allowed to grow and have silted up and dammed the ditch. As a result, the drainage ditch dams up stormwater which has created wetland characteristics. The cattails should be removed, the sediment needs to be properly disposed of and the ditch needs to be properly sloped at 1% minimum. The excavated material should be properly disposed of offsite.

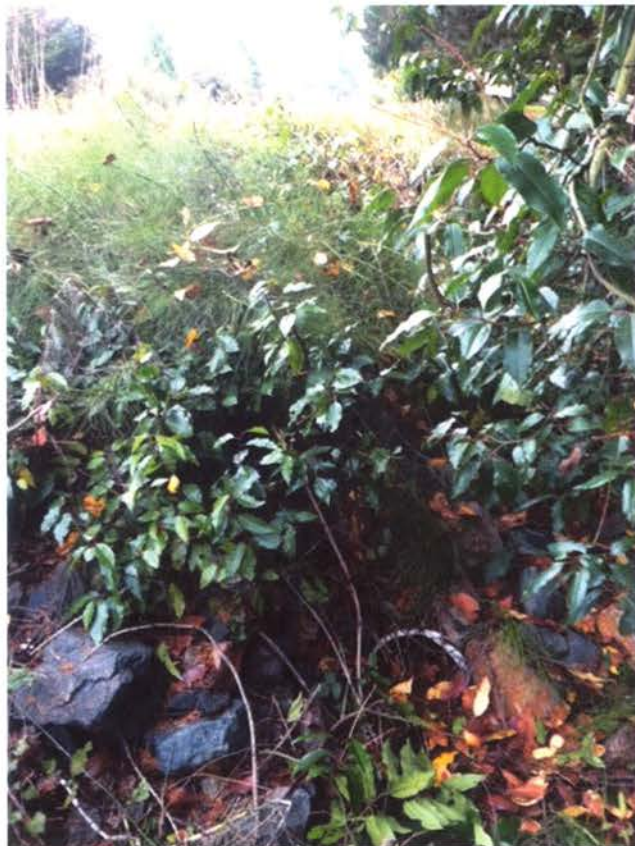
Photo H: Approximately 100 feet north of Photo G, looking south at 12-inch diameter corrugated metal pipe outlet and drainage ditch along the South (Betrozoff) Parcel.

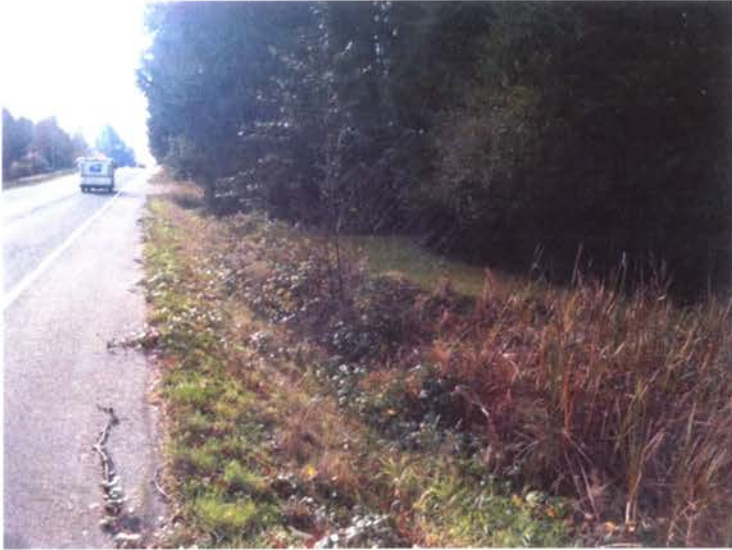
Photo I: Looking south at unmaintained drainage ditch that slopes down to the north.
