## **CRITICAL AREA STUDY**

## Ellsworth - 134th Avenue

Wetland Resources, Inc. Project #11122

September 24, 2013

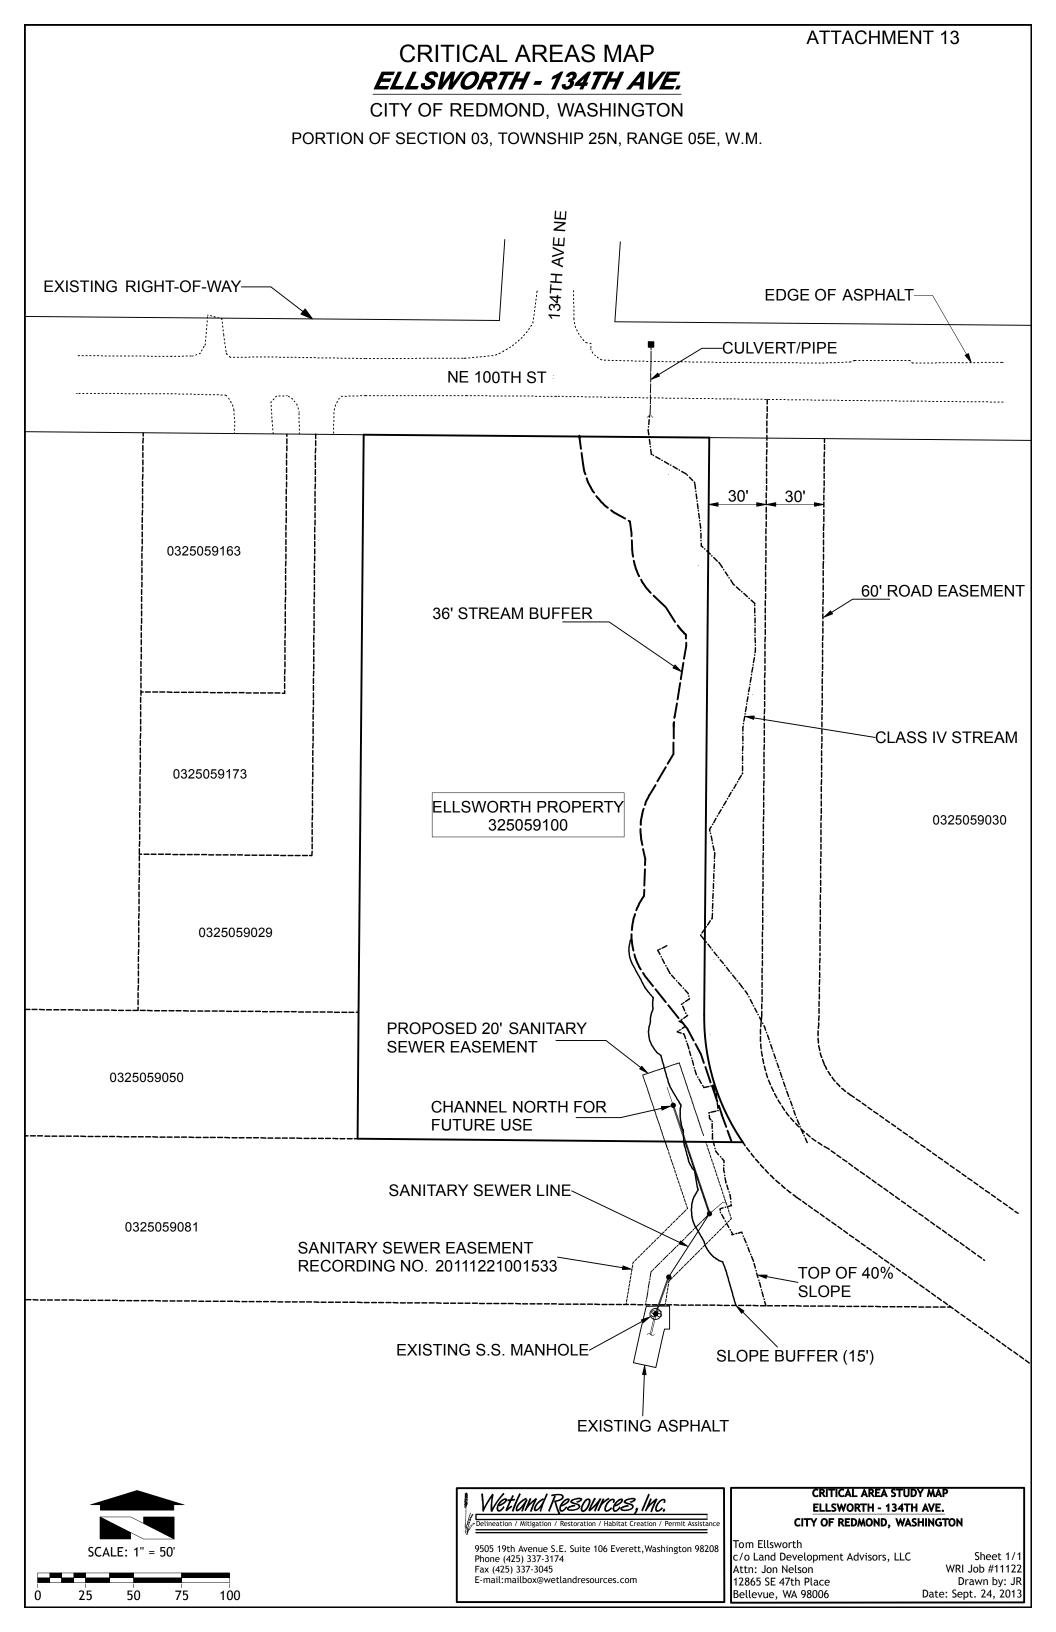
The proposed sanitary sewer project will have no impact to the stream or stream buffer. The proposed work will occur outside (west) of the stream buffer. Work may occur in a portion of the steep slope buffer, however (see attached Critical Areas Map for more details).
