**CRITICAL AREA STUDY  
AND  
MITIGATION PLAN  
FOR  
Heathers Ridge South**

*Wetland Resources, Inc.* Project #15023

June 29, 2015

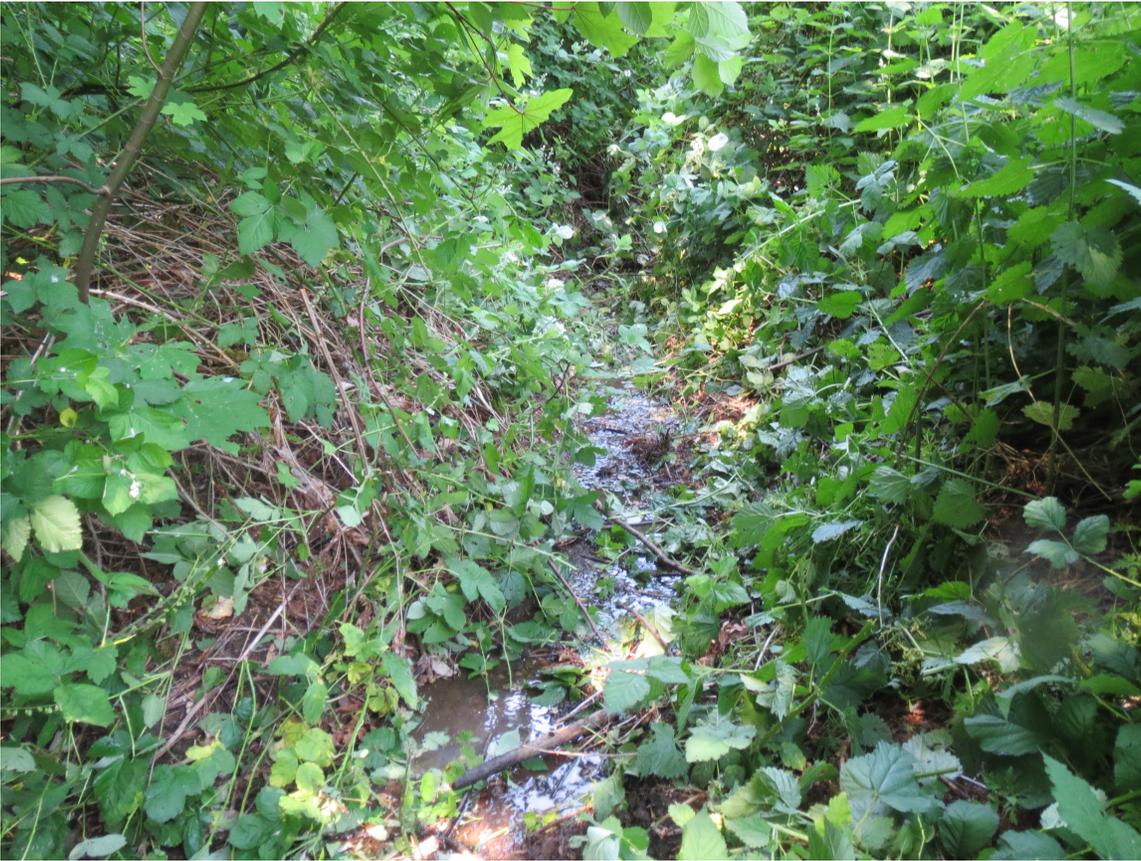
**Stream A flowing through blackberry near northern property boundary**

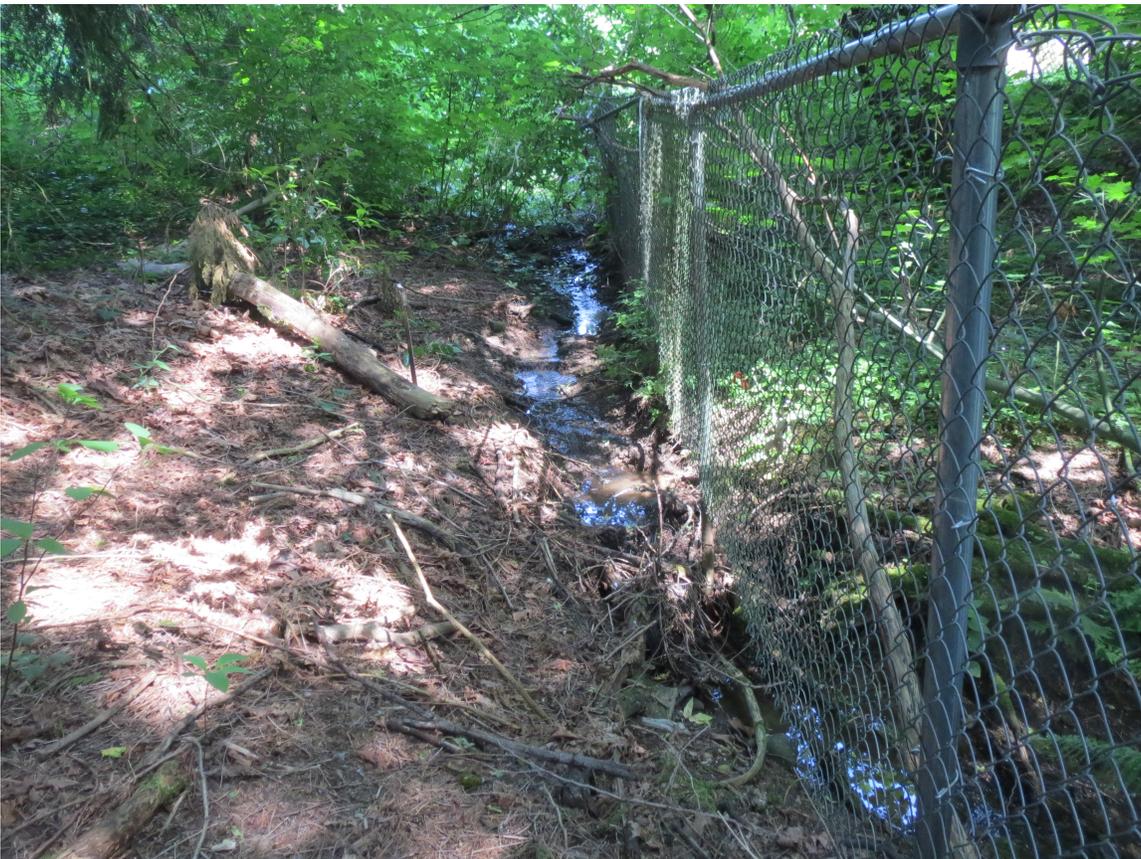
**Upstream view of Stream A along eastern property boundary**

The identified stream is a perennial feature that meets the criteria for a Class IV stream per RZC 21.64.020(2)(d). It enters the property in the northeast corner via a culvert under NE 100th Street, crosses the northeast property corner, and then flows off-site to the southeast. The stream continues flowing south, roughly paralleling the eastern property boundary. Based on the Cowardin Classification System, the stream is a riverine, lower perennial, unconsolidated bottom, mud and cobble-gravel system (R2UB1/3).

The on-site portion of the stream, as well as a section of the off-site portion, was inspected during the 2011, 2013, and 2015 site investigations. Stream substrate is comprised of small cobbles, gravel, and mud/silt. The channel is shaded by fairly dense riparian vegetation, though the northernmost section, adjacent to NE 100th Street, is dominated by invasive Himalayan blackberry. Small woody debris was observed throughout most of the inspected portion of the stream. A few larger pieces were also observed. An approximate 5-foot drop was observed in the off-site portion of the stream. The stream channel was dry in this location. Upstream of this location, however, as well as on-site, the stream was flowing.

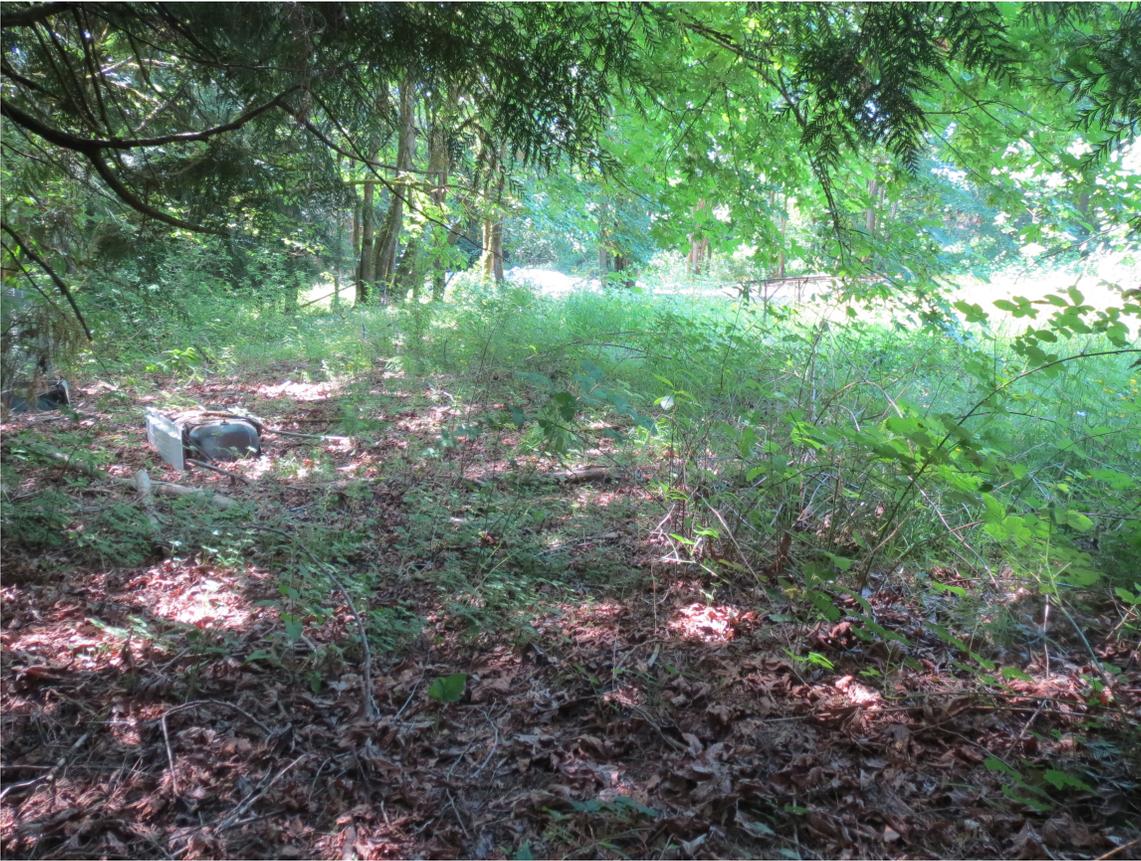
**View south of existing stream buffer**

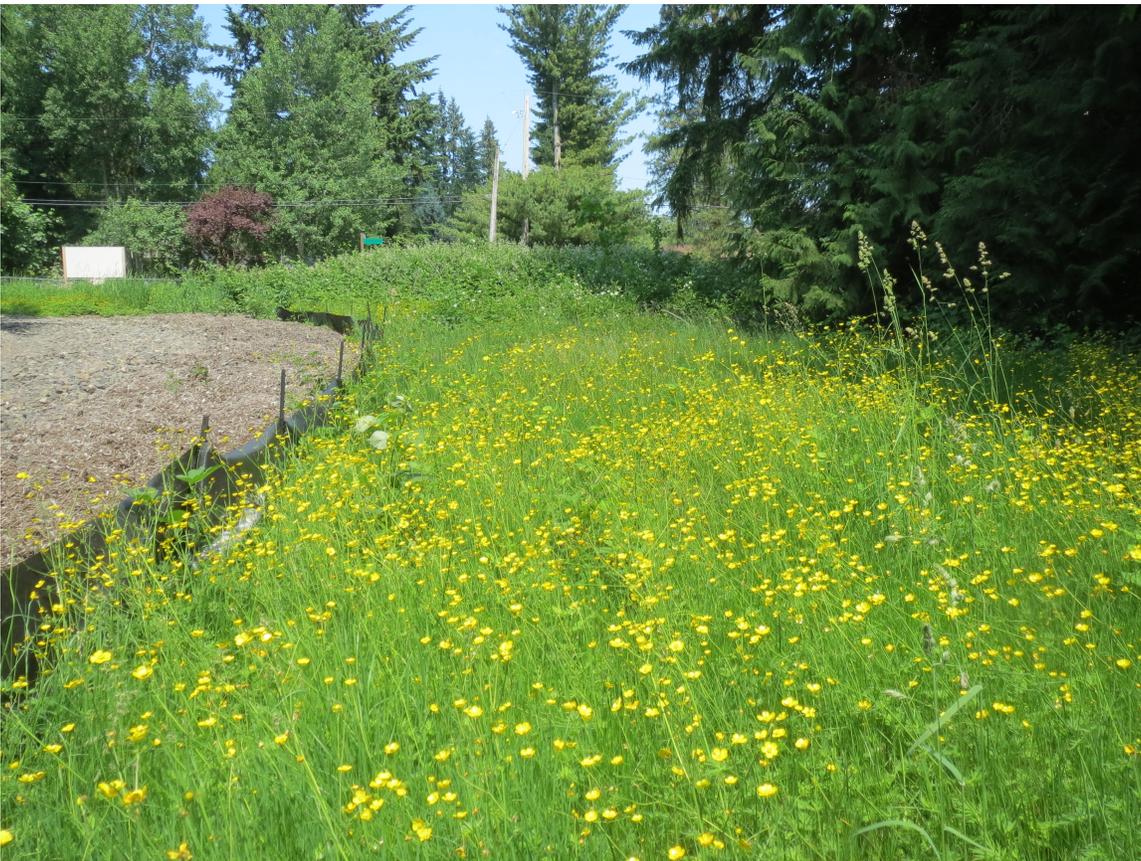
**View north of existing stream buffer**

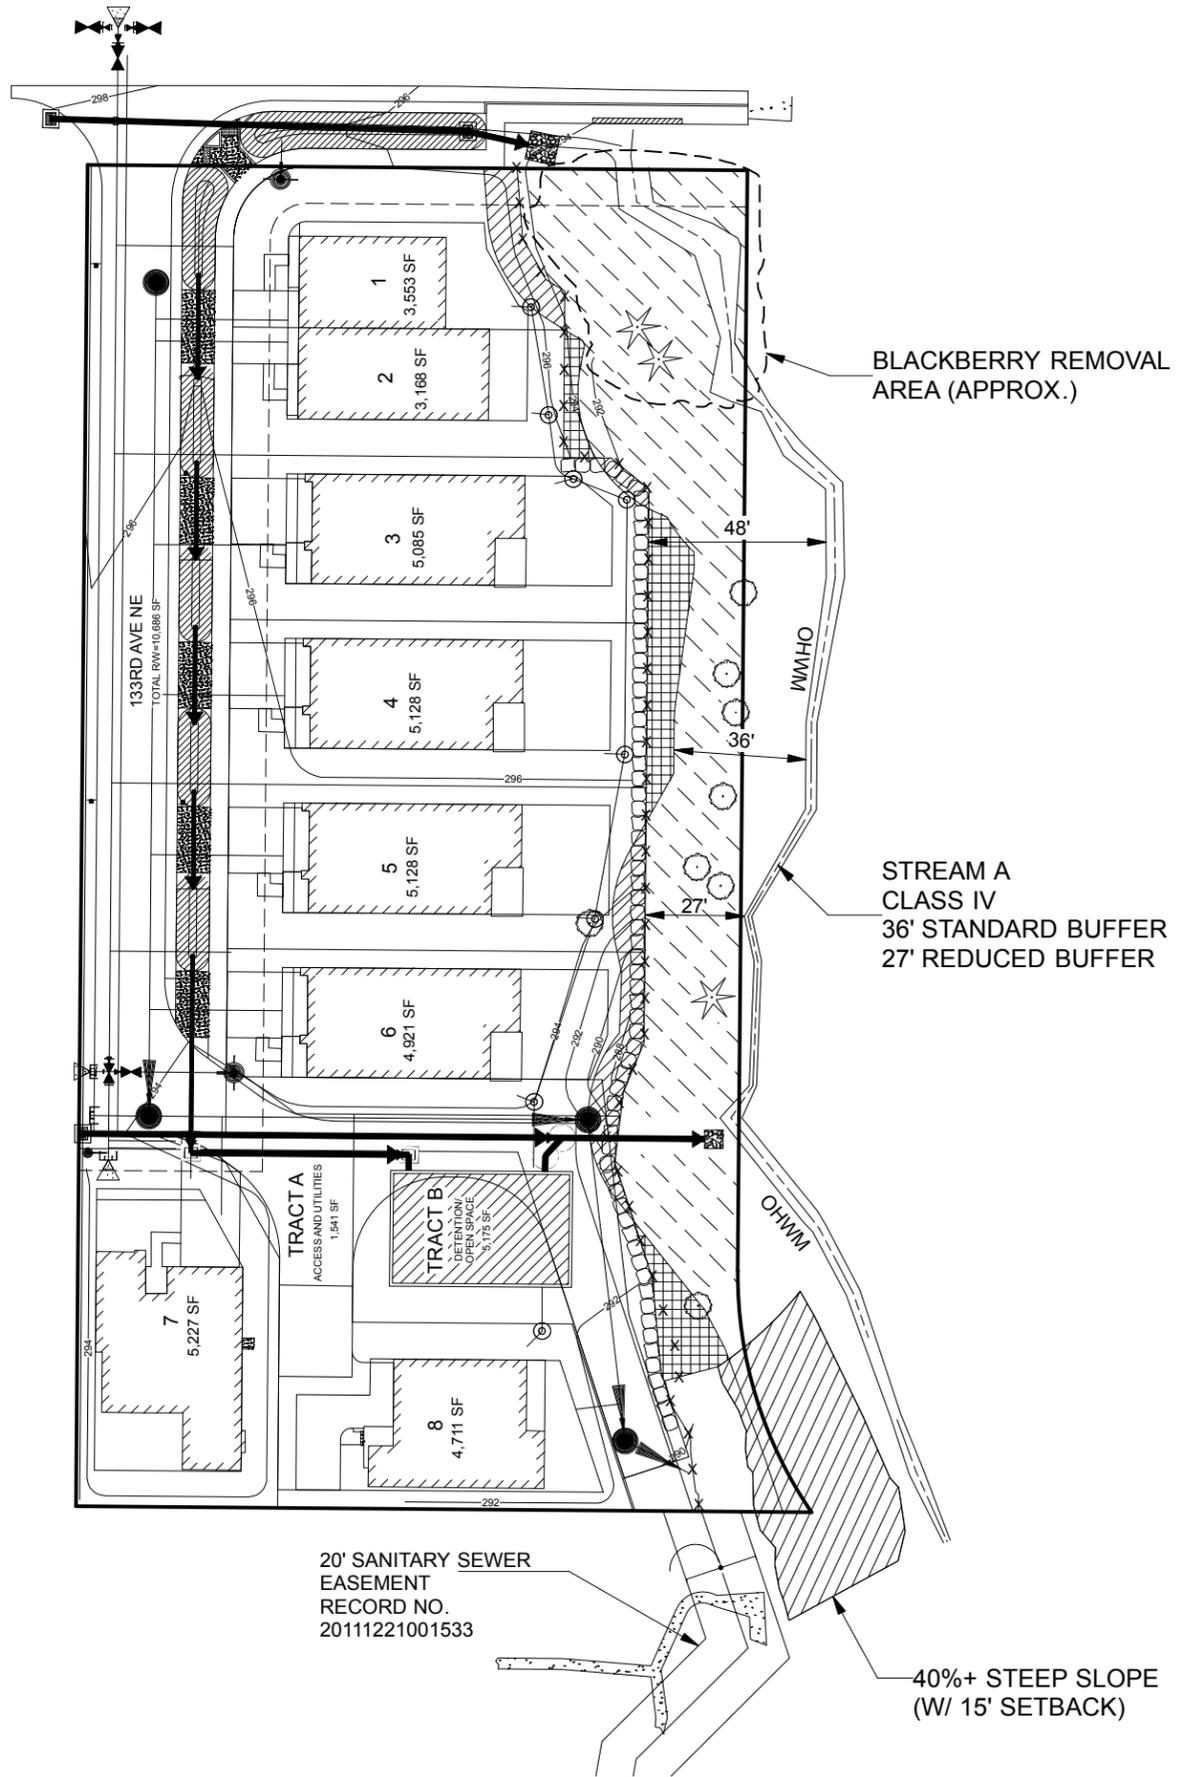
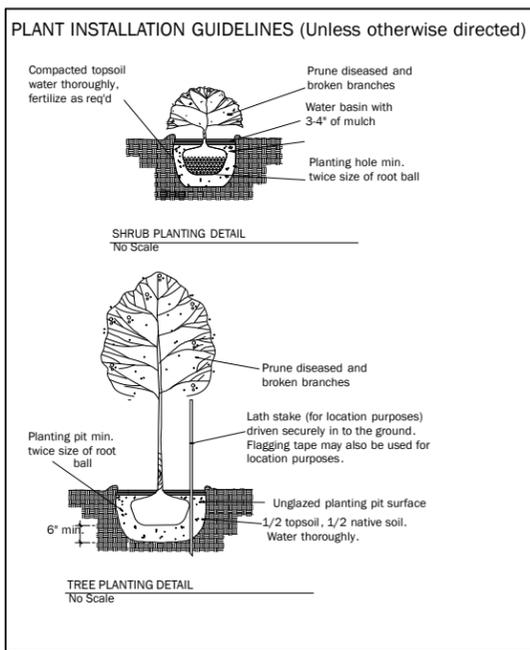
# MITIGATION PLAN MAP HEATHERS RIDGE SOUTH

PORTION OF SECTION 03, TOWNSHIP 25N, RANGE 05E, W.M.

\*Refer to the Critical Areas Study and Mitigation Plan (WRI 2015) for plan details.

\*\*For rip-rap dispersion pads only. The northern rip-rap pad shall be planted with 16 whips; the southern pad shall be planted with 7 whips

Permanent signage and fencing shall be installed along the perimeter of the critical area boundary per RZC 21.64.010(R). In addition, a Native Growth Protection Area (NGPA) tract will be established for the on-site stream and buffer area to provide permanent protection for these resources (Tract C on the project site plans and critical areas study map).

Two stormwater outfall pipes will be constructed within the project site. One will be placed within a portion of the southern stream buffer. This pipe will originate south of Lot 6 and extend east into the buffer. The second outfall pipe will be located adjacent/parallel to the northern property boundary and will extend east into the stream buffer. Rip-rap dispersion pads will be located at both pipe outlets. These pipes represent temporary impacts; they will be placed below ground and the areas will be returned to their previously existing conditions following installation. The dispersion pads will be planted with willow whips (*Salix* sp.) to aid in stormwater dispersion and help reduce the velocity of stormwater as it exits the pipe. The northern rip-rap pad (64 SF) will be planted with 16 willow whips while the southern pad (25 SF) will be planted with 7 willow whips. Whips will be planted two feet on-center (OC).

In order to compensate for buffer width averaging and provide additional habitat protection, approximately 8,925 SF of stream buffer will be enhanced with native trees and shrubs. Currently, the stream buffer contains only scattered, mature trees, a sparse shrub layer, and a fairly dense herbaceous layer. The northernmost portion of the buffer is dominated by a dense layer of Himalayan blackberry, which will be removed as part of the enhancement plan. The enhancement plan includes the additional buffer areas being designated as part of buffer width averaging (1,303 SF).
