**CRITICAL AREA STUDY
AND
MITIGATION PLAN
FOR
Heathers Ridge South**

Wetland Resources, Inc. Project #15023

June 29, 2015

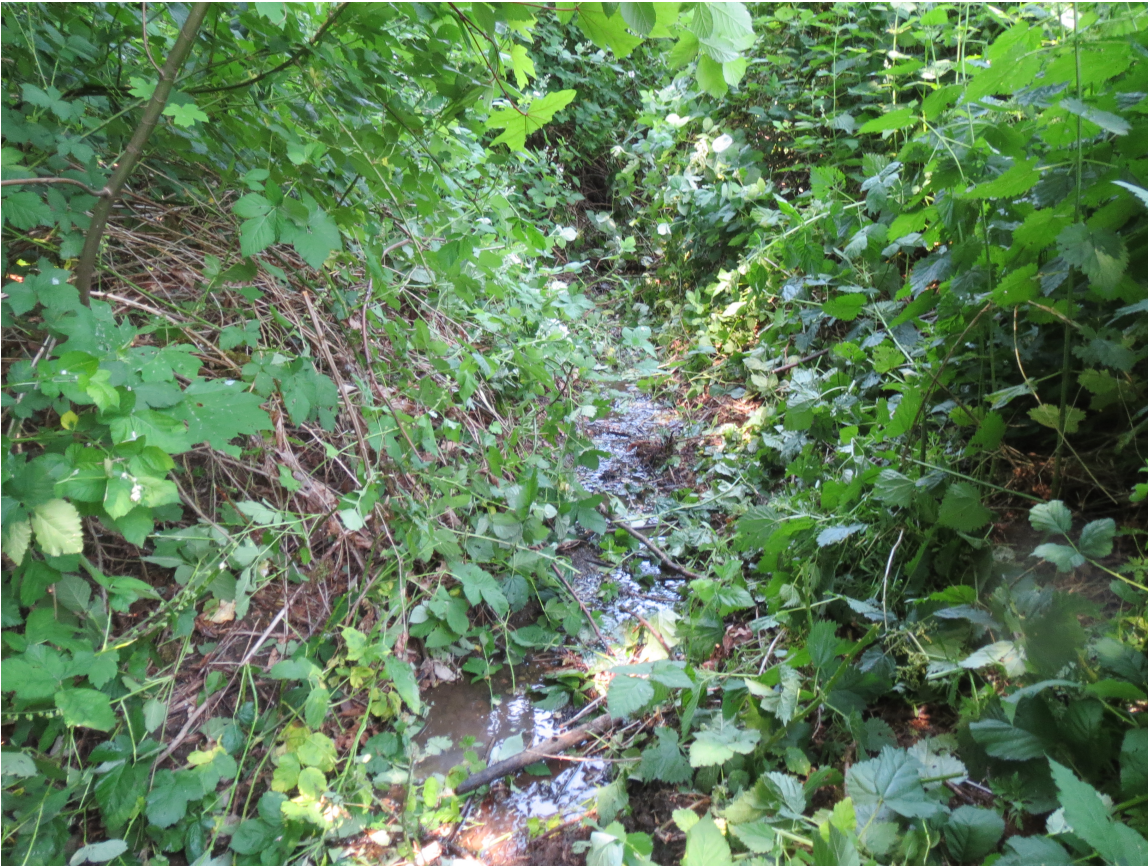
Stream A flowing through blackberry near northern property boundary

The on-site portion of the stream, as well as a section of the off-site portion, was inspected during the 2011, 2013, and 2015 site investigations. Stream substrate is comprised of small cobbles, gravel, and mud/silt. The channel is shaded by fairly dense riparian vegetation, though the northernmost section, adjacent to NE 100th Street, is dominated by invasive Himalayan blackberry. Small woody debris was observed throughout most of the inspected portion of the stream. A few larger pieces were also observed. An approximate 5-foot drop was observed in the off-site portion of the stream. The stream channel was dry in this location. Upstream of this location, however, as well as on-site, the stream was flowing.

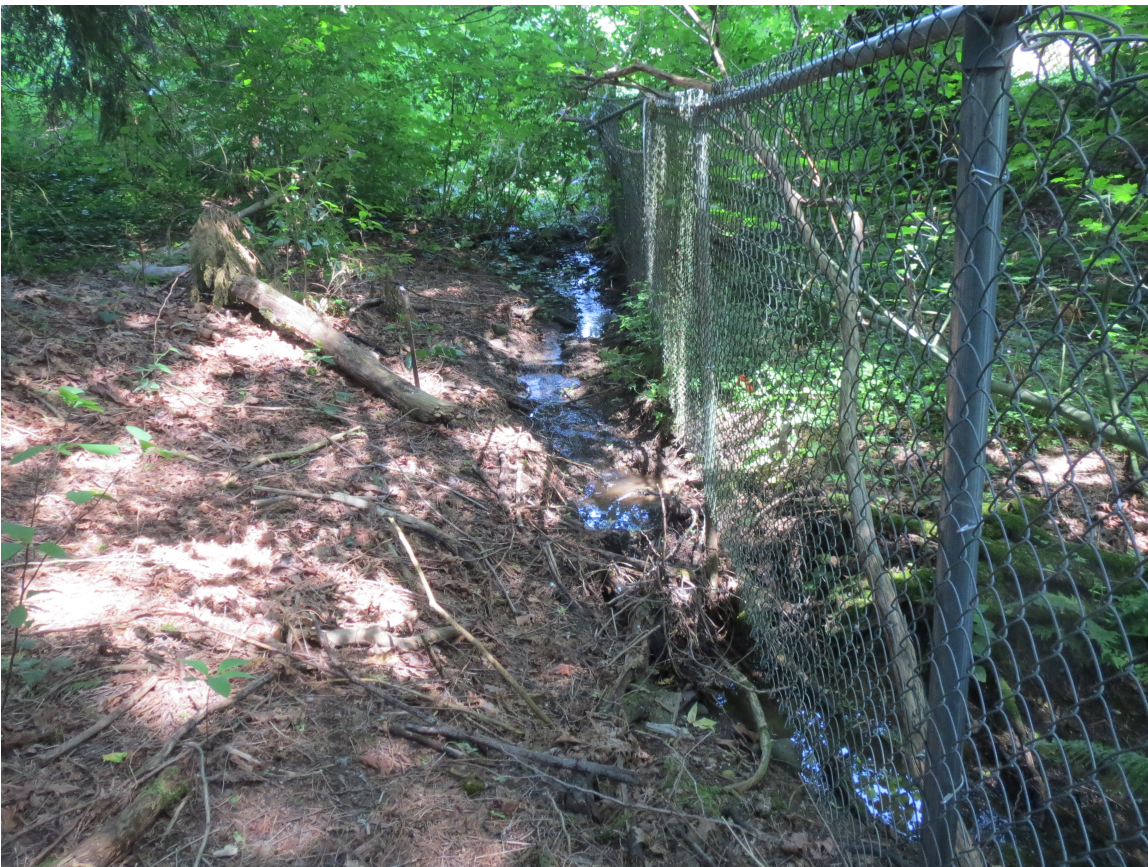
Upstream view of Stream A along eastern property boundary

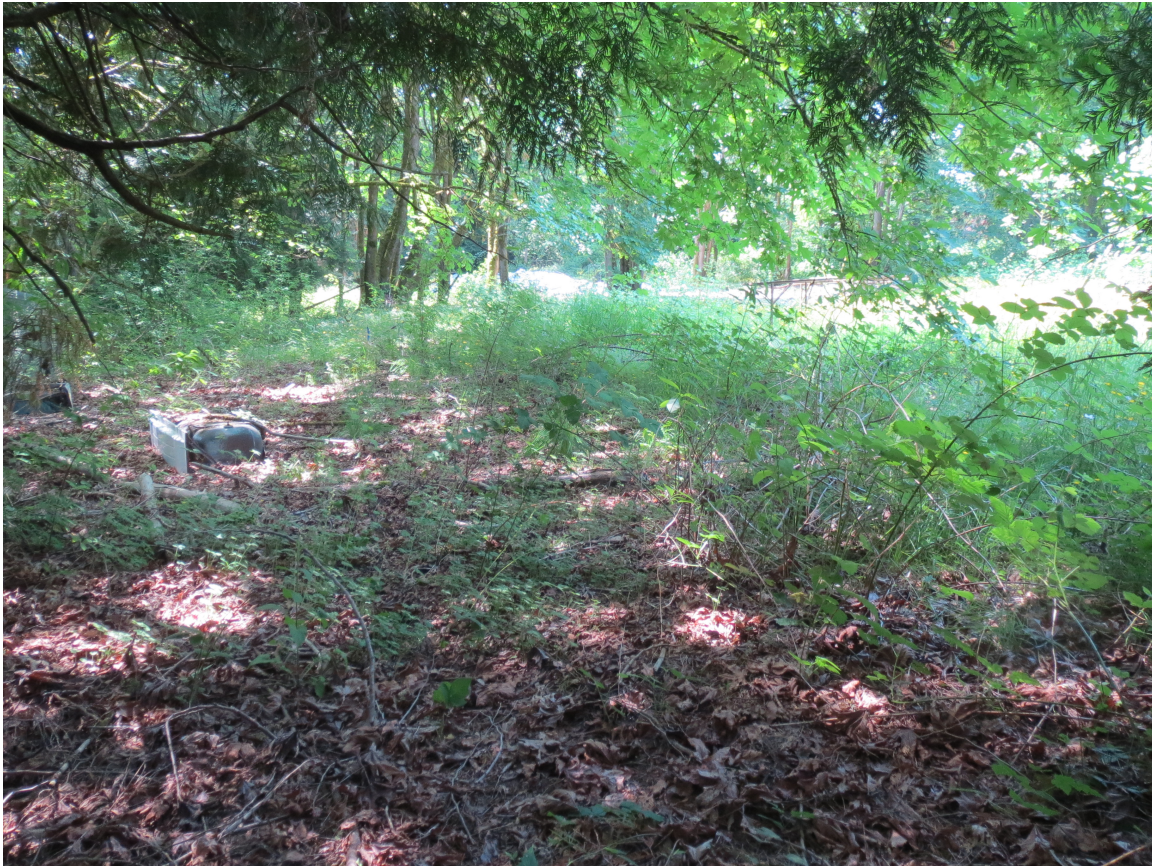
View south of existing stream buffer

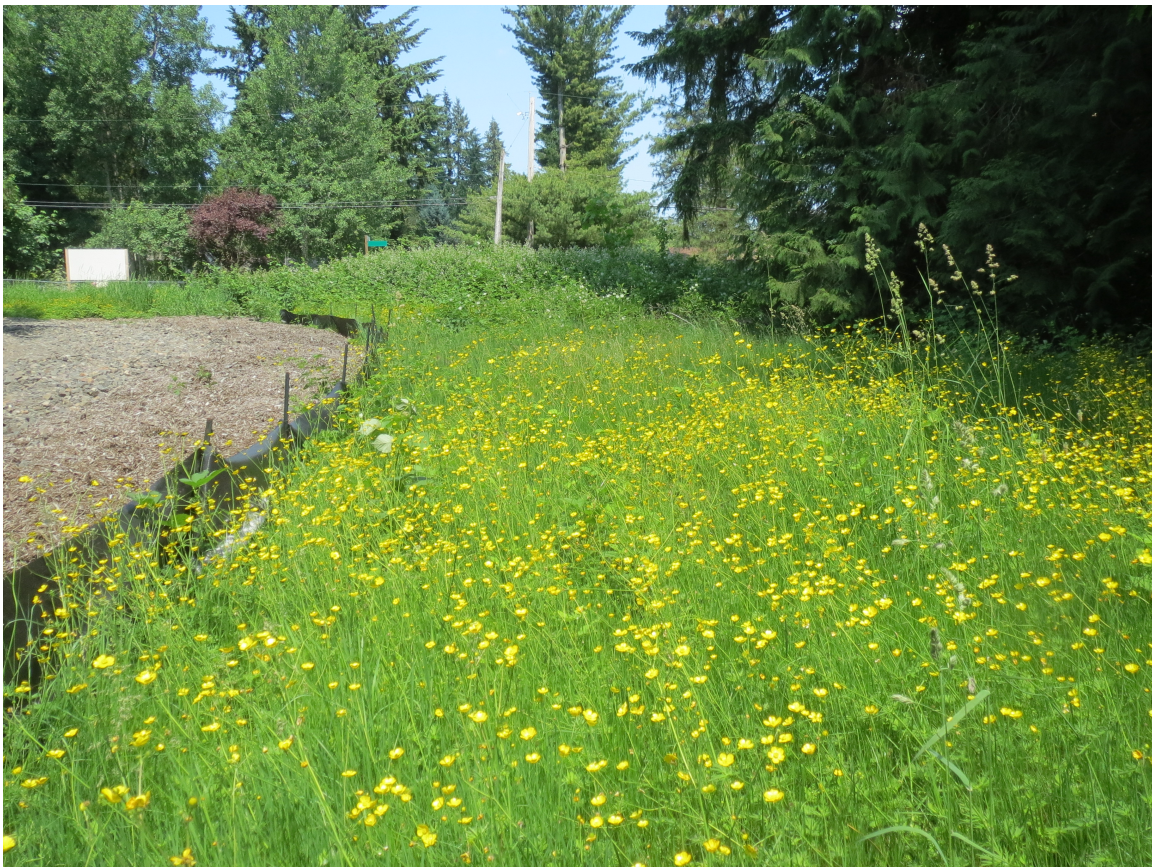
View north of existing stream buffer

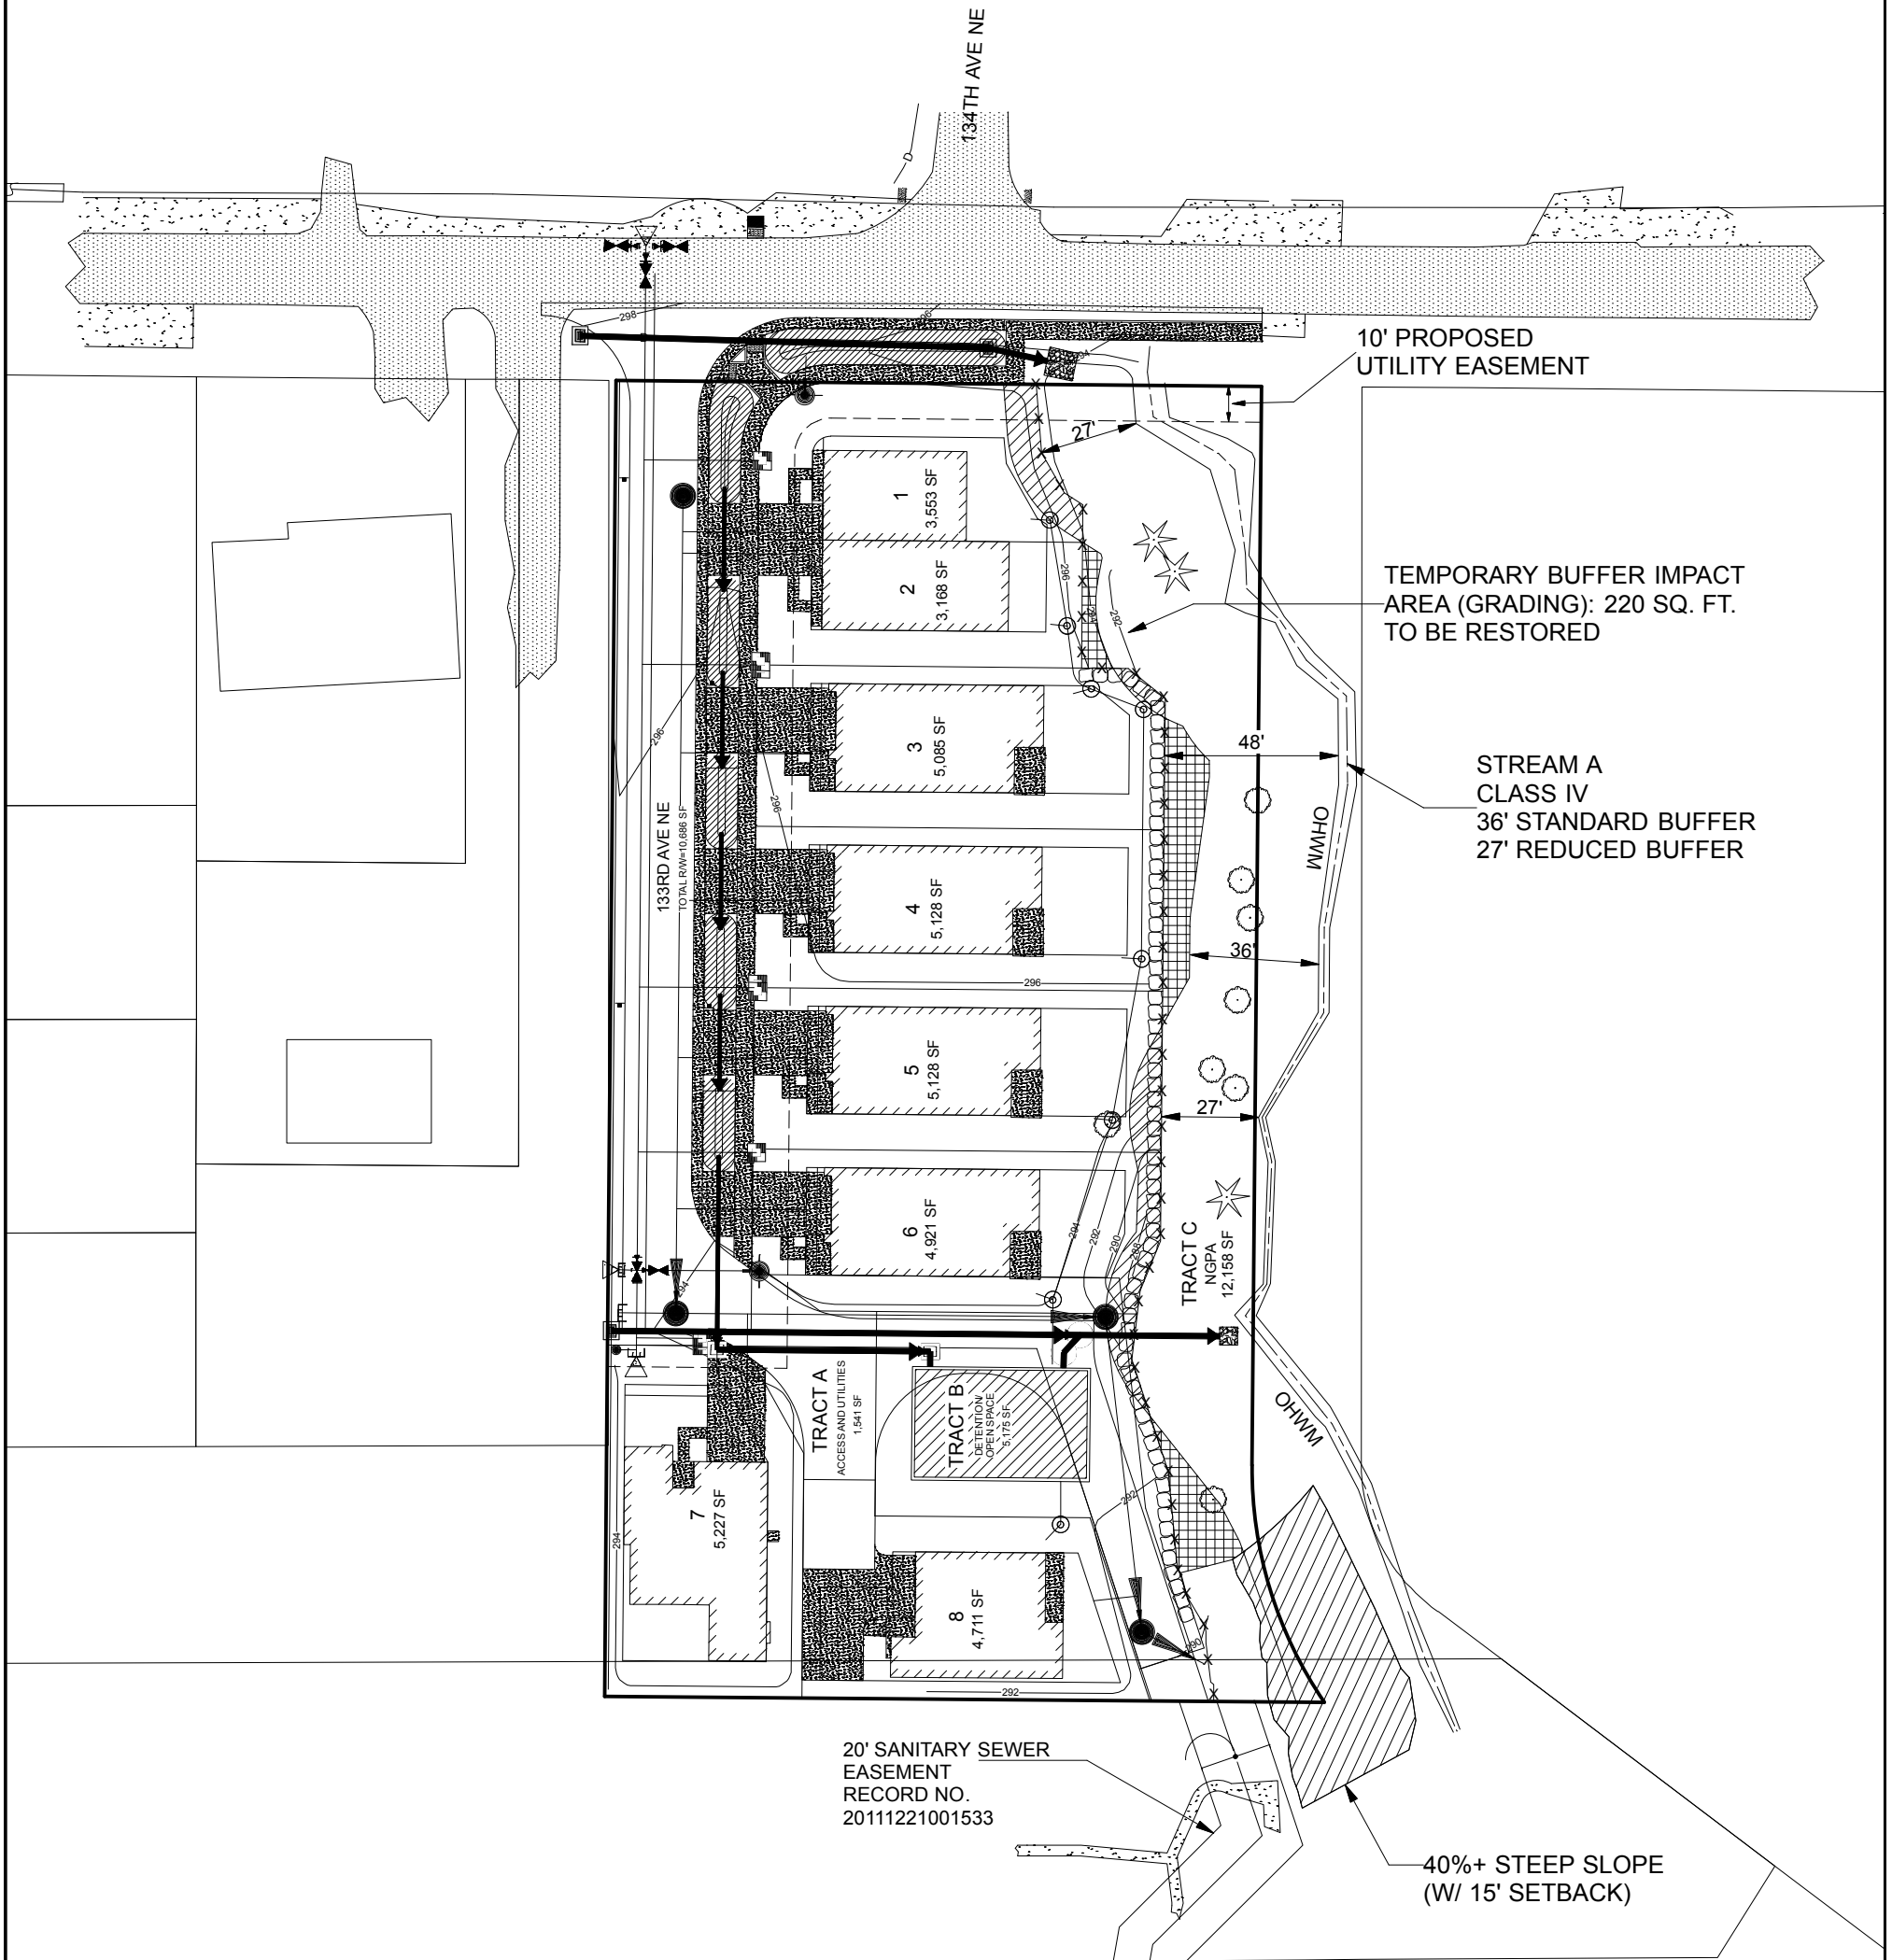
CRITICAL AREAS MAP AND SITE PLAN HEATHERS RIDGE SOUTH

LEGEND	
	STREAM
	BUFFER REDUCTION (1,215 SF)
	BUFFER ADDITION (1,303 SF)
	STEEP SLOPE
	FENCE/NGPA SIGN BNDRY
	EXISTING TREES TO REMAIN

The amount of stream buffer being reduced/removed is 1,215 SF. The replacement buffer totals 1,303 SF.

Permanent signage and fencing shall be installed along the perimeter of the critical area boundary per RZC 21.64.010(R). In addition, a Native Growth Protection Area (NGPA) tract will be established for the on-site stream and buffer area to provide permanent protection for these resources (Tract C on the project site plans and critical areas study map).

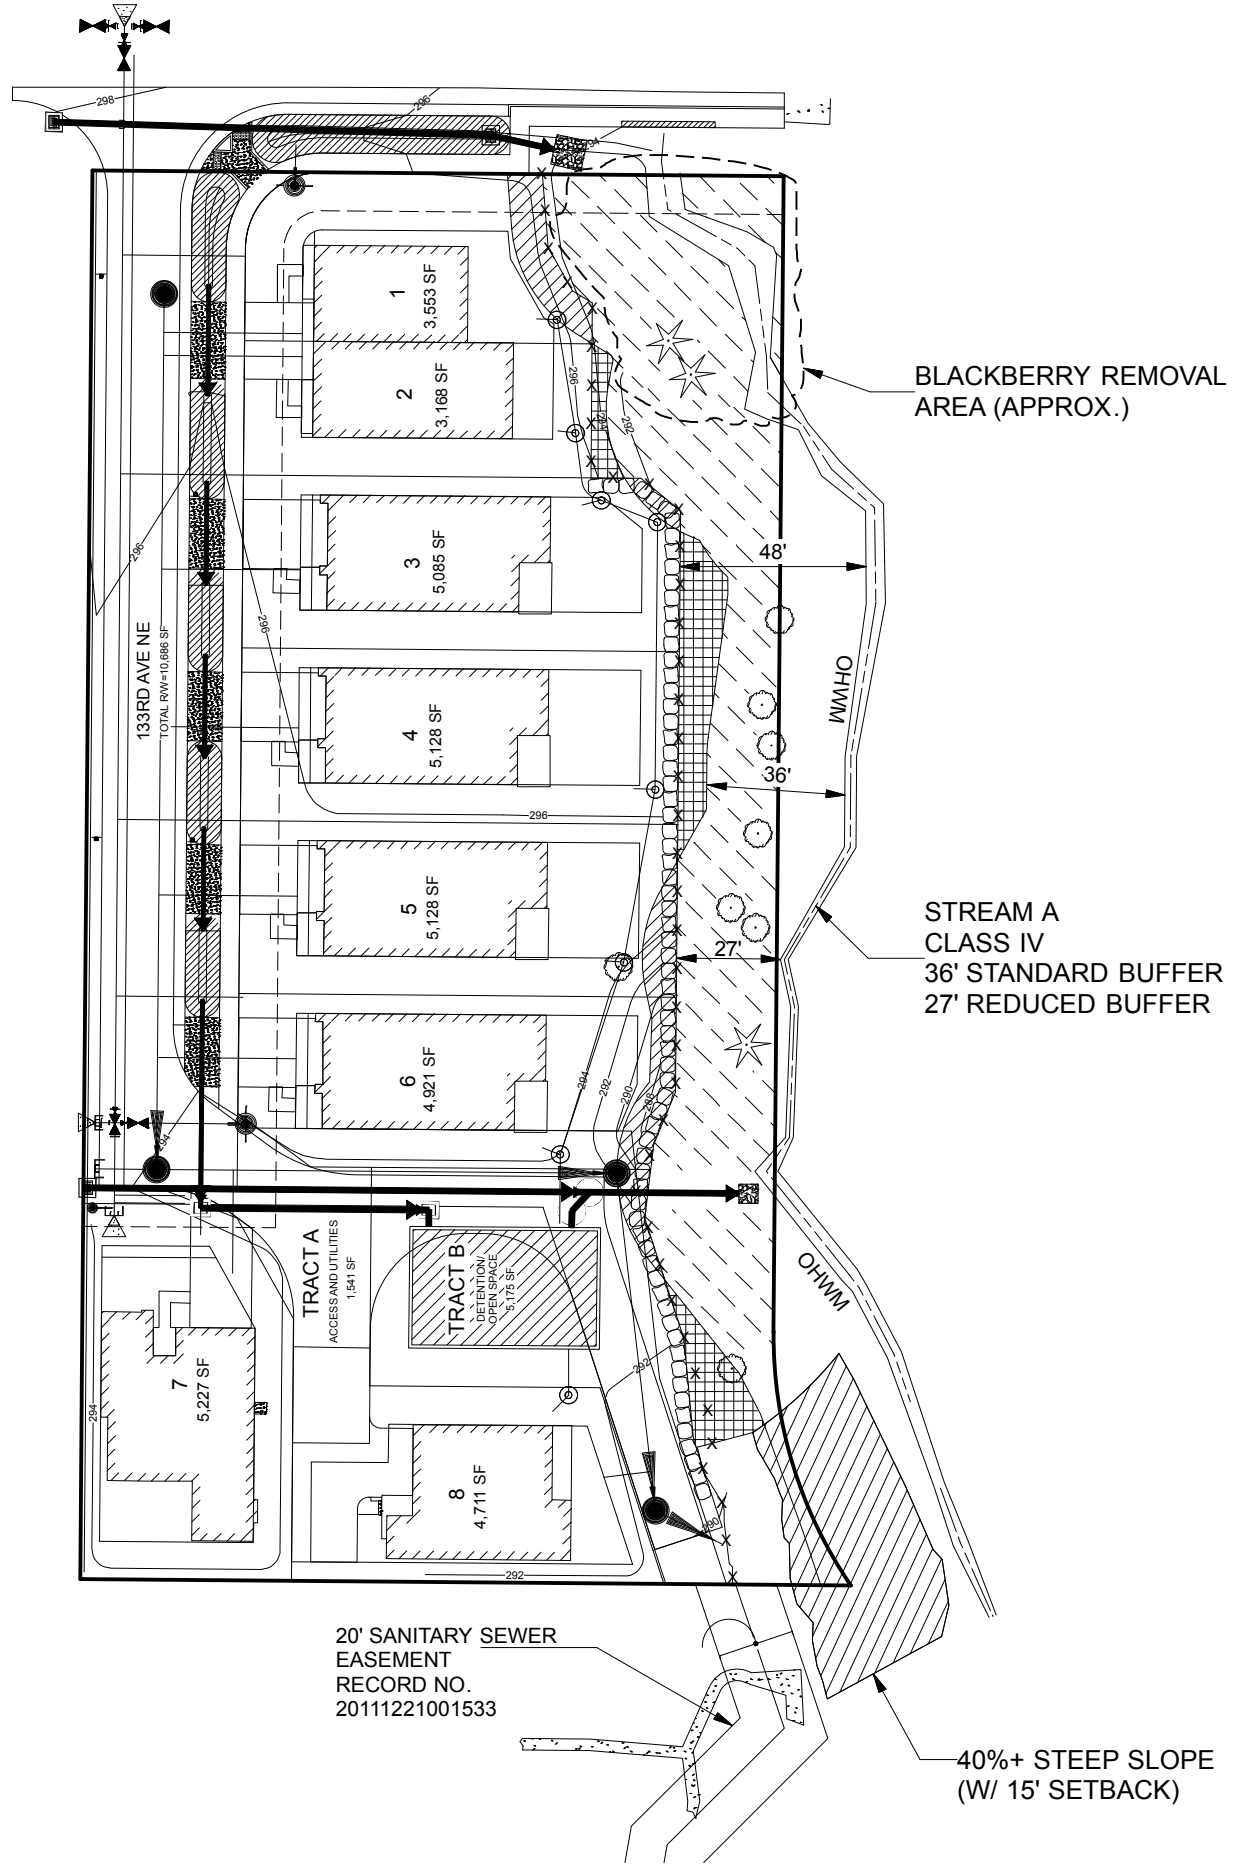
MITIGATION PLAN MAP HEATHERS RIDGE SOUTH

*Refer to the Critical Areas Study and Mitigation Plan (WRI 2015) for plan details.

**For rip-rap dispersion pads only. The northern rip-rap pad shall be planted with 16 whips; the southern pad shall be planted with 7 whips

Two stormwater outfall pipes will be constructed within the project site. One will be placed within a portion of the southern stream buffer. This pipe will originate south of Lot 6 and extend east into the buffer. The second outfall pipe will be located adjacent/parallel to the northern property boundary and will extend east into the stream buffer. Rip-rap dispersion pads will be located at both pipe outlets. These pipes represent temporary impacts; they will be placed below ground and the areas will be returned to their previously existing conditions following installation. The dispersion pads will be planted with willow whips (*Salix* sp.) to aid in stormwater dispersion and help reduce the velocity of stormwater as it exits the pipe. The northern rip-rap pad (64 SF) will be planted with 16 willow whips while the southern pad (25 SF) will be planted with 7 willow whips. Whips will be planted two feet on-center (OC).

In order to compensate for buffer width averaging and provide additional habitat protection, approximately 8,925 SF of stream buffer will be enhanced with native trees and shrubs. Currently, the stream buffer contains only scattered, mature trees, a sparse shrub layer, and a fairly dense herbaceous layer. The northernmost portion of the buffer is dominated by a dense layer of Himalayan blackberry, which will be removed as part of the enhancement plan. The enhancement plan includes the additional buffer areas being designated as part of buffer width averaging (1,303 SF).
