CRITICAL AREAS REPORT

Edgewood East Short Plat

Redmond, Washington

November 3, 2014

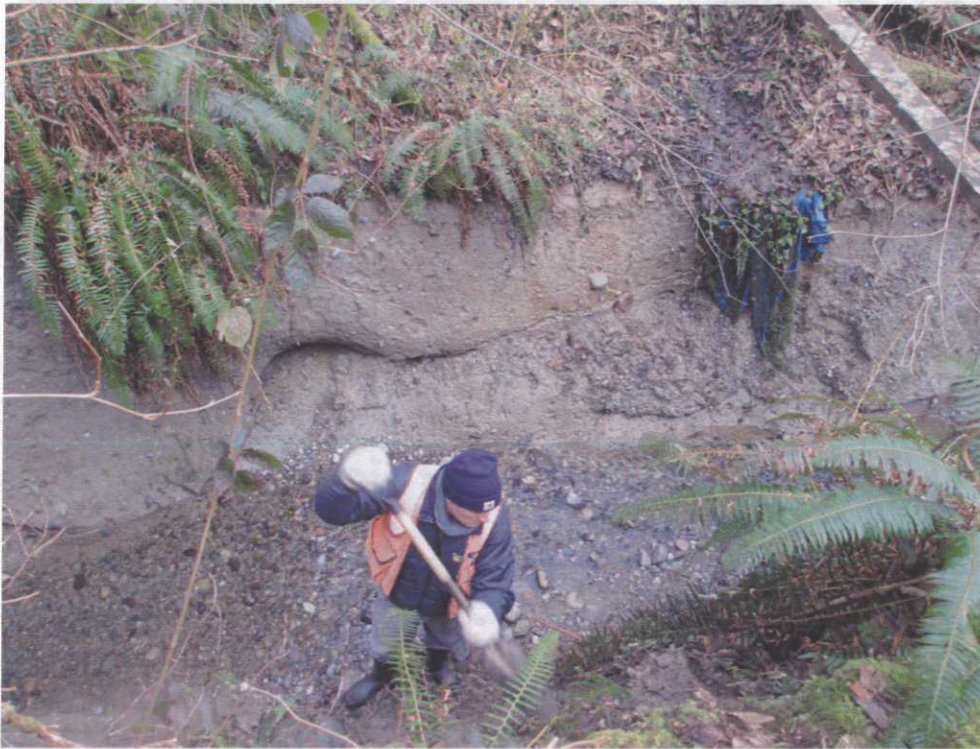
Photo 1. View of deeply incised channel in Stream A. February 4, 2014.

Soils on the property are mapped entirely as Alderwood gravelly sandy loam (USDA NRCS 2014). Stream A is a second order stream that is highly incised through the overlying gravelly sandy loam. The incising process appears, however, to have reached the hardened till layer without further incision in recent years (as an indication of this, a deciduous tree fallen laterally from the bank was observed to have continued to grow back to a vertical position to a diameter of approximately 4 to 6 inches).

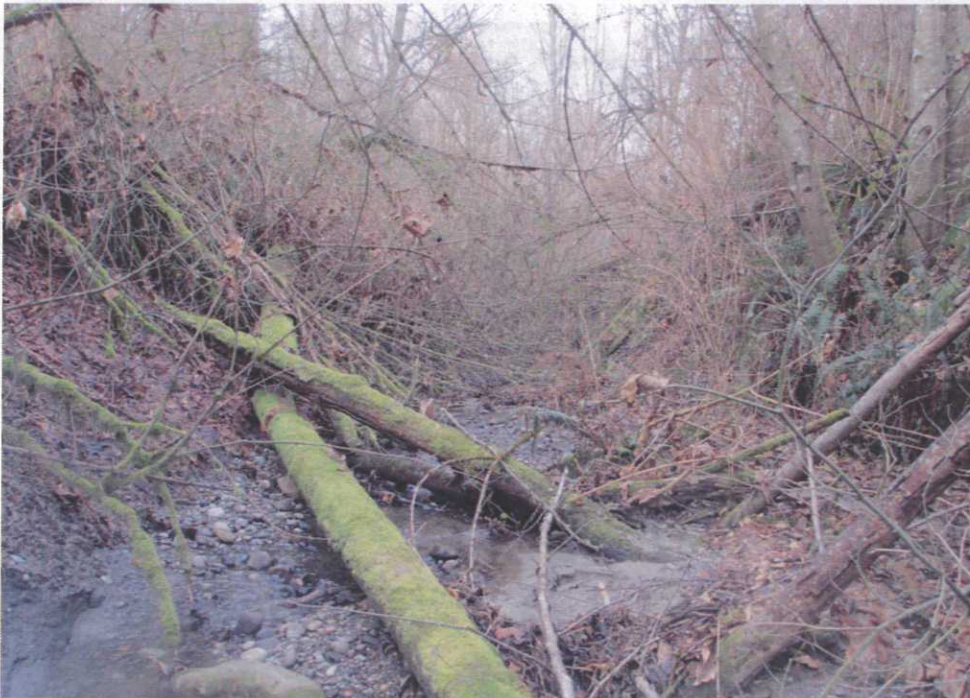
Photo 2. Less incised channel in Stream A as the stream passes through the site. February 4, 2014.

A large down log approximately (15 inch diameter and 20 feet long) was noted approximately 50 feet up from the stream channel, in addition to several smaller standing snags in the southern part of the site. The channel is less incised at this point on the property and large woody debris was more abundant than upstream. We noted at least one log of greater than 20 inches diameter fallen across the stream channel. Our visual estimations indicate that the stream is approximately 70 to 90 percent shaded in this portion of the reach due to dense canopy overhang

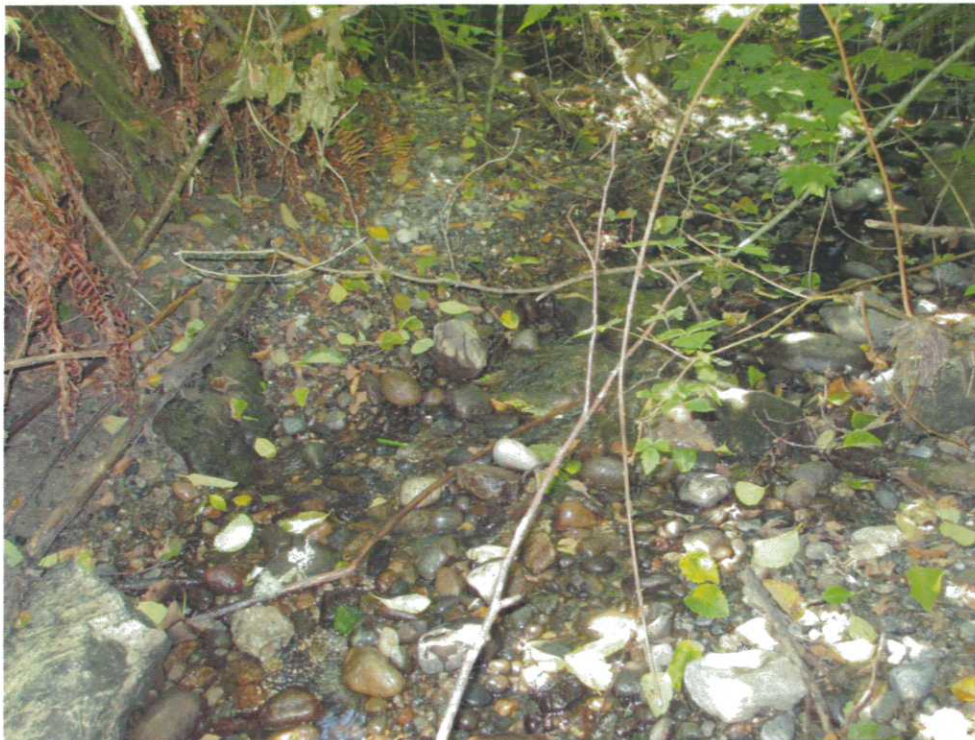
Photo 3. Typical stream bed substrate and flow observed at southern end of project site. July 14, 2014.

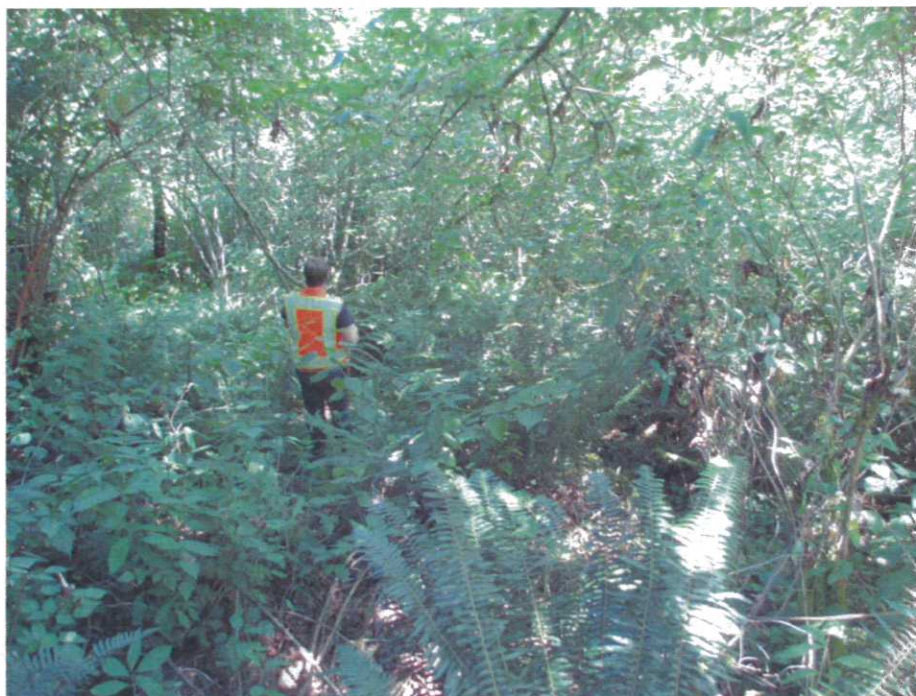
Photo 4. Typical canopy coverage on the west bank riparian corridor of stream A. July 14, 2014.

We observed at least one snag 30 feet tall and greater than 8 inches in diameter in the riparian corridor, as well as a number of downed logs of greater than 6 inches diameter. Woodpecker foraging excavations were also noted on at least one of these features. This portion of the stream is deeply incised, but primarily small diameter (4 to 8 inches) woody debris and vegetation is abundant in the stream channel. The canopy cover provided approximately 50% stream cover in this reach, greatly contributing to stream temperature moderation.
