Edgewood West Preliminary Plat

Preliminary Stormwater Report Final PREP Submittal

Revised June 2015
Job Number 14123

Prepared for:
Quadrant Homes

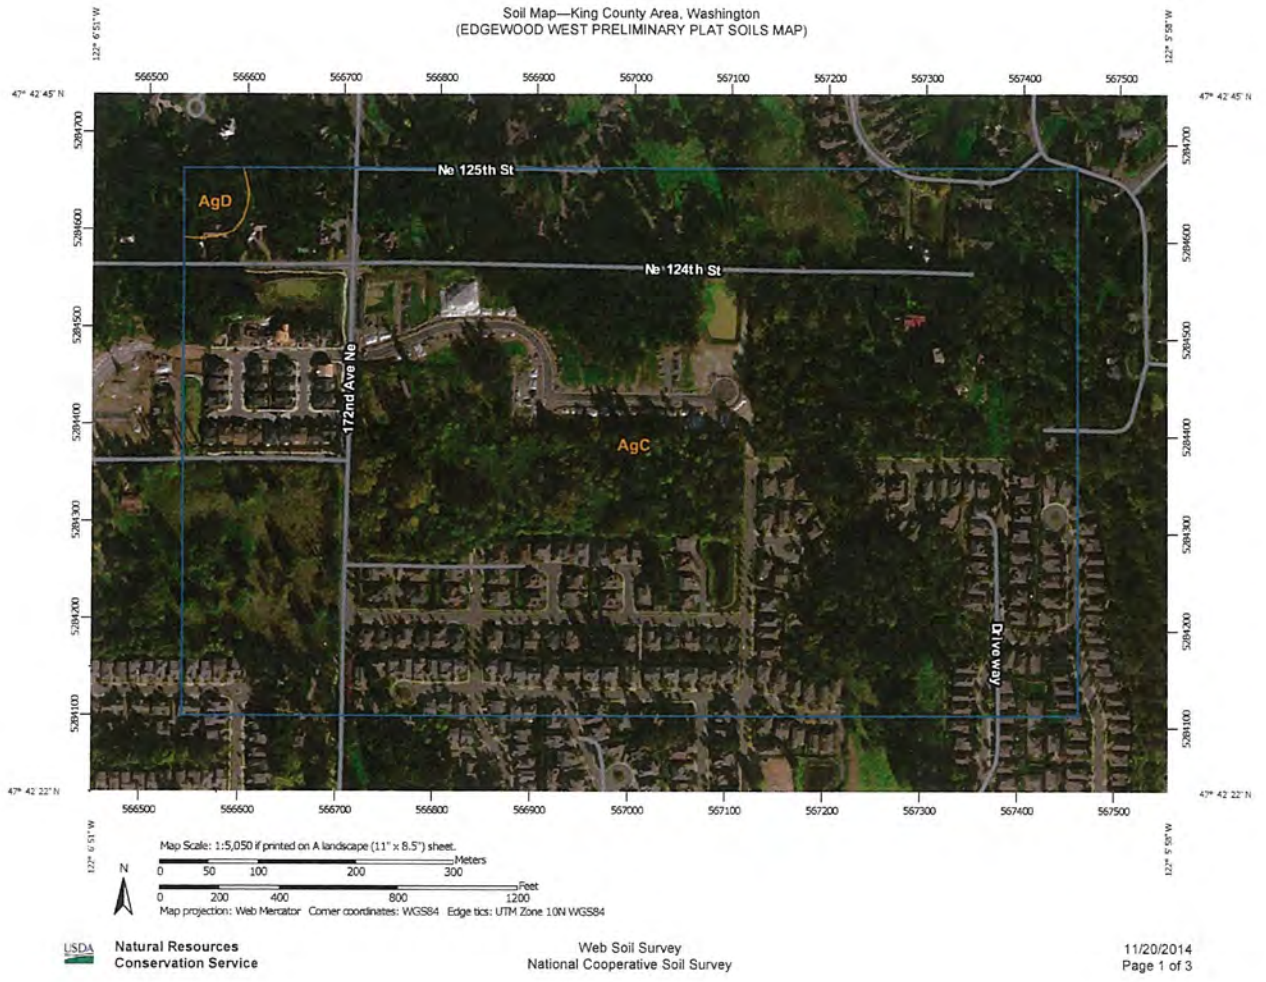
FIGURE 4

Soil Map—King County Area, Washington
(EDGEWOOD WEST PRELIMINARY PLAT SOILS MAP)

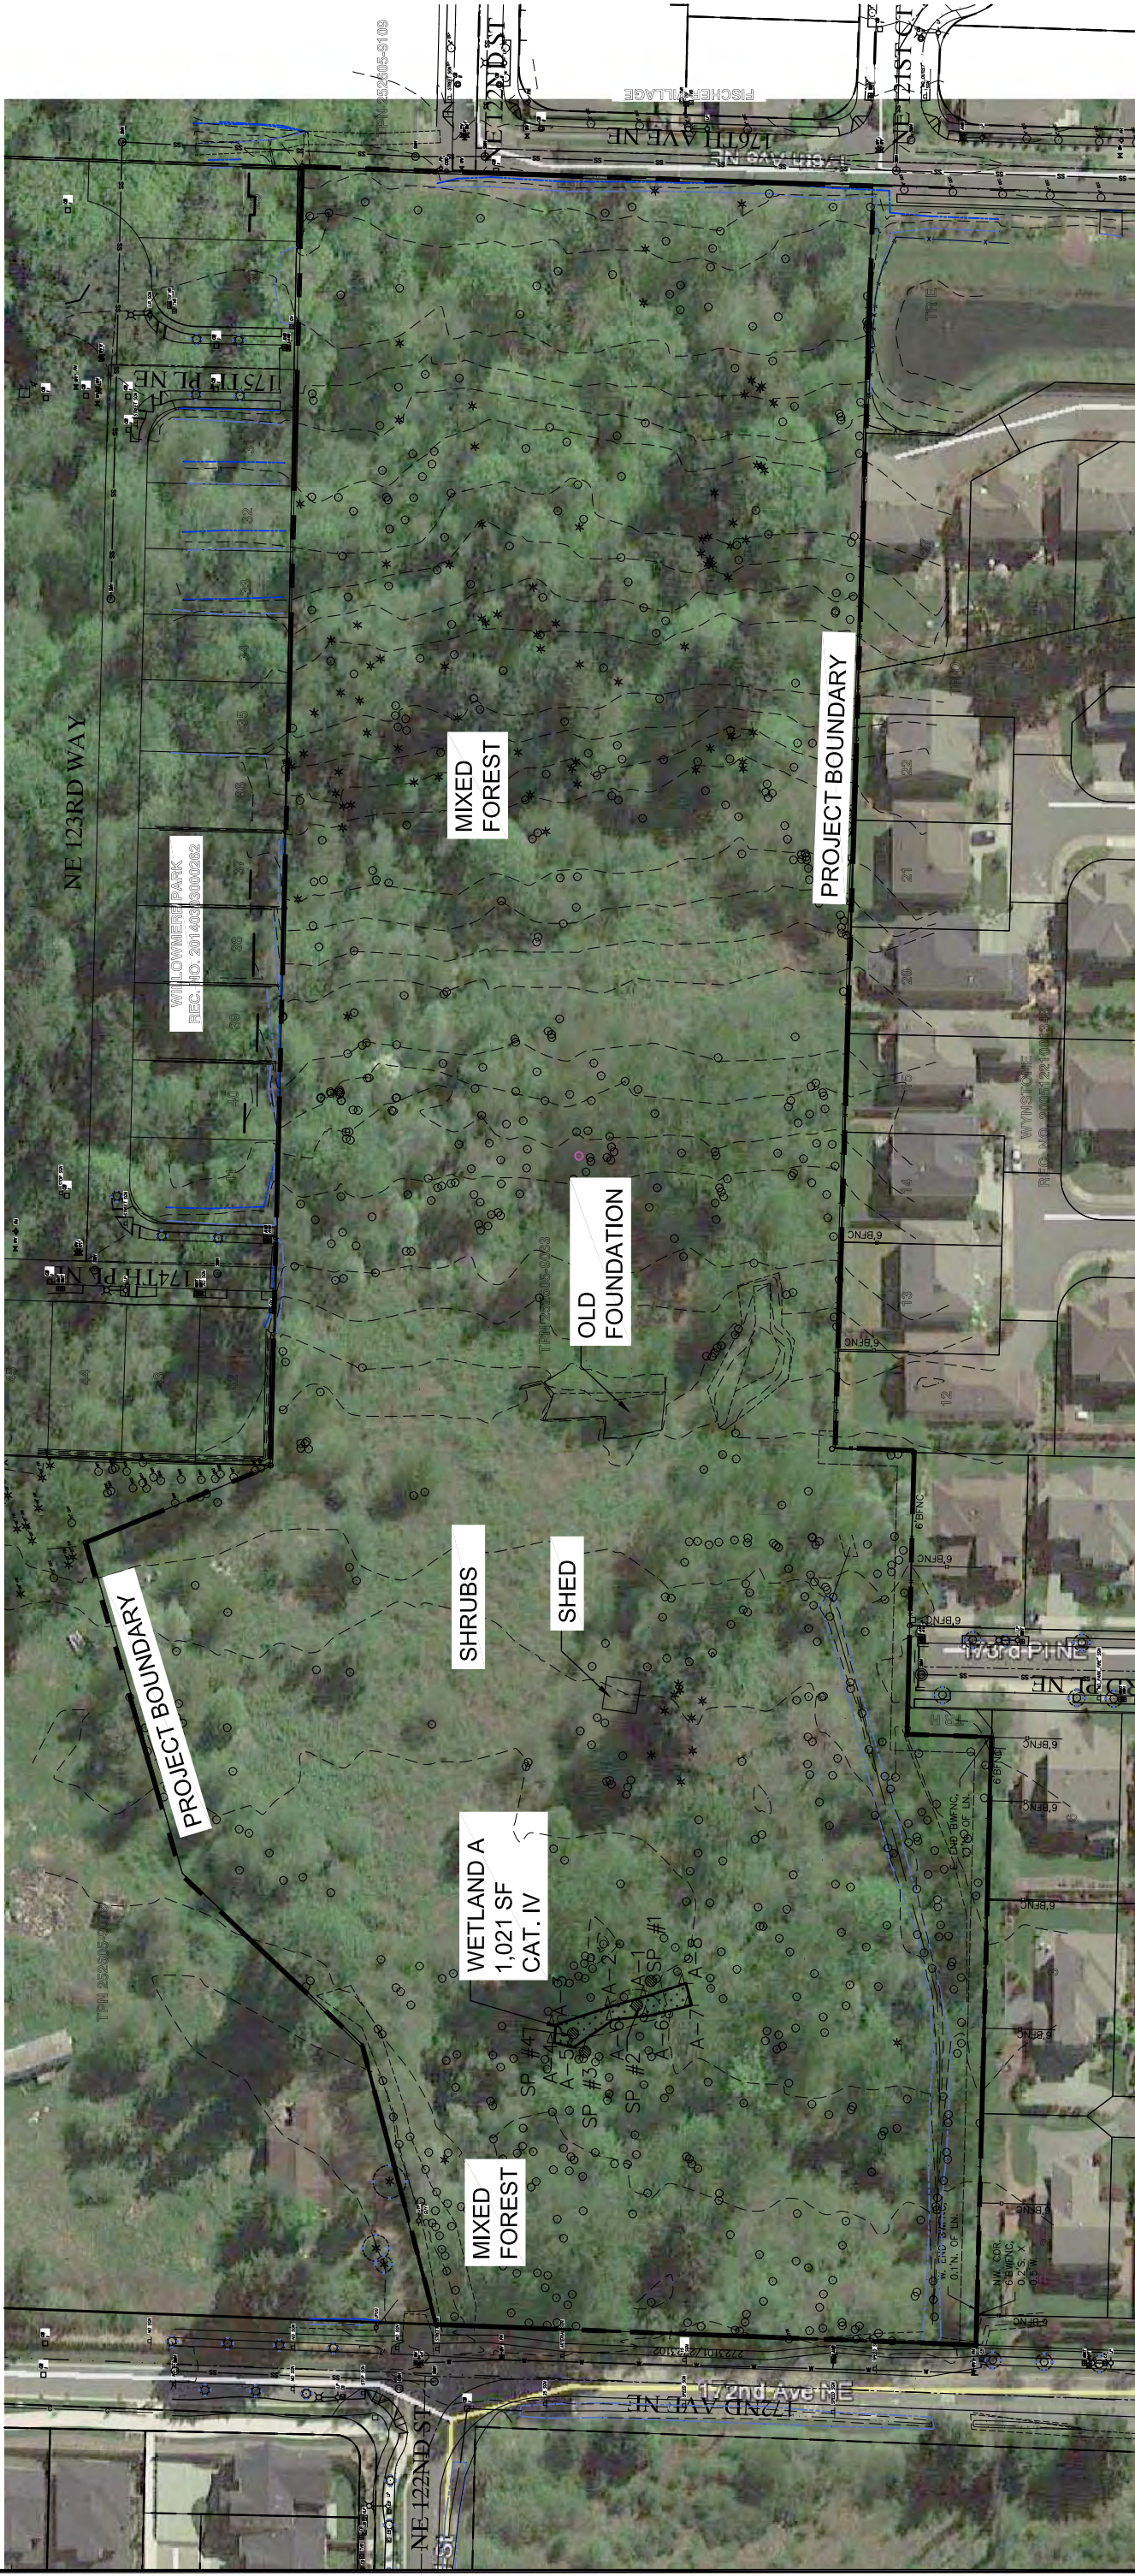
FIGURE 3
Quadrant Homes
Edgewood West
 CRITICAL AREAS REPORT
EXISTING CONDITIONS

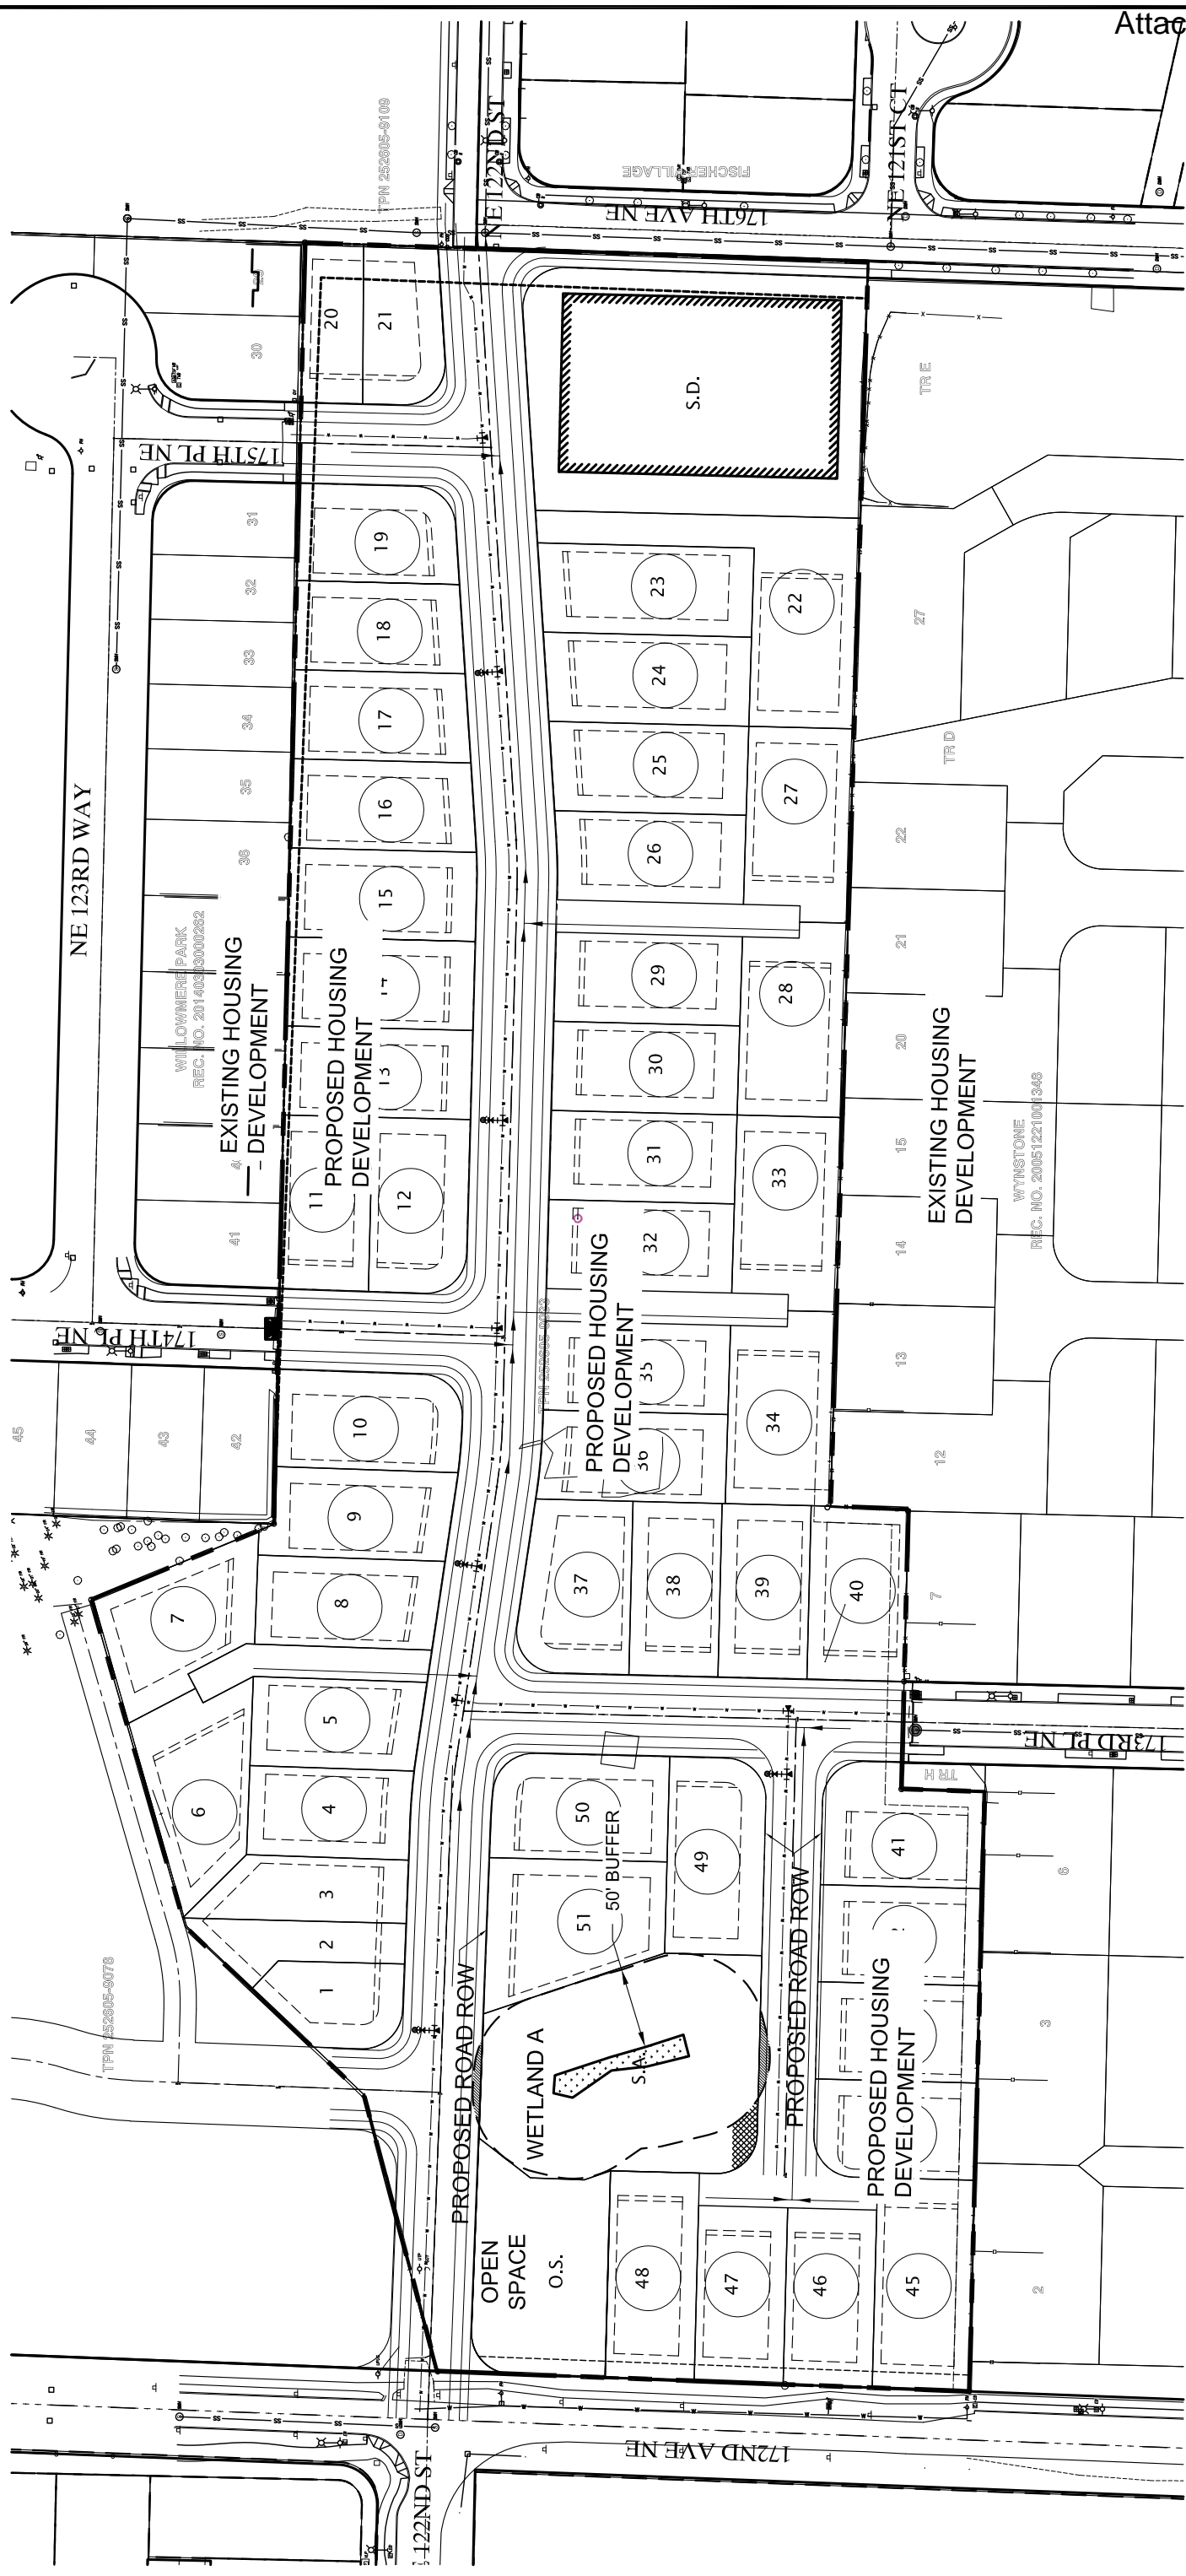
FIGURE 4
Quadrant Homes
Edgewood West
 WETLAND ASSESSMENT
PROPOSED SITE PLAN

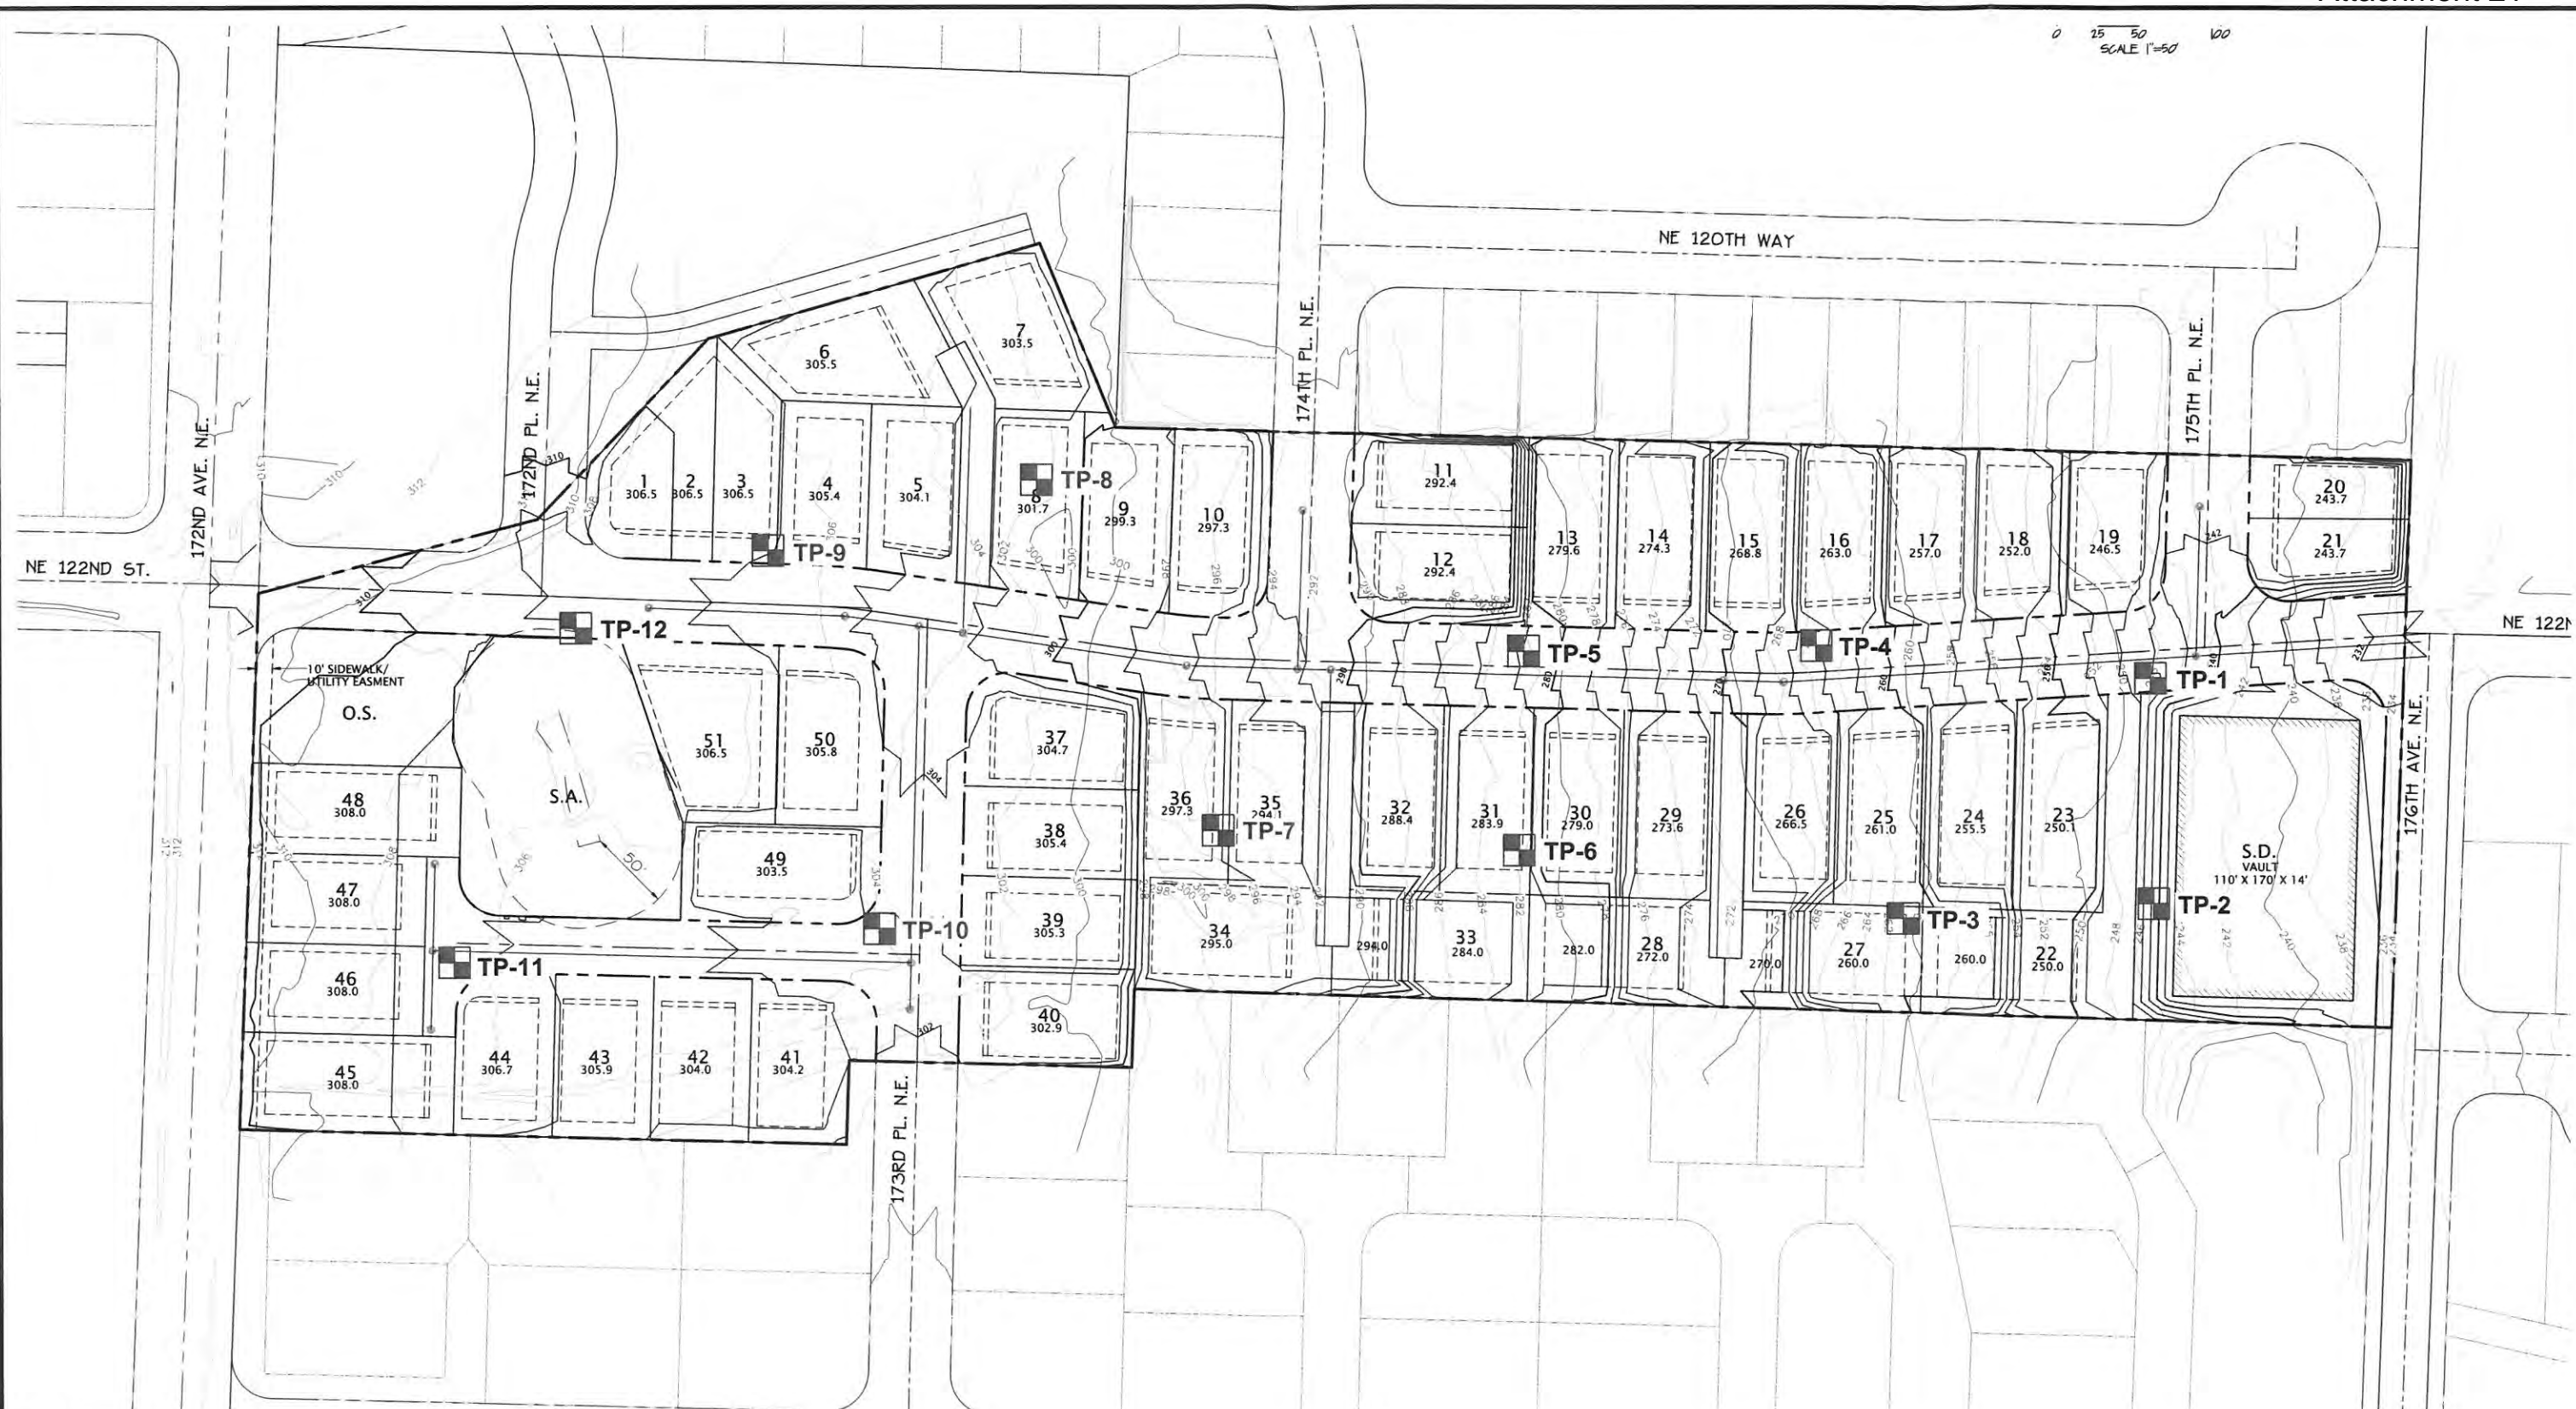
EXPLORATION LOCATION PLAN EDGEWOOD WEST REDMOND, WASHINGTON		
Proj. No. T-7037	Date OCT 2014	Figure 3
