# **CRITICAL AREAS REPORT**

**BMC Rose Hill, LLC**

**Redmond, Washington**

**March 14, 2016**  
**Revised April 6, 2016**

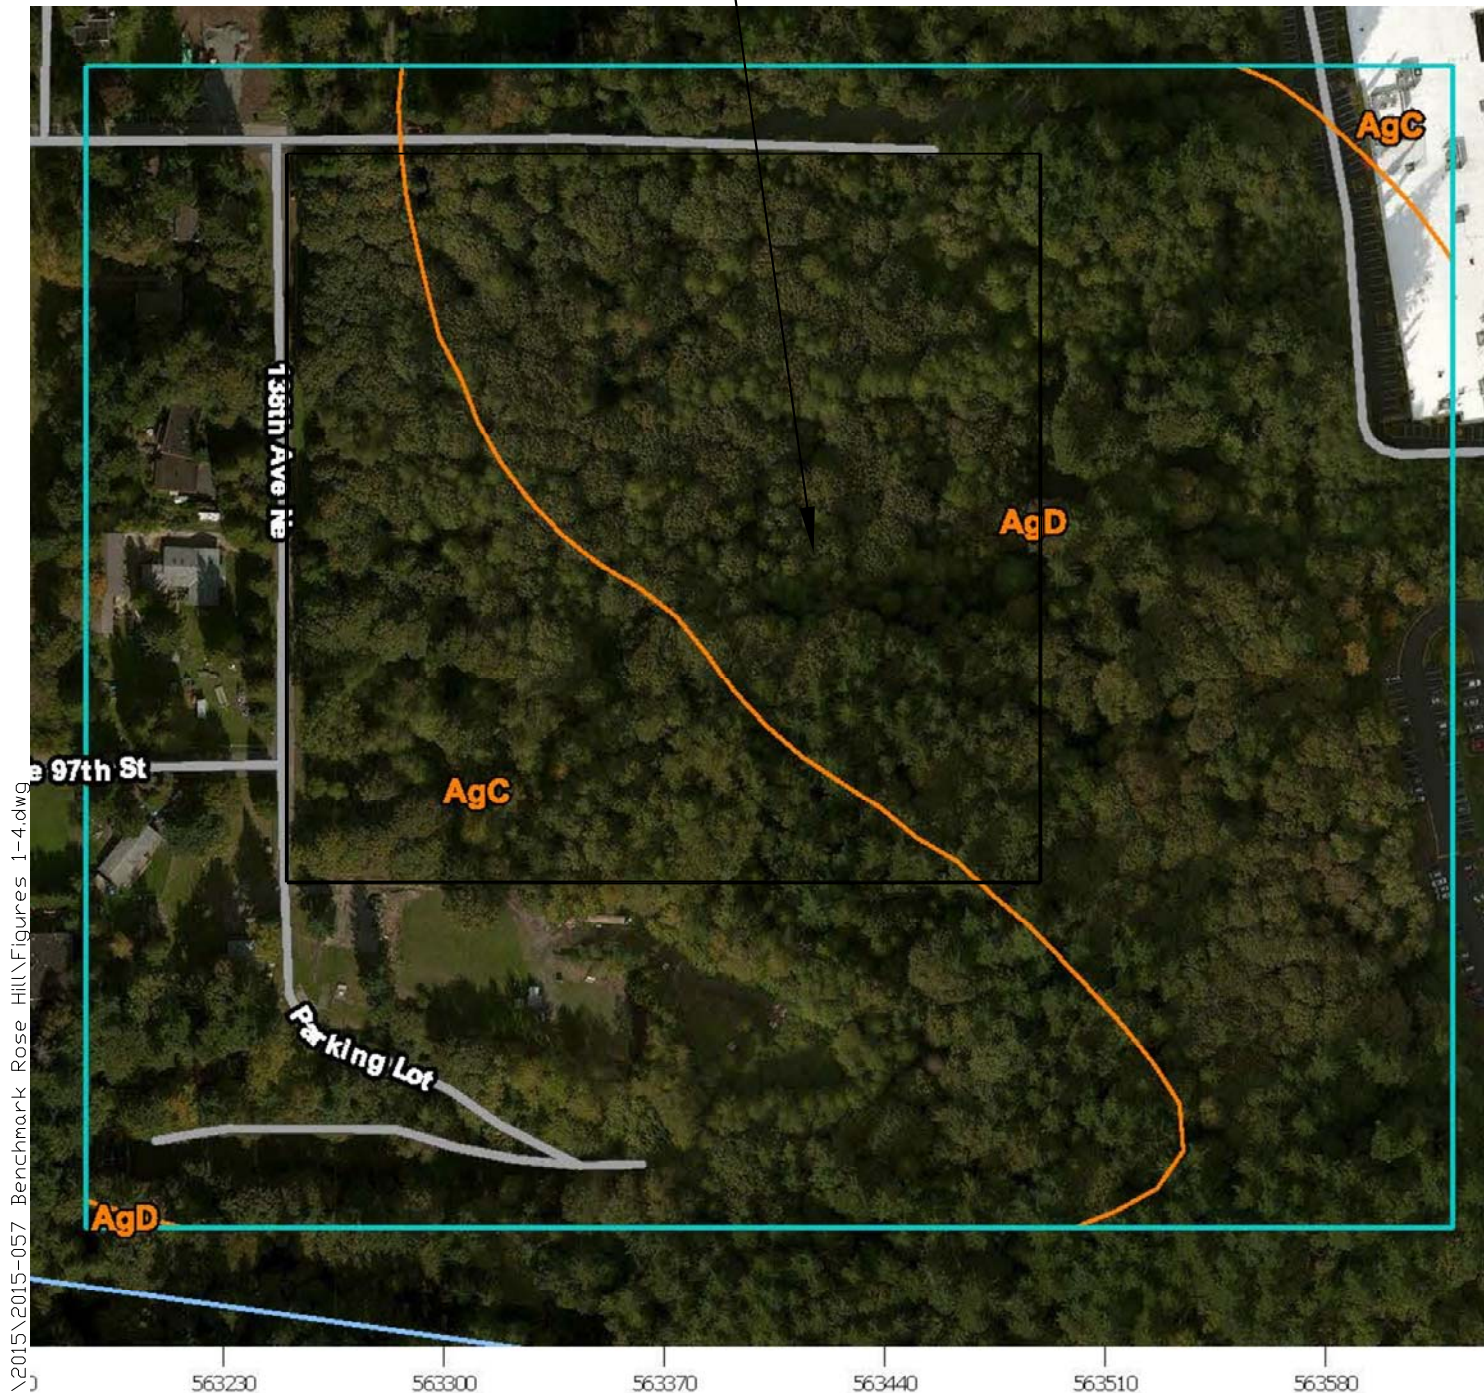
Source: Soil Survey Staff, Natural Resources Conservation Service, United States Department of Agriculture. Web Soil Survey. Available online at <http://websoilsurvey.nrcs.usda.gov/>. Accessed [2015/9/23].

Soils were generally consistent with the Alderwood series mapped for the site, with brown to dark brown (10YR 4/3 to 10YR 4/2) subsoil and without redoximorphic features or any indicators of hydric soil conditions. No water table or saturated soil was observed anywhere outside of the delineated wetland on site. Sample plots were located in the vicinity of the wetland (Figure 4, Appendix A).

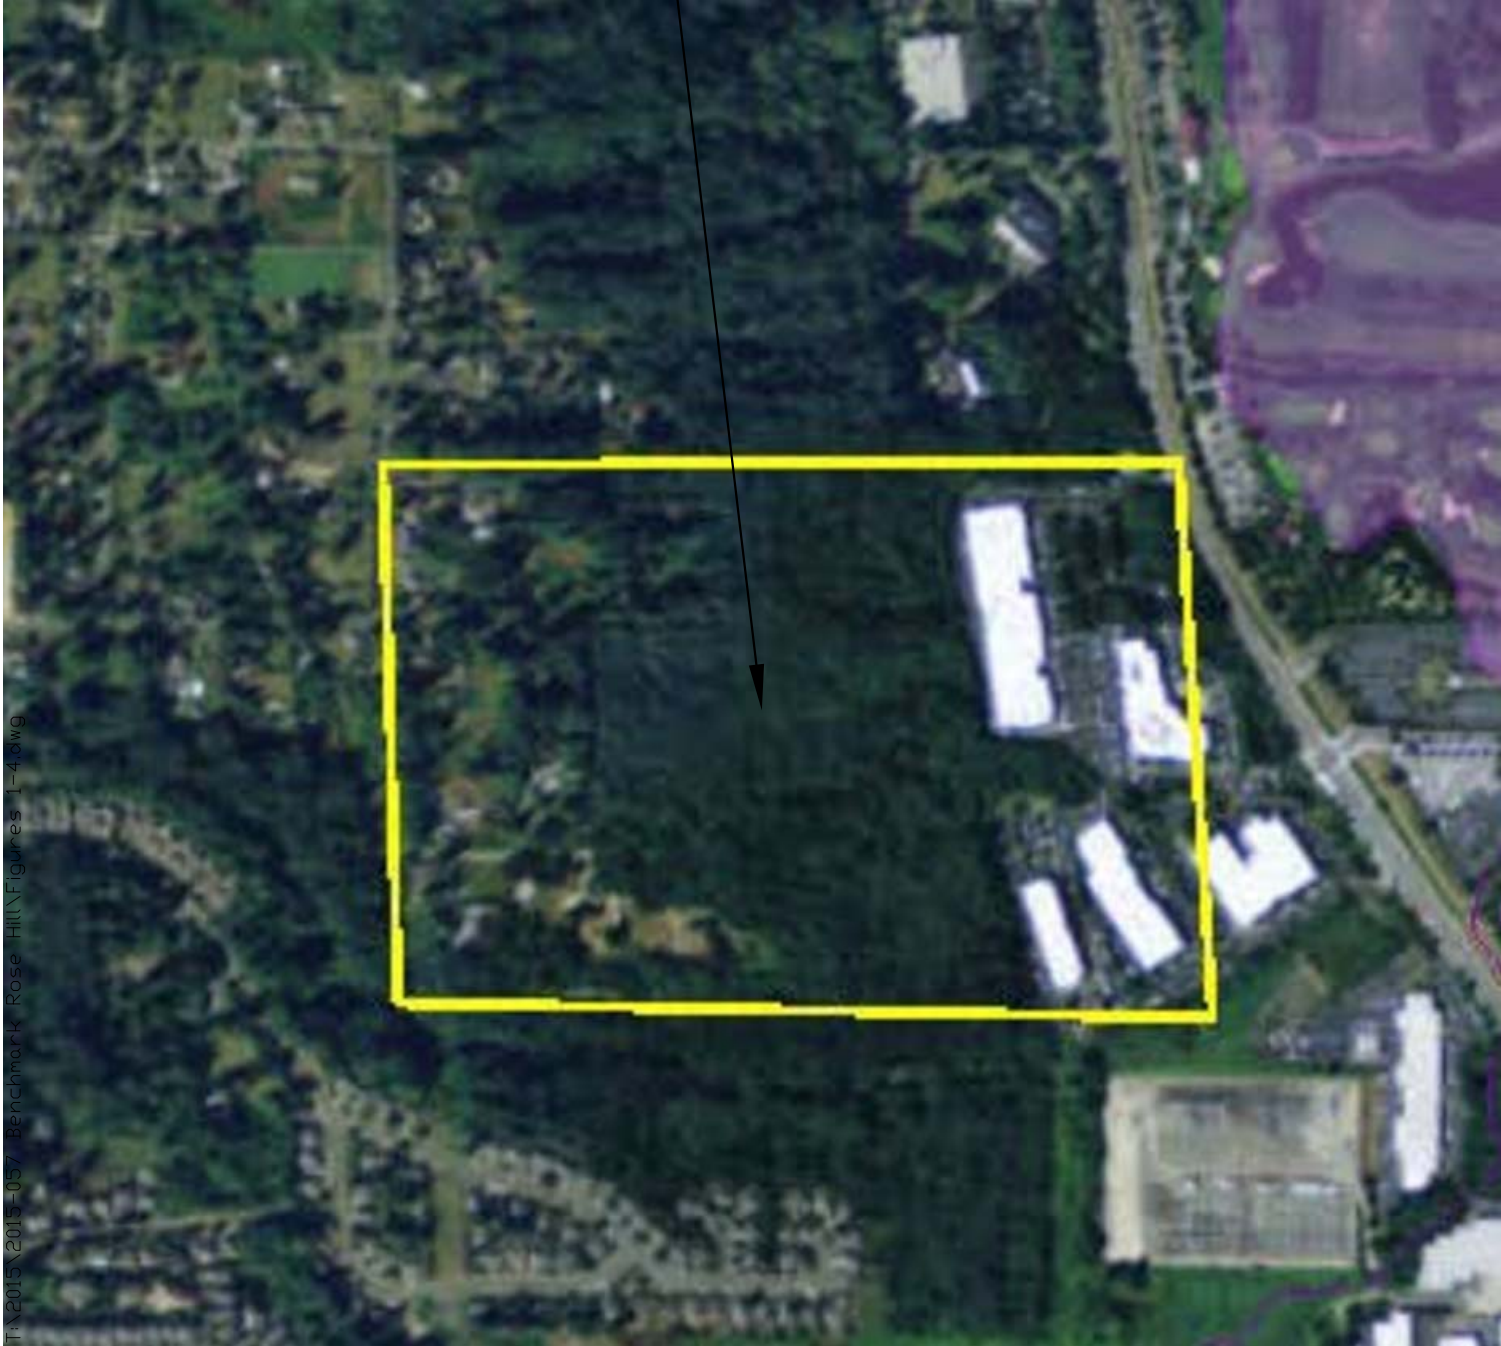
Source: Washington Department of Fish and Wildlife, Priority Habitat and Species Mapping. Available at <http://wdfw.wa.gov/mapping/phs/>. Accessed on 9/1/2015
