# Hawks Glen

## Preliminary Storm Drainage Report

Date: June 14, 2016

Blueline Job No. 14-332

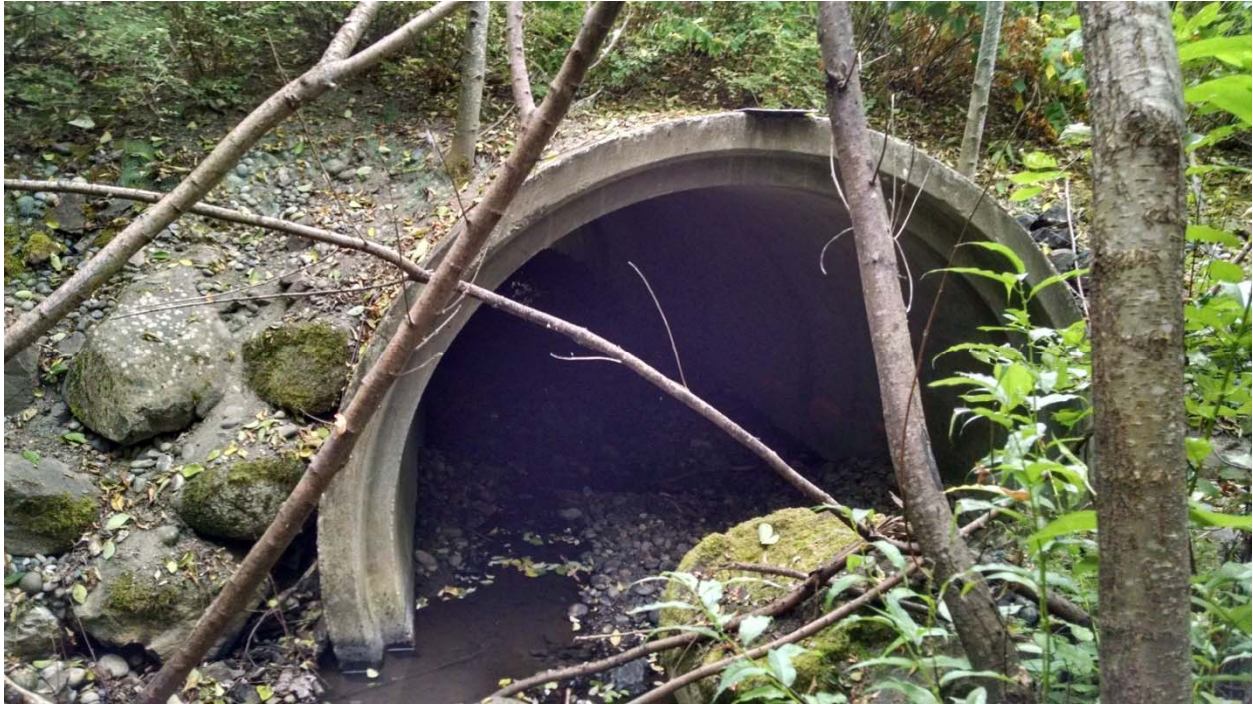
Photo 1: Looking east into the culvert conveying flows from Monticello Creek and the undeveloped portion of the site under 178<sup>th</sup> Ave NE.

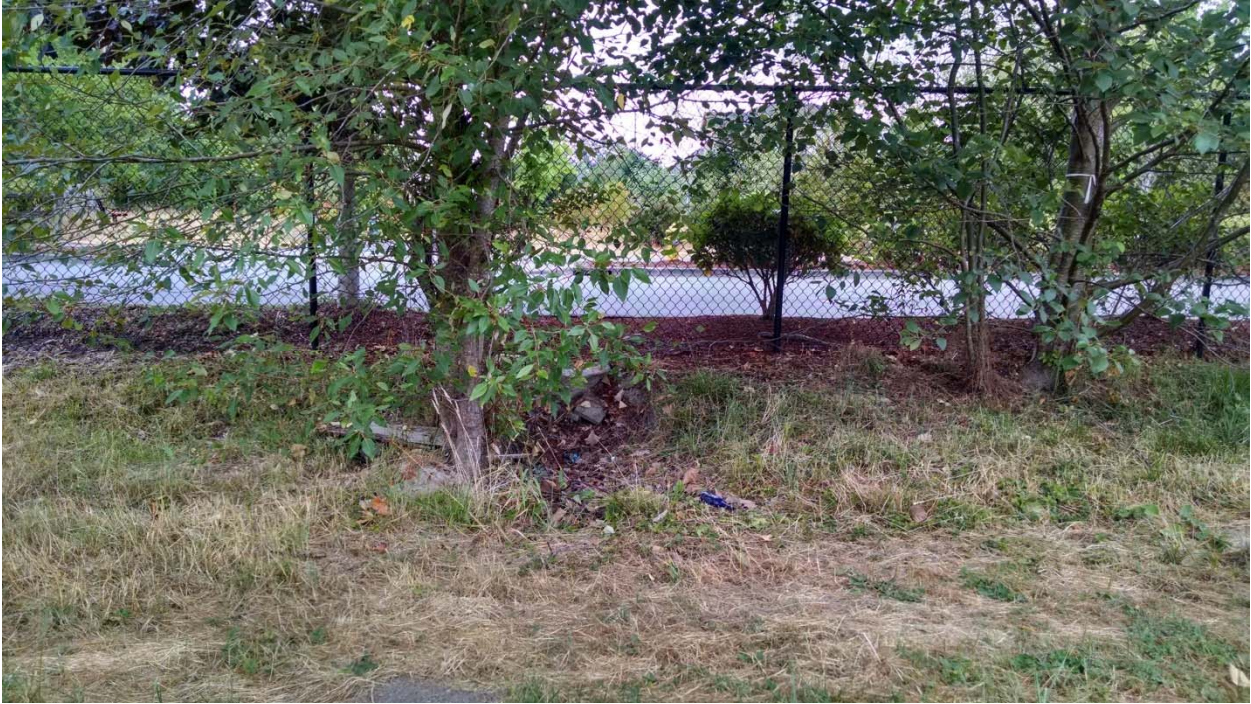
Photo 3: Looking east at the 6" culver, which runs east underneath 178<sup>th</sup> Ave NE draining the northern portion of the developed site.

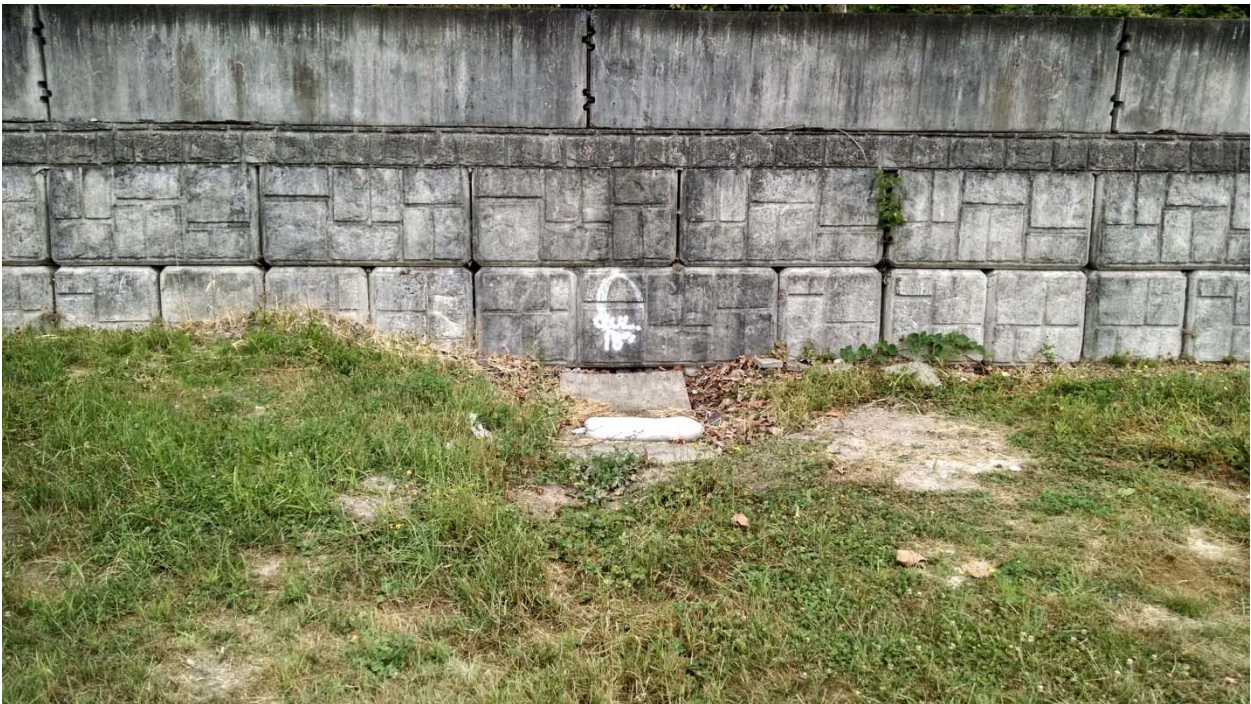
Photo 4: Looking east at the 18" culvert which runs east underneath 178<sup>th</sup> Ave NE draining the southern portion of the developed site.

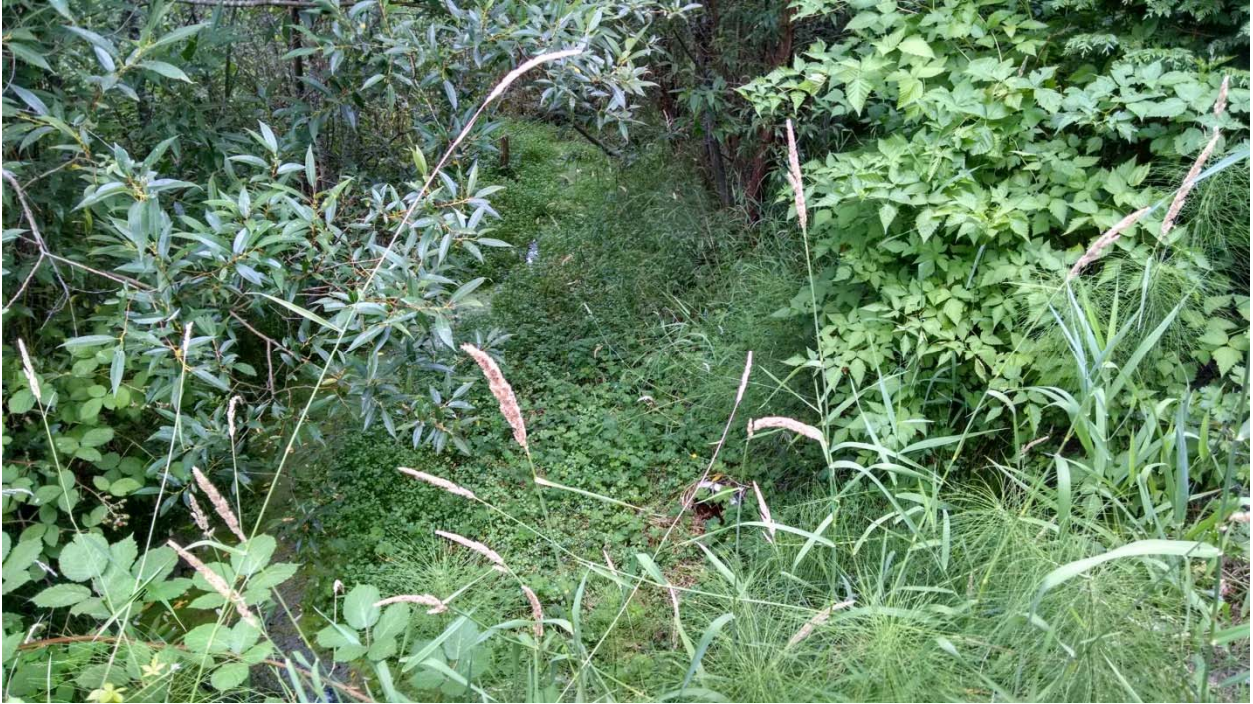
Photo 5: Unnamed tributary to Monticello Creek, east of 178<sup>th</sup> Ave NE, fed by southernmost onsite culvert.

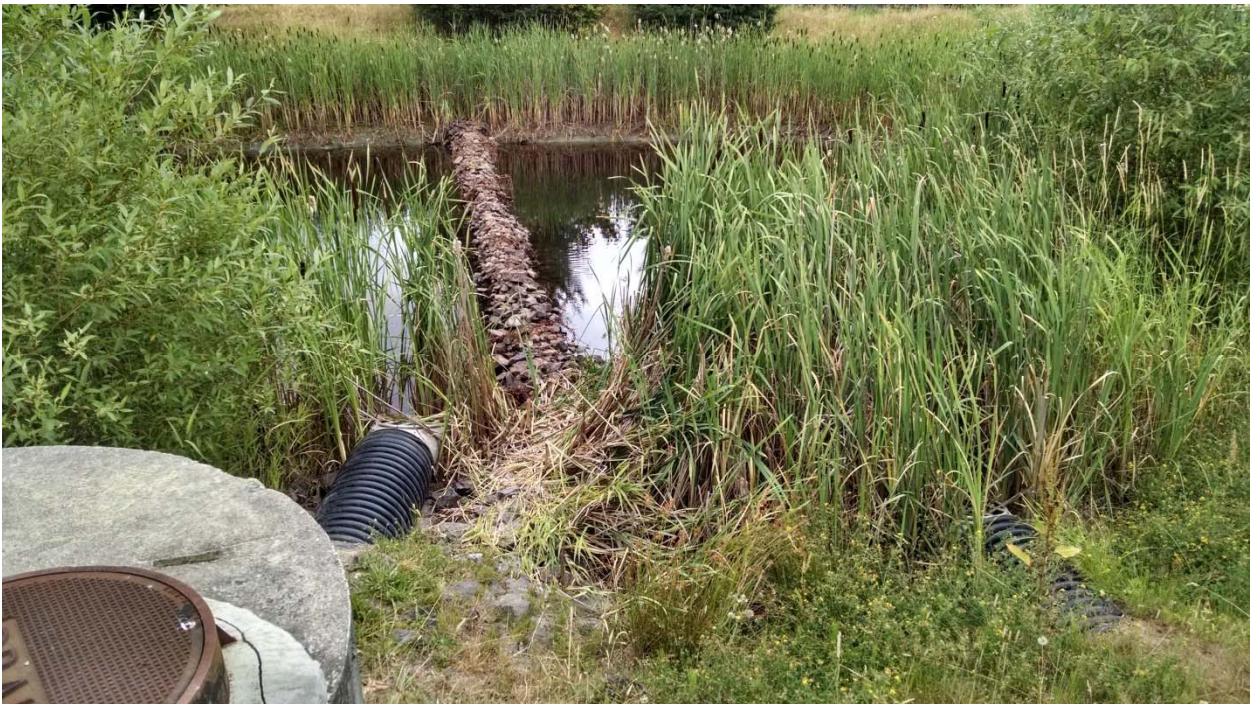
Photo 6: Storm water pond for Fischer Village.

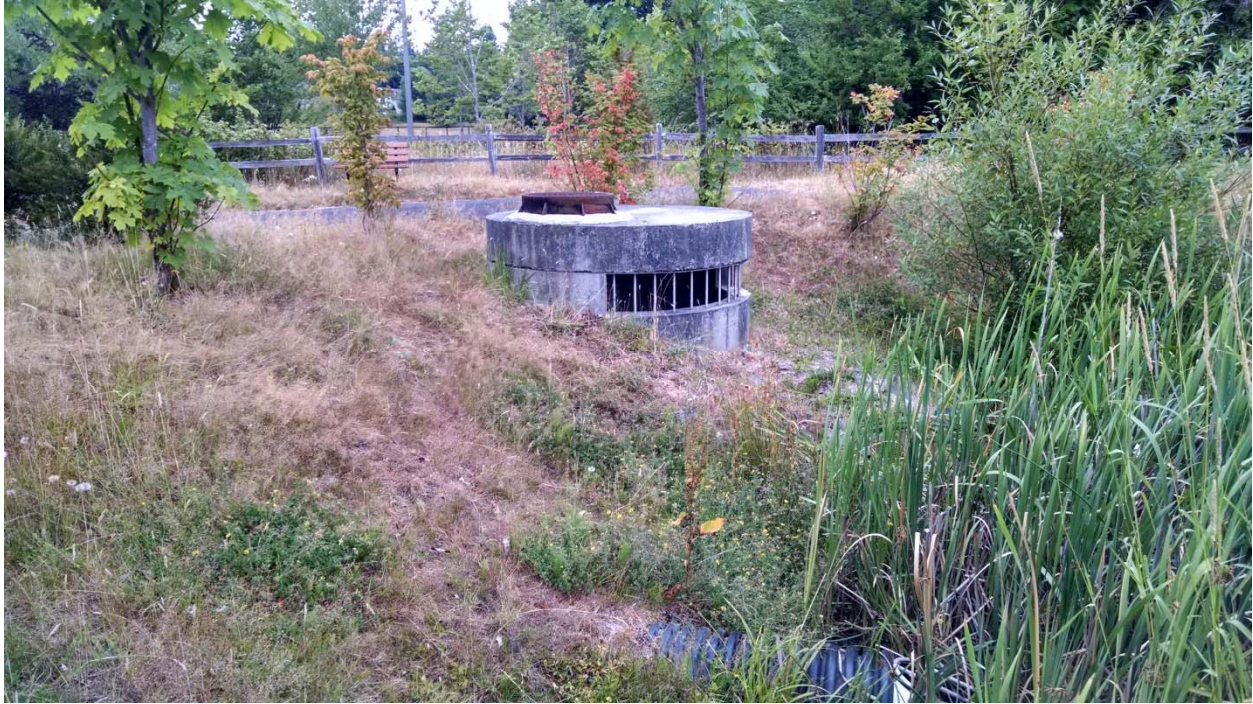
Photo 7: Overflow structure serving the above storm water pond.

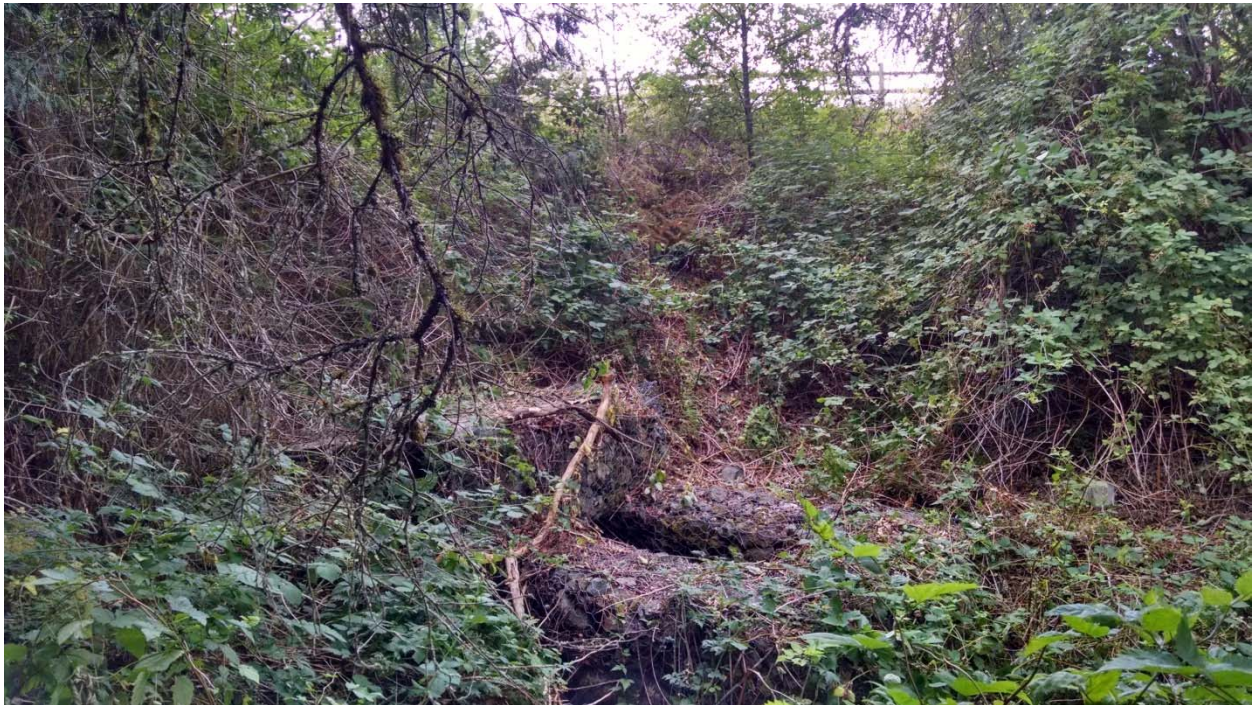
Photo 8: Gabion basket outfall from the Fischer Village storm water pond outfall.

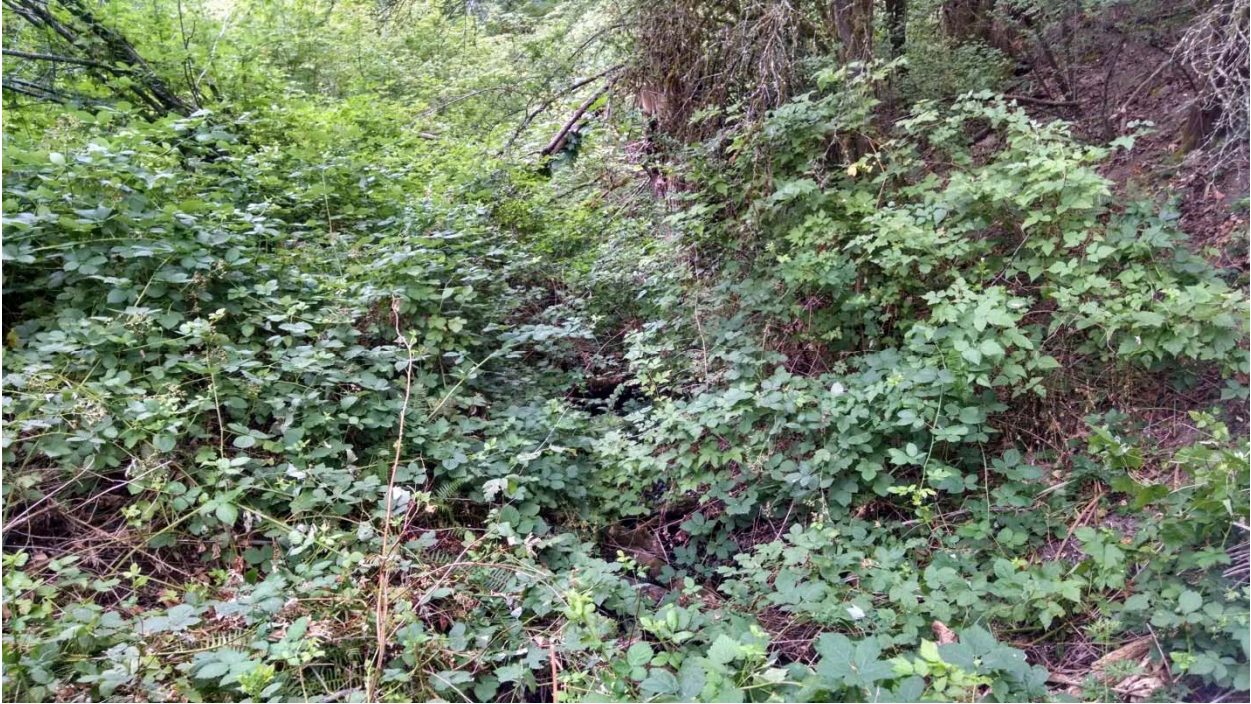
Picture 9: Looking east downstream of the gabion basket outfall.

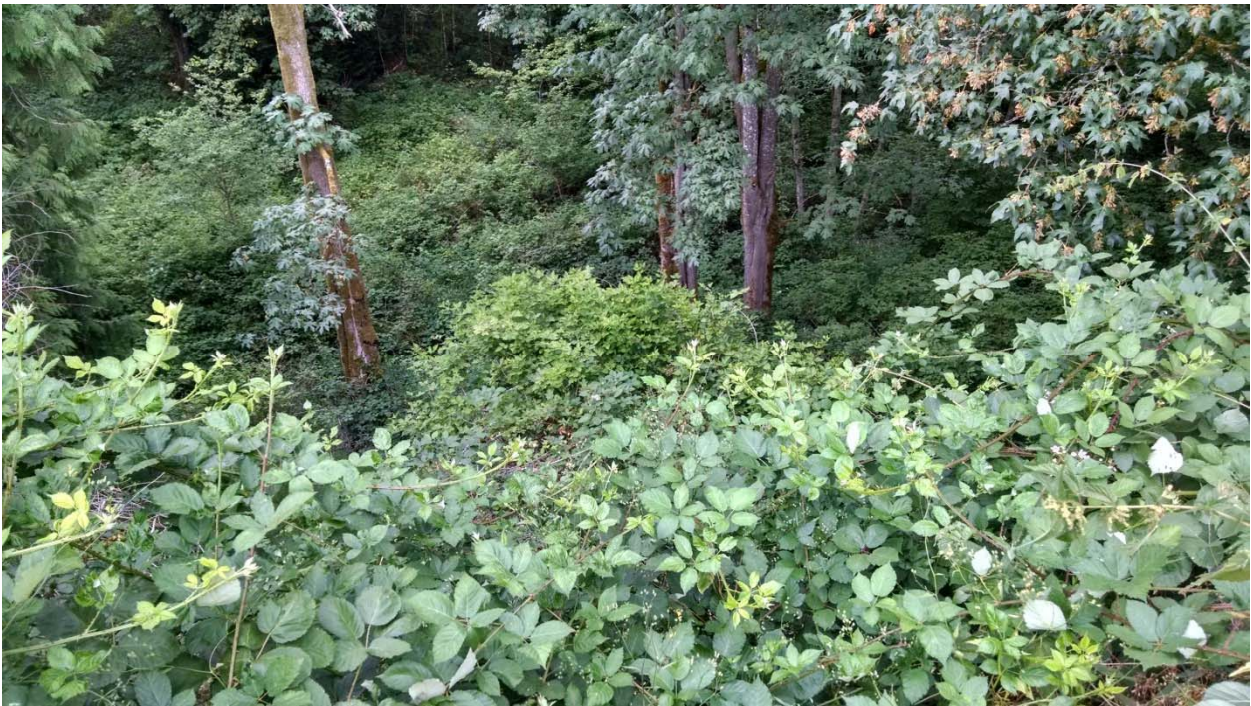
Picture 10: Looking into the steep overgrown ravine, at the point of convergence for the tributary to Monticello Creek and Monticello Creek.

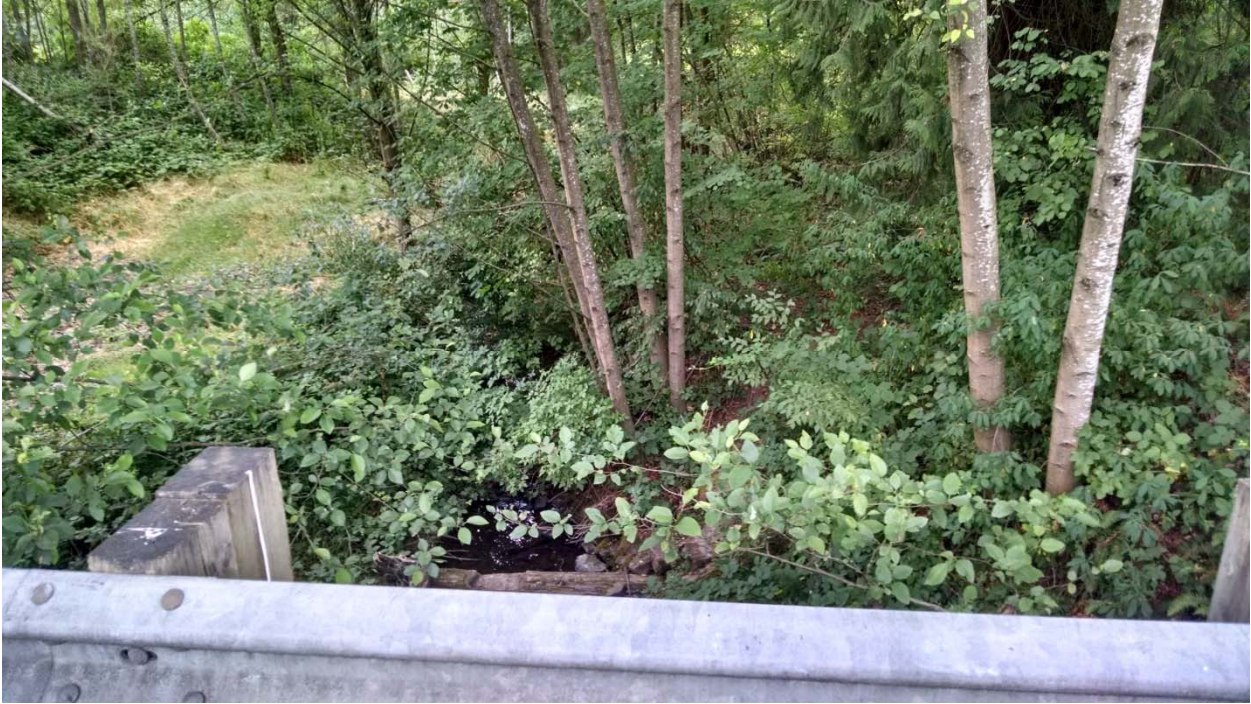
Picture 11: Looking east from Avondale Road toward the convergence of Monticello Creek and Bear creek, approximately two-thirds of a mile downstream of the site.

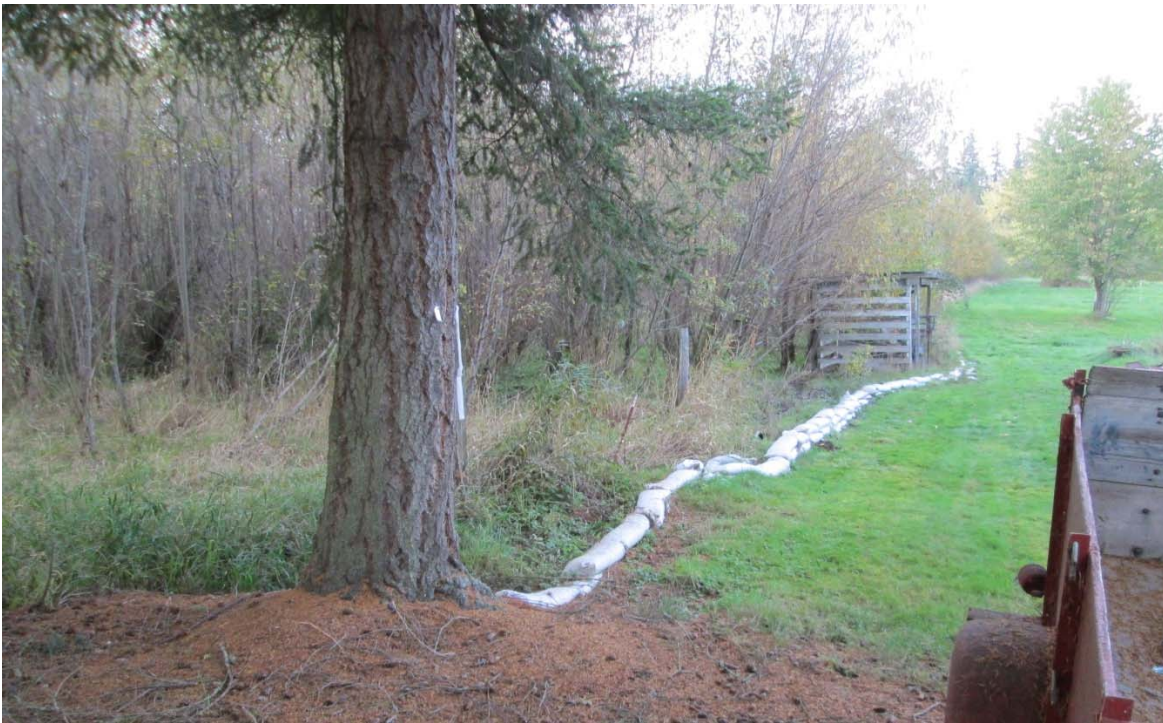
Picture 12: Looking north - existing temporary sandbags (to be removed).

As shown on the Existing Conditions exhibit, the site contains sand bags and a sump installed along the west property line. According to conversations between Wetland Resources staff and the prior property owner, the sand bags were installed as a temporary measure to prevent flooding of onsite buildings which occurred during large rainfall events. The sand bags directed runoff to a sump area where it was pumped around the buildings to avoid flooding. The discharge location of the pump was not stated. The City of Redmond considers shallow groundwater to be a Critical Area per RZC 21.64.050 (Critical Aquifer Recharge Area). The existing sand bags, sump, and perforated pipe are considered permanent dewatering by the City and therefore, are required to be removed. As such, the sand bags and sump will be removed as part of this development as requested by the city. An alternate drainage system will be installed along the west edge of the proposed lots to prevent upstream runoff from adversely impacting the proposed yards and homes.

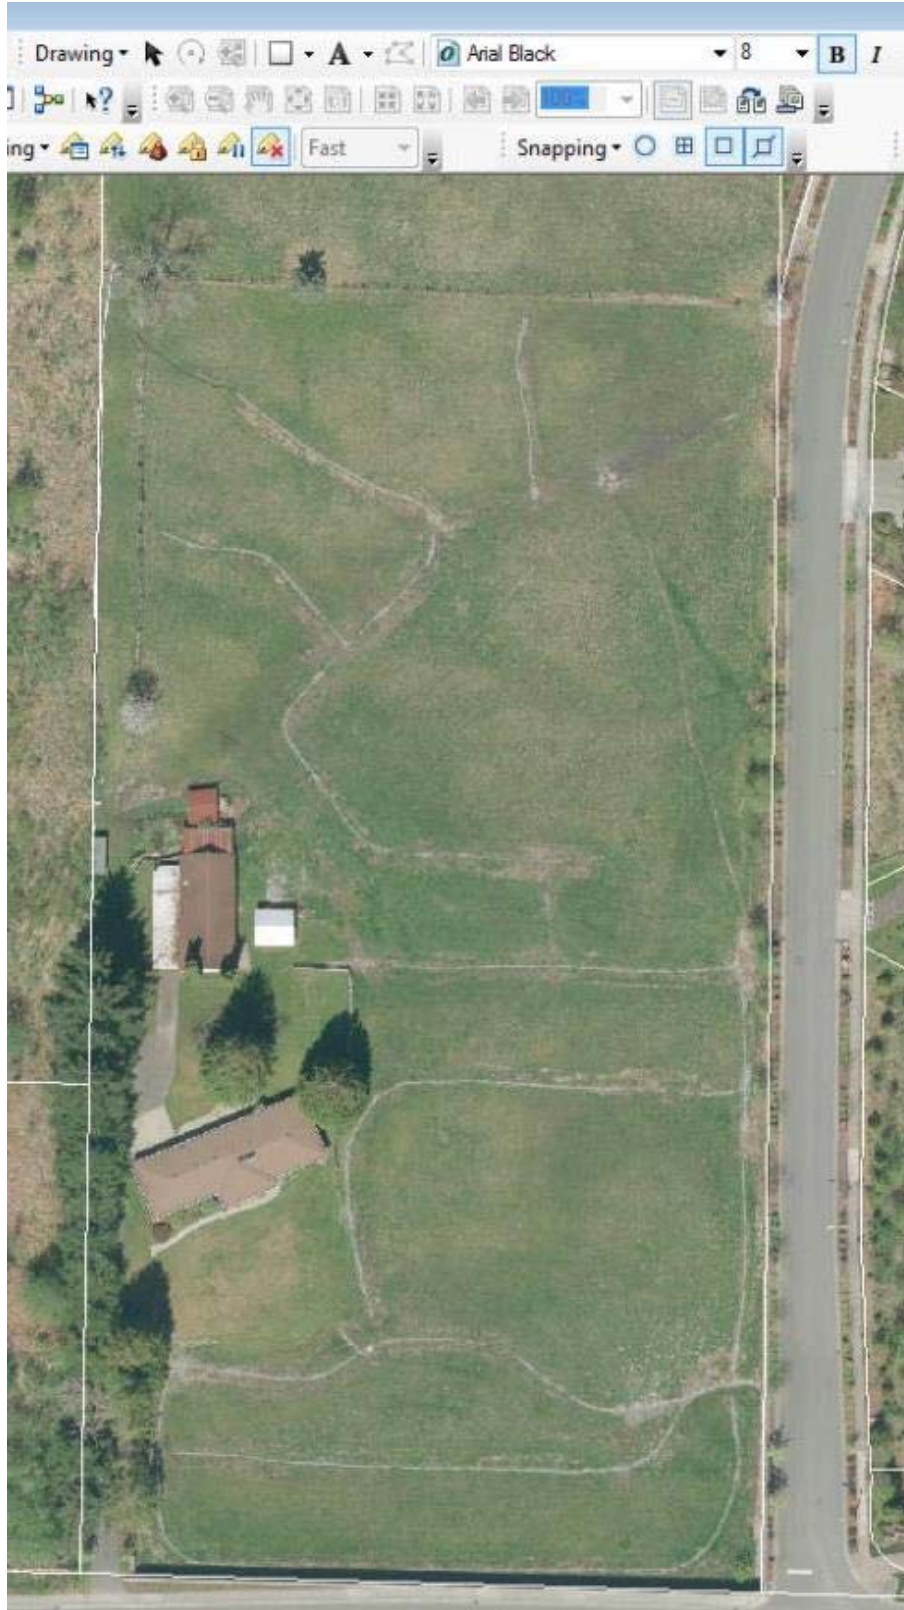
Picture 13: Existing subsurface perforated pipes (aerial image provided by City of Redmond).

The site contains existing perforated pipes that were installed and used for agricultural purposes and are located as shown on the Existing Conditions exhibit. The location of the pipes were based on an aerial photo provided by the city and therefore considered approximate. As part of the development the pipes will be removed. According to conversations between Wetland Resources staff and the prior property owner, the pipes were installed by the property owner for agricultural purposes.

In January 2016, we visited the subject site to view existing shallow perforated pipes installed previously by the property owner. Based on our observations, it appears that all of the existing on-site perforated pipes were intended to intercept and convey surface water and shallow perched interflow to the downgradient eastern side of the property. Passive dewatering devices that we observed include several shallow ditches dug along the western site margin; several rows of sand bags placed on the ground surface along the western site margin; and a network of shallow perforated pipes in the pasture areas located in the southern approximately 620 feet of the site.
