CRITICAL AREAS REPORT

New North Redmond Elementary School Redmond, Washington

Lake Washington School District

July 26, 2016

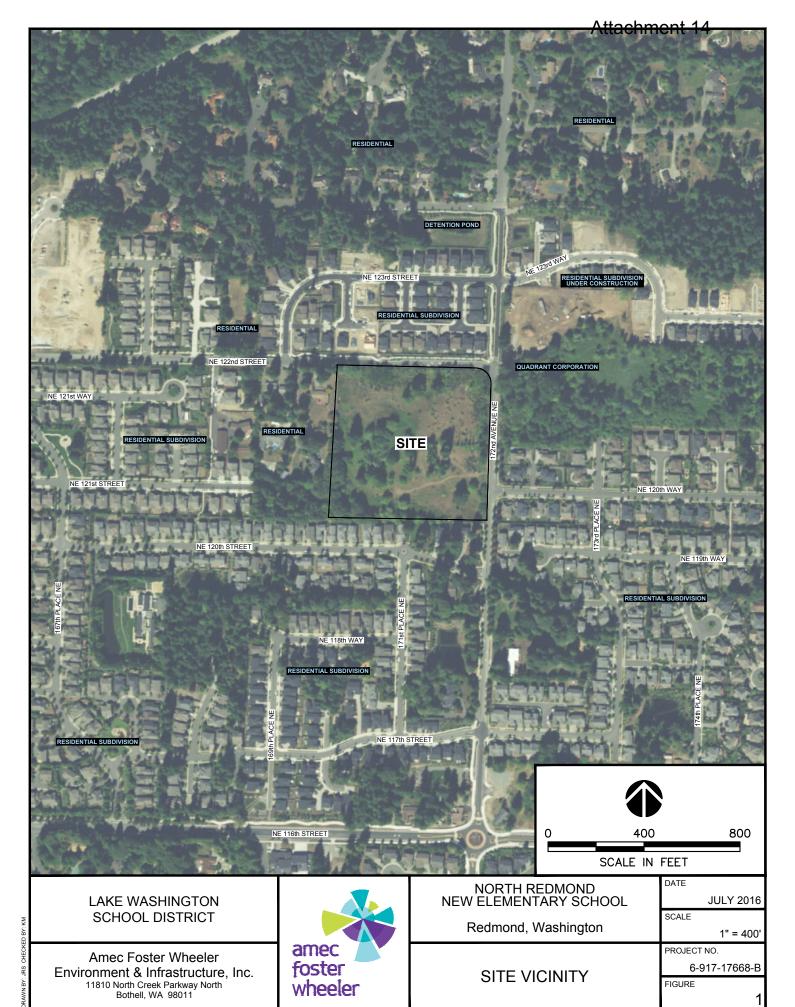
The proposed new North Redmond Elementary school is located in Section 25 of Township 26, Range 5 East in Redmond, King County, Washington (Figure 1). The site is bordered by NE 122nd

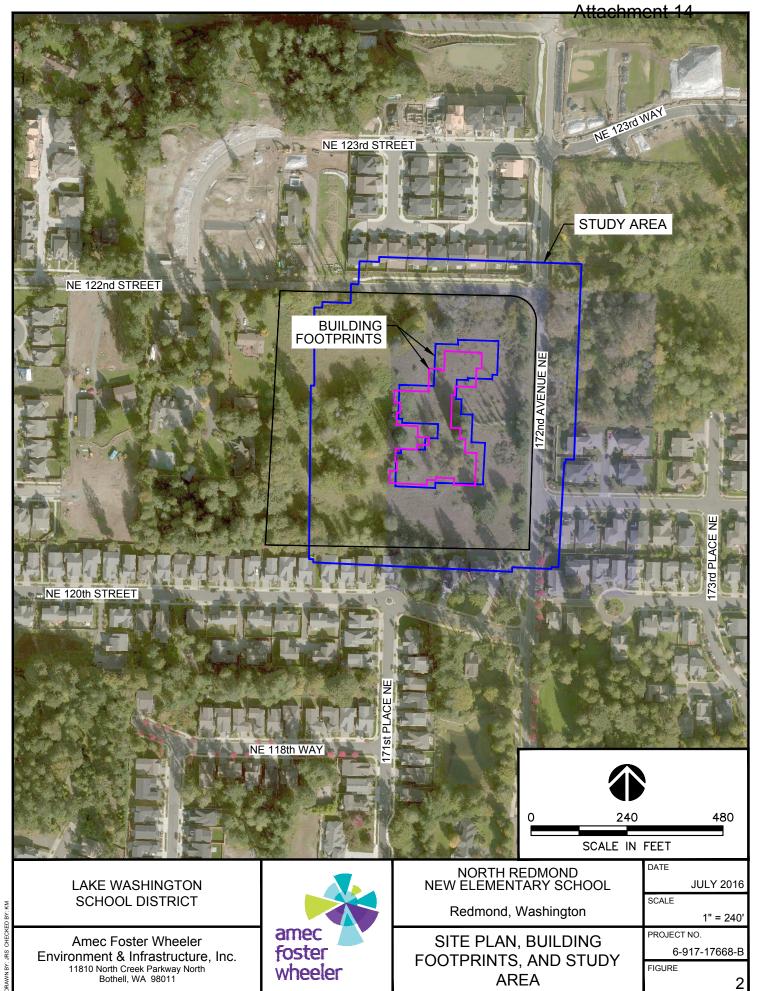
The study area for this report includes the proposed the property area (Figure 2), along with the area 200 feet beyond the property boundary as required by the Redmond Zoning Code (Figure 2).

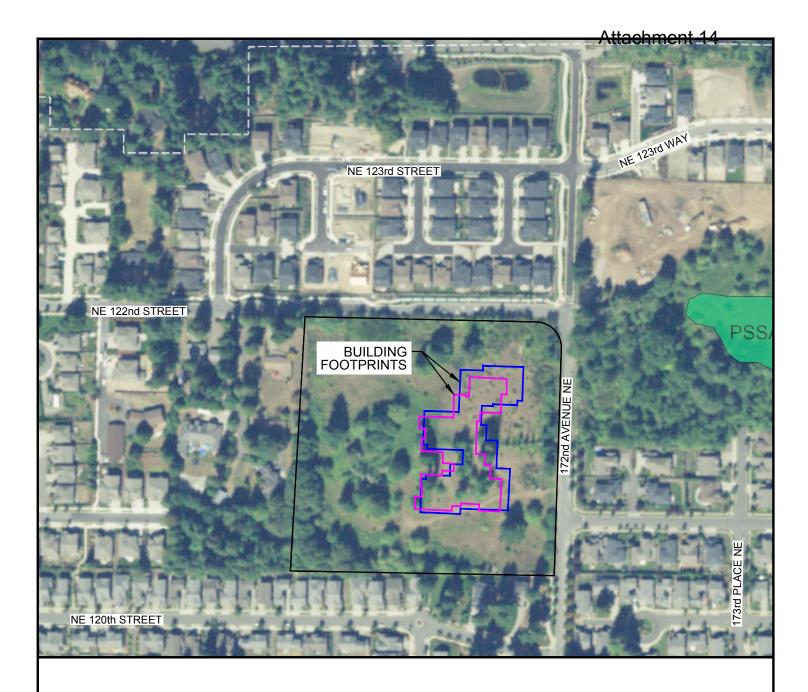
WETLANDS IN THE PROJECT **AREA**

Neither the NWI (shown on Figure 4) nor the City's Fish and Wildlife Conservation Area Map (City of Redmond, 2011a) show any wetlands occurring in the study area. The NWI shows a palustrine scrub shrub, seasonally flooded system approximately 315 feet due east of the project site. The start of a tributary to the Sammamish River is noted 775 feet north of the project site. Beer Creek is located 0.3 mile east of the project site. City of Redmond Critical Areas Maps (2011a – 2011g and 2016a, 2016b) did not identify any wetlands or streams on the property.

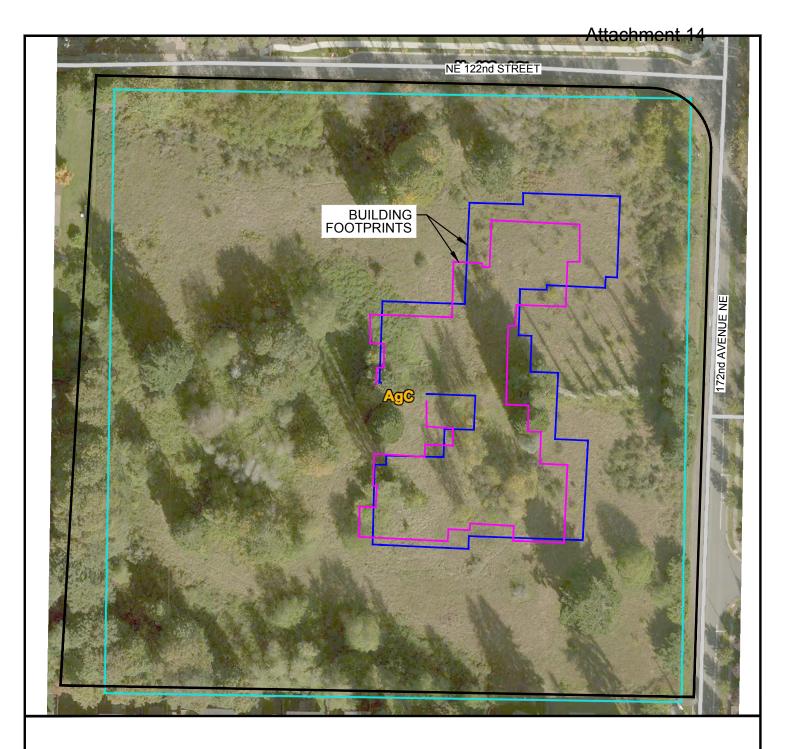
SOILS ON THE PROJECT SITE

Soils in the study area are mapped by the US Geological Survey (USGS 2016) as Alderwood Gravelly Sandy Loam. The Alderwood soil series is a moderately deep, moderately well drained soil. The soils are on glacial drift plains formed in glacial till. They are characterized by high saturation above the dense layer, with a perched water table at its highest from January through March. Soils mapped on the project site are shown on Figure 5.

AgC - ALDERWOOD GRAVELLY SANDY LOAM, 8 TO 15 PERCENT SLOPES
