August 10, 2015

Site: TPN #0325059100  
13400 NE 100<sup>th</sup> St (approx.)  
Kirkland, WA98033

At your request I performed a Visual Risk Assessment (VRA) of the Kirkland site noted above on March 4<sup>th</sup> and 7<sup>th</sup>, 2014. The VRA is a systematic process that reviews risk factors and ranks them into risk categories. It is a standard used by the International Society of Arboriculture (ISA) to ascertain tree health.

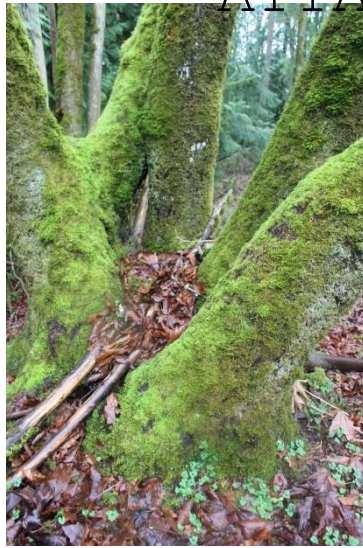
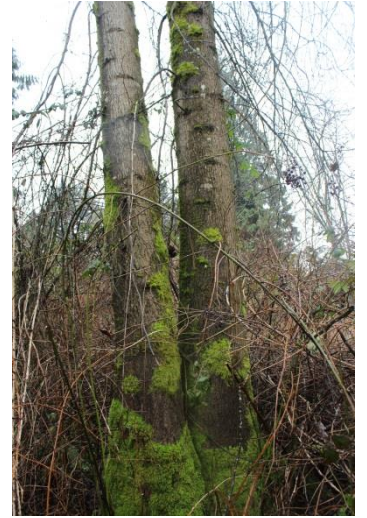
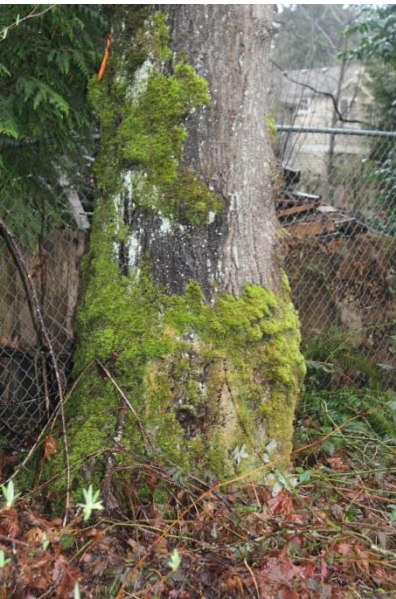
#1545 Large column of decay, with carpenter ants, woodpecker activity, sparse canopy

#1550 exposed roots with decay, large column of dead wood, carpenter ants and woodpecker

#1549; red ring rot canker and conk
