May 11, 2015

Re: TPN: 252605-9023; 6.89 acres

EDGEWOOD EAST TREE PRESERVATION PLAN

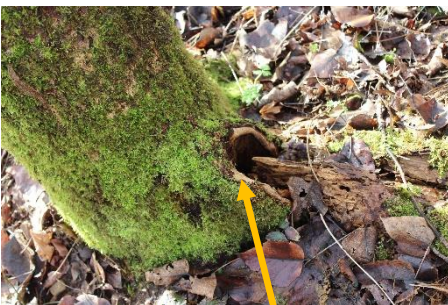
13

7455 Cottonwood, decay at root crown, previous co-dom, currently 1/2 of tree failed

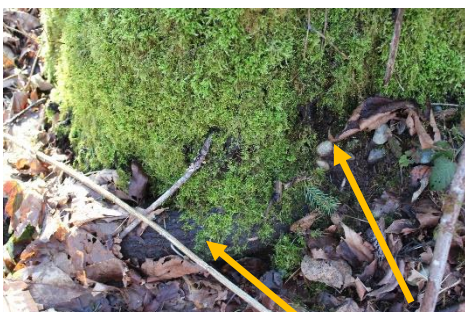
16

7359 Bigleaf maple, large girdling root, decay at root crown

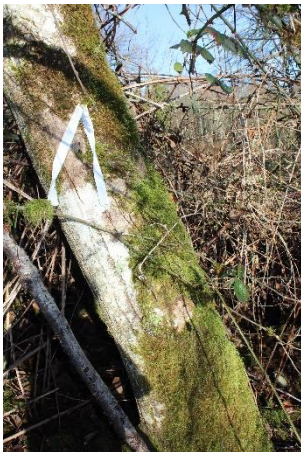
28

7650 Red alder, soil failure, + crown decay, falling to west (>10 degrees)

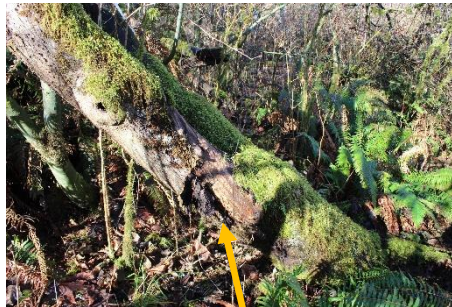
30

7561 Red alder: decay, fallen over

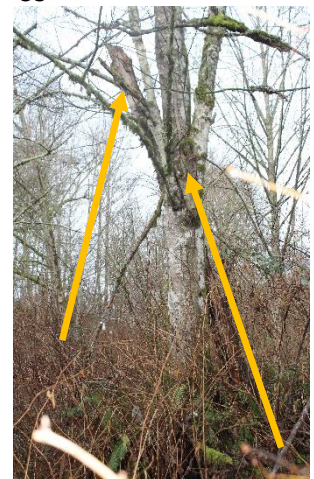
53

8215 Red alder: mostly dead, previous failure, some conks
