Benjamin Estates Residential Plat and Hill Property Development Redmond, WA

Preliminary Drainage Report

Benjamin Estates Residential Plat and
Hill Property Development

*October 23, 2013
Job No: 12-166*

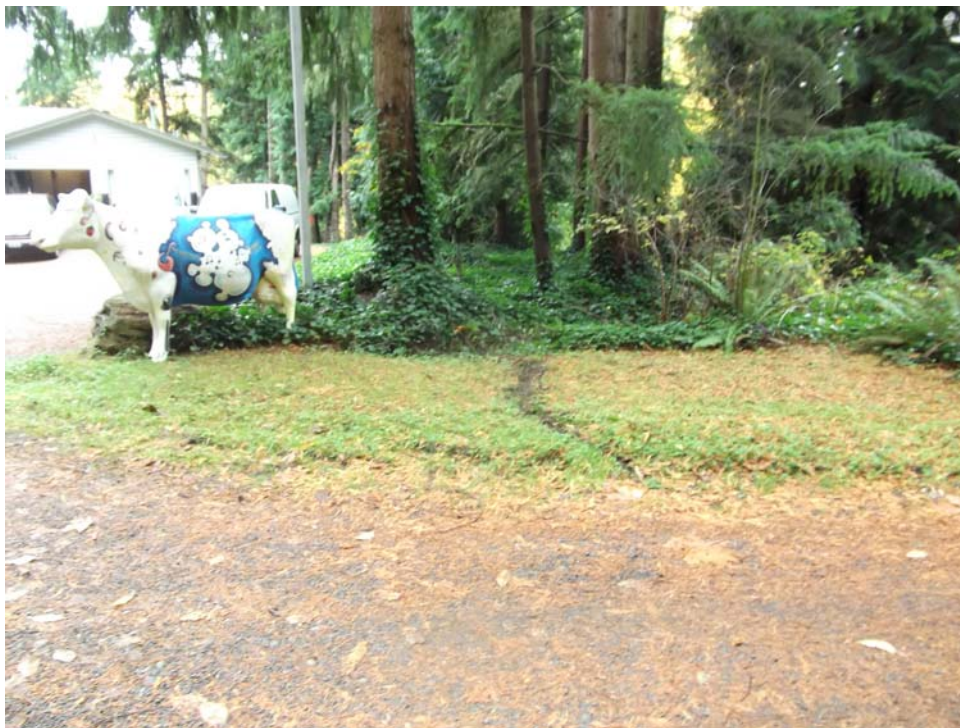
Stormwater flows under 138th Ave NE here via a culvert❶. The culvert outfalls into the brush in the center of the photo.

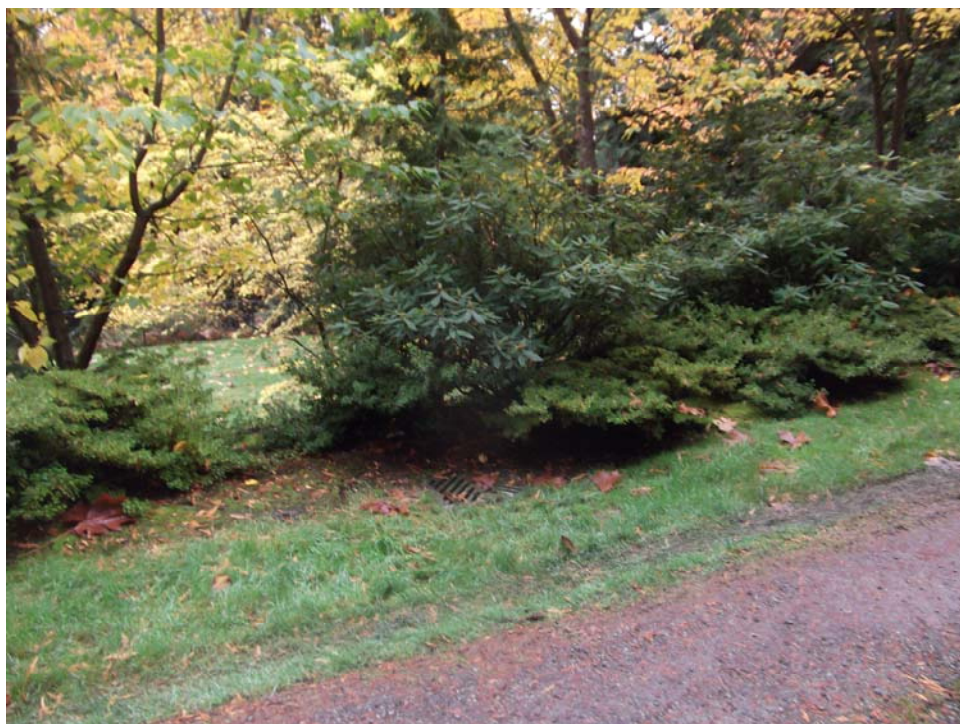
Flows enter this catch basin on the east side of 138th Ave NE❷

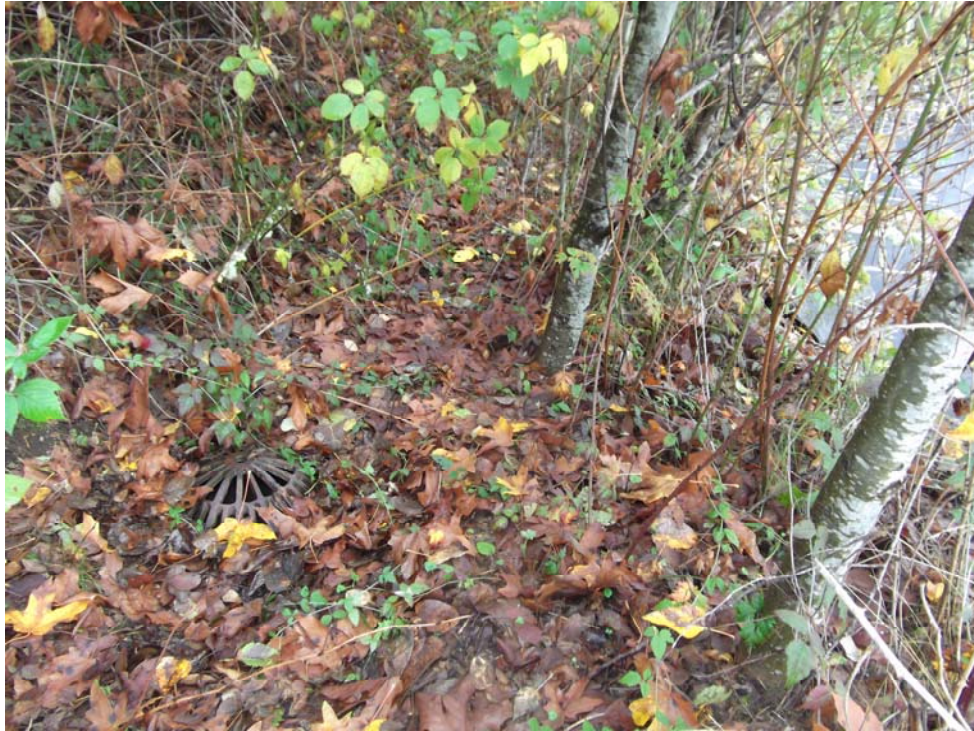
Stormwater enters this structure③ at the base of the hill

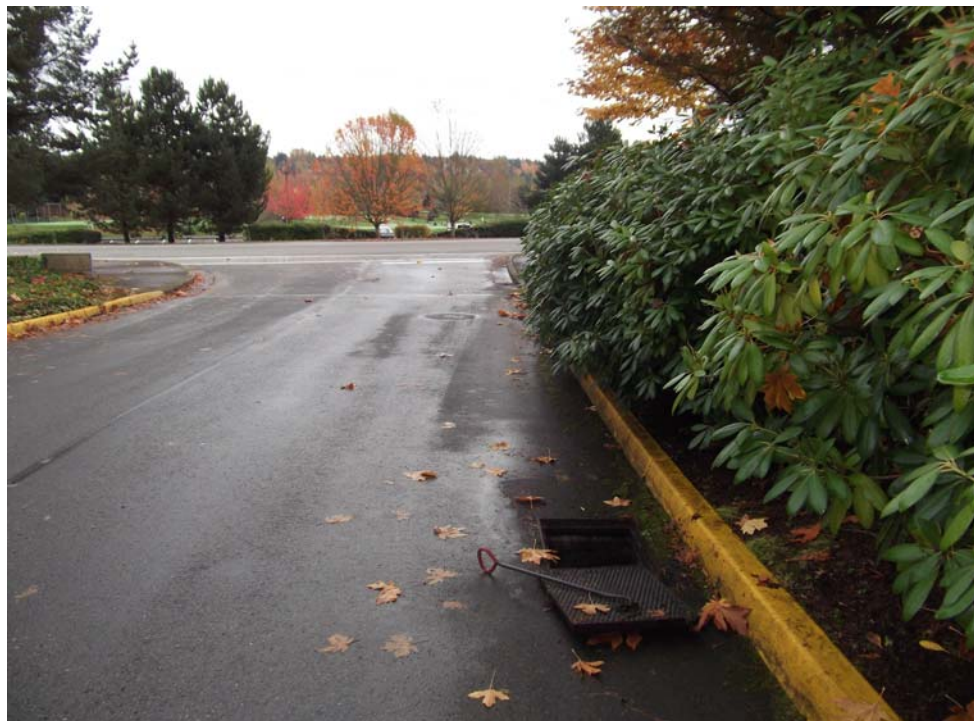
Flows are directed through the parking lot via the business park's storm system. Flows enter this catch basin just beyond the quarter mile buffer. Willows Rd NE is visible in the background of the photo.
