**Preliminary
Drainage Report**

Ellsworth Residential Plat

July 2015

Job No: 13-171

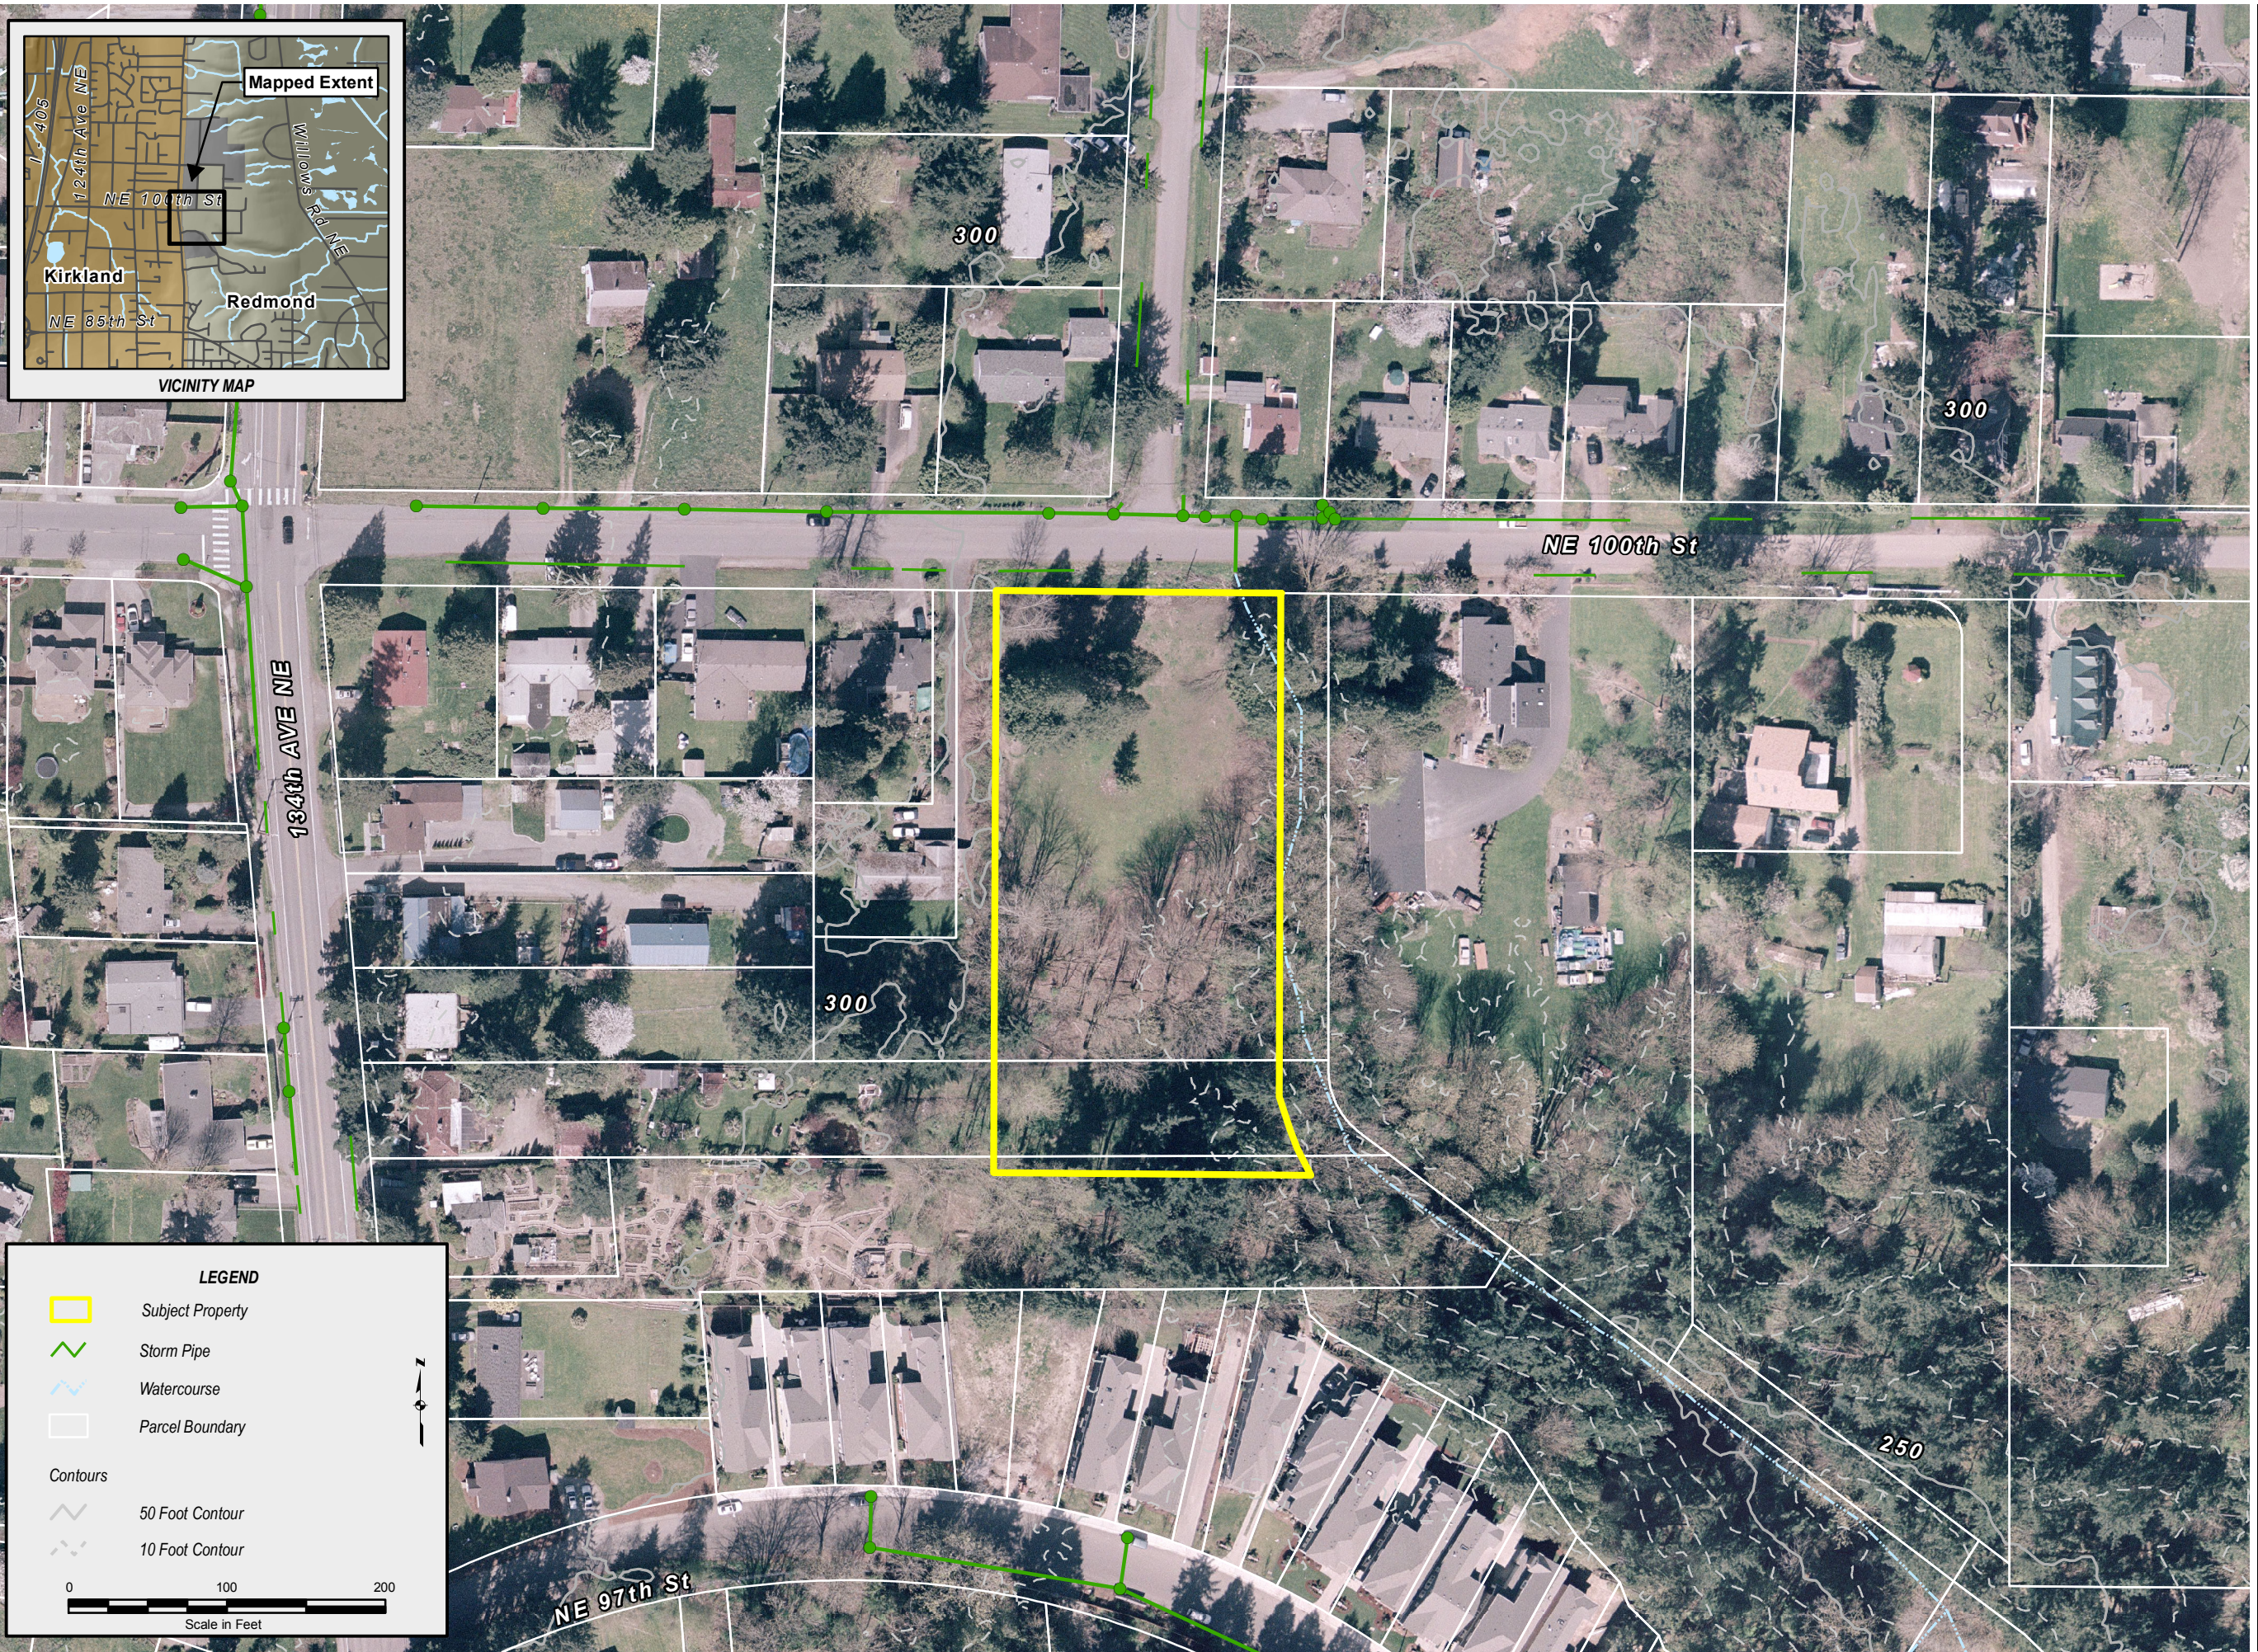
FIGURE:
1.0

LEGEND

- Subject Property
- ~ Storm Pipe
- ~ Watercourse
- Parcel Boundary

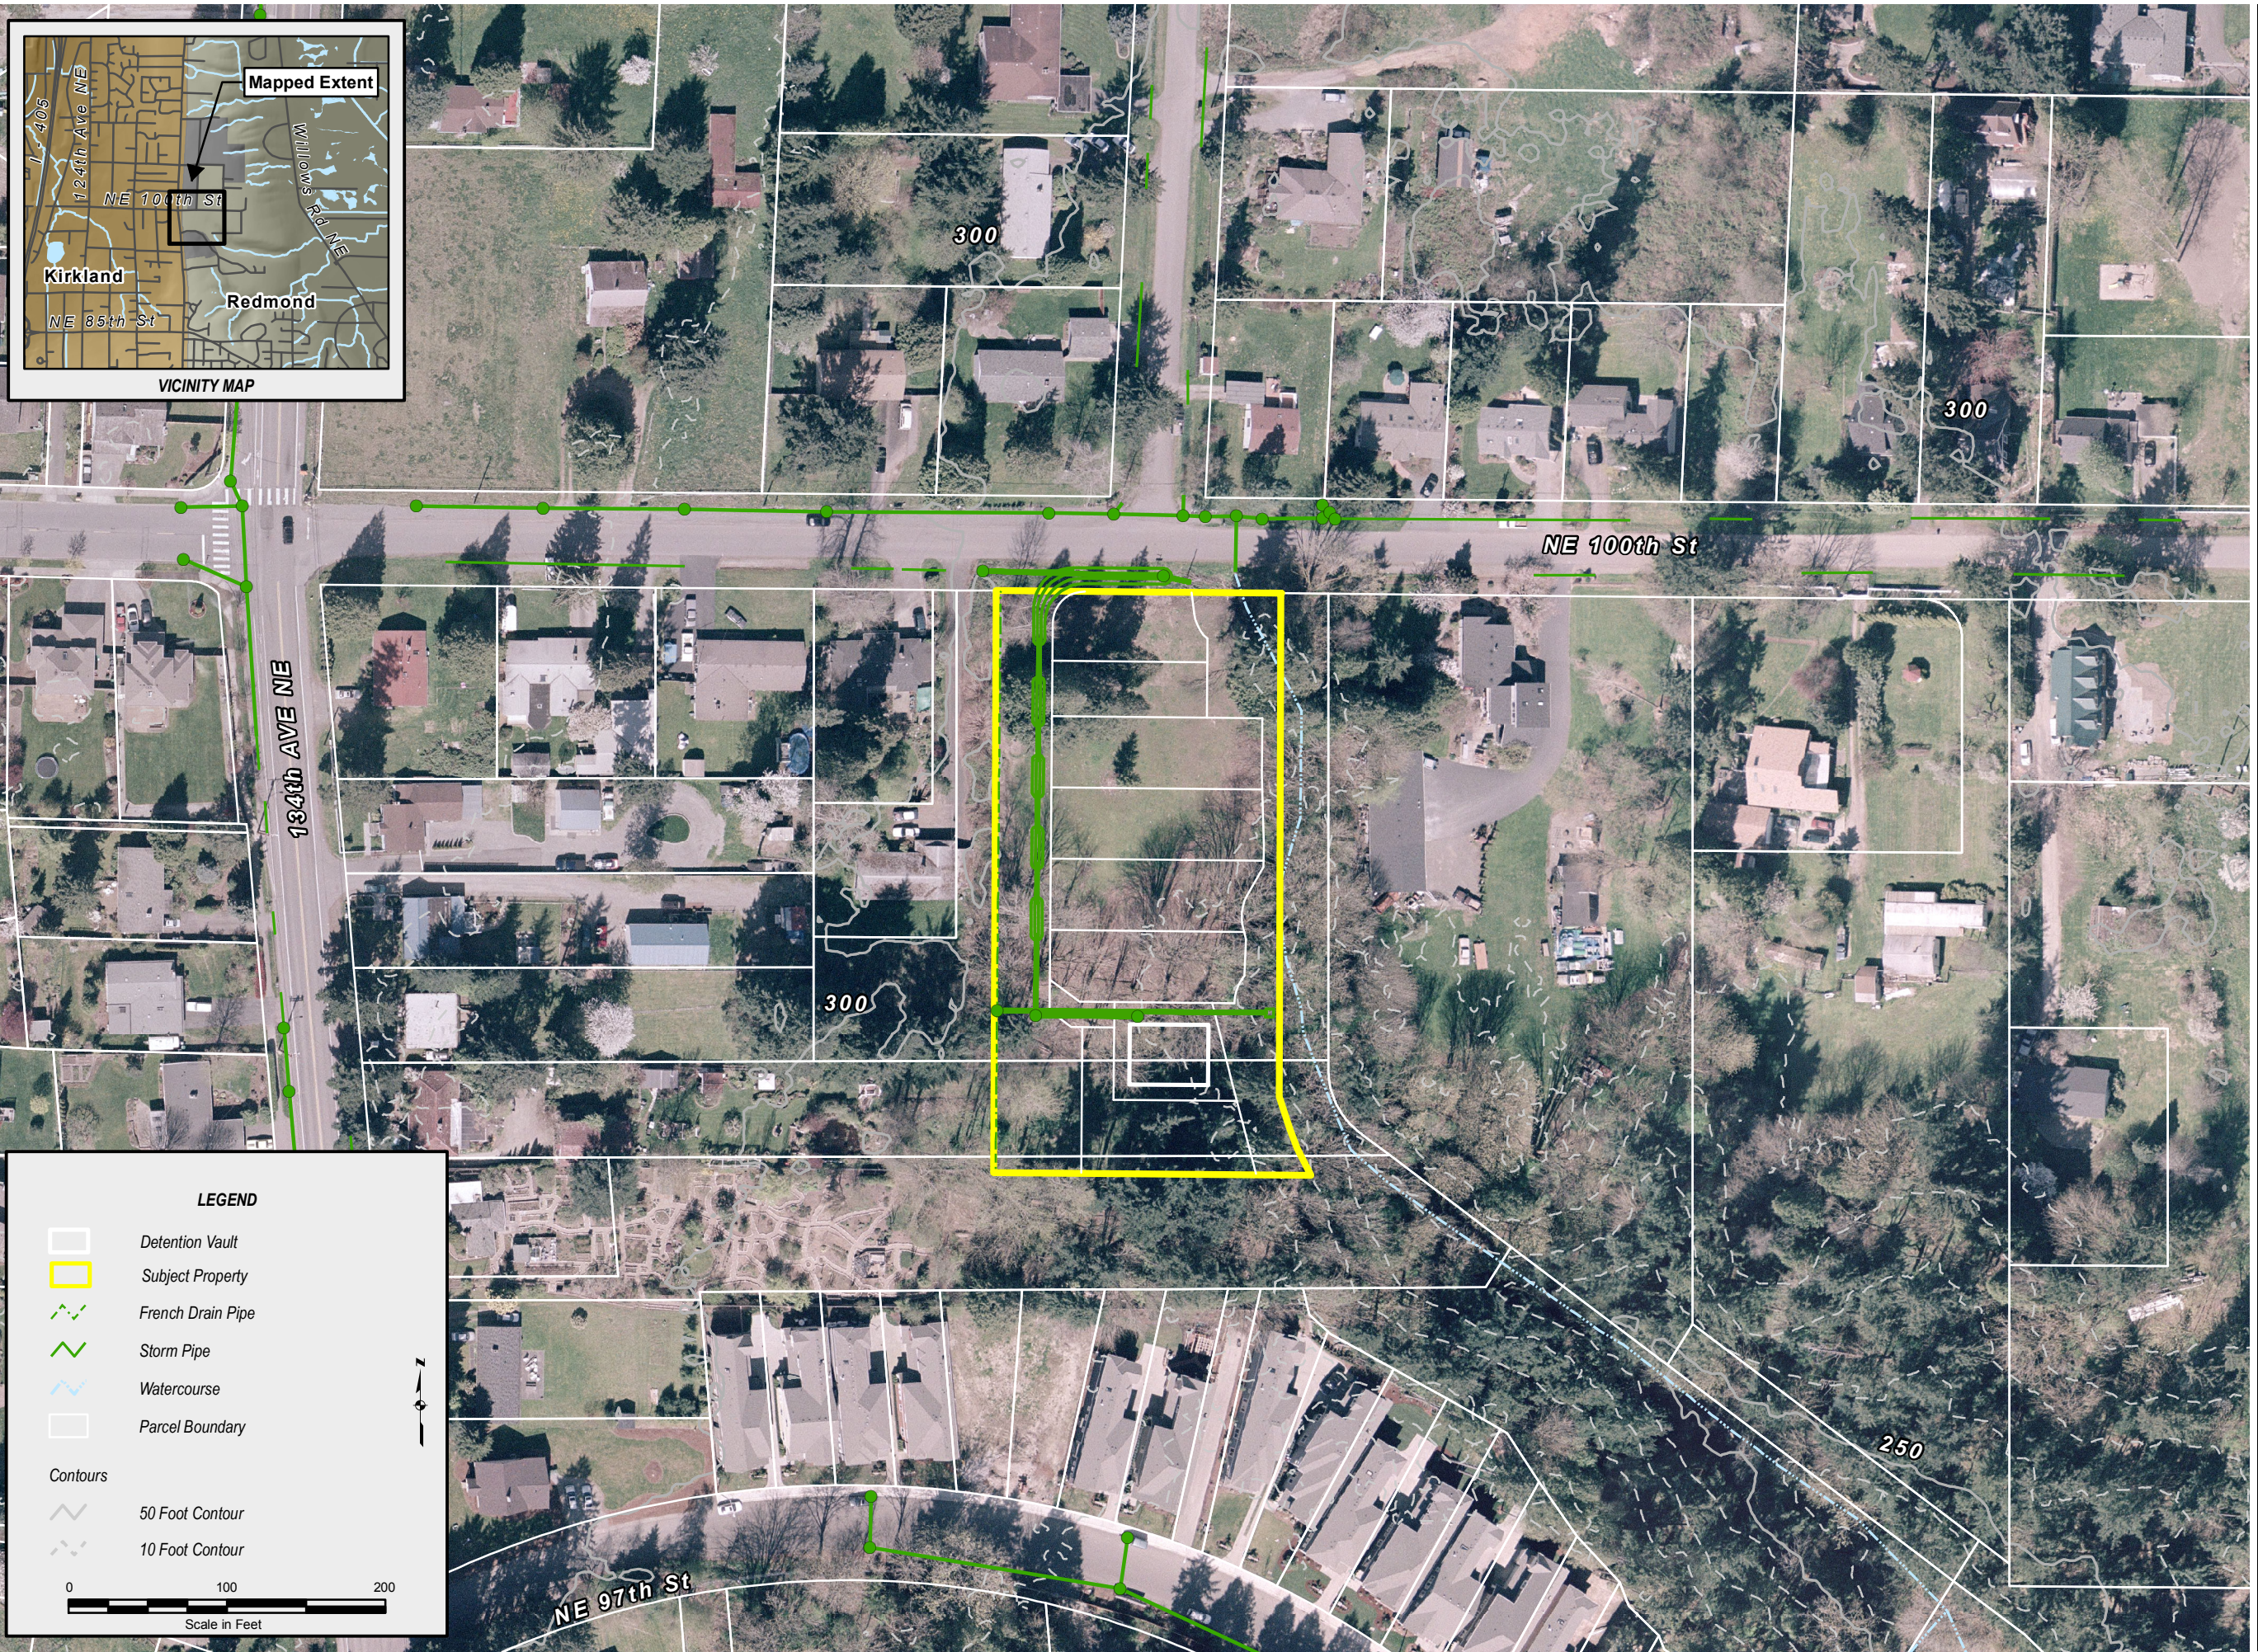
FIGURE:
2.0

LEGEND

- Detention Vault
- Subject Property
- French Drain Pipe
- Storm Pipe
- Watercourse
- Parcel Boundary

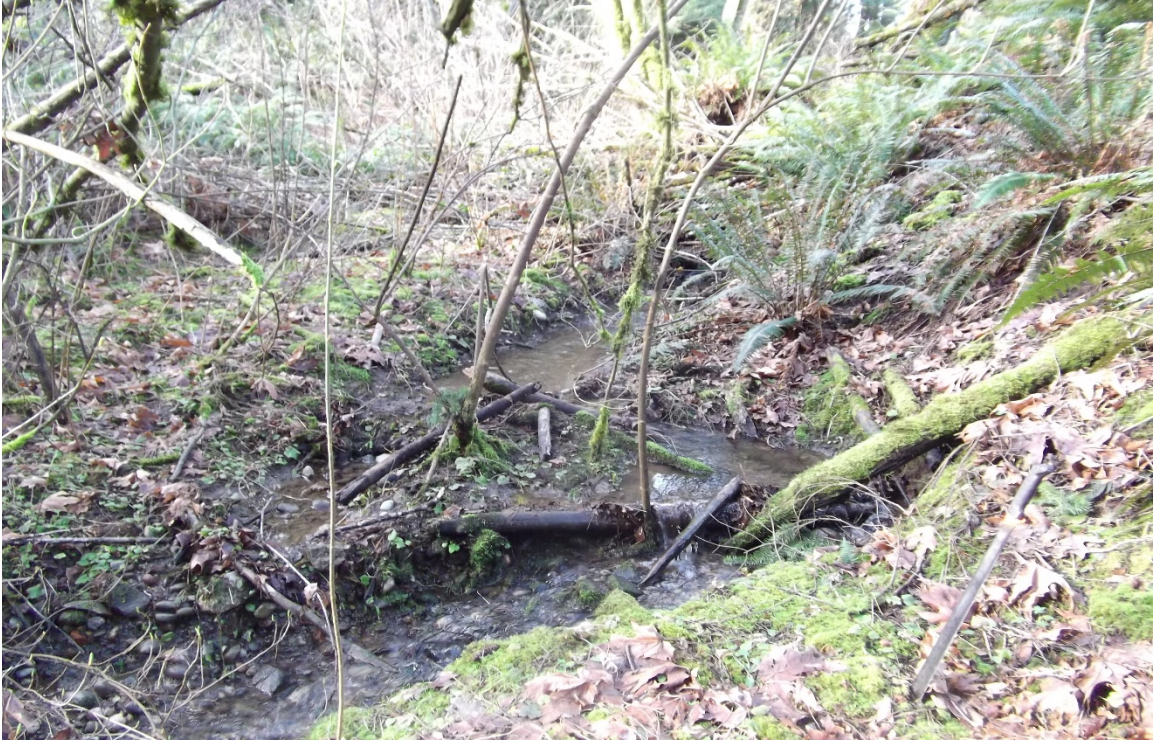
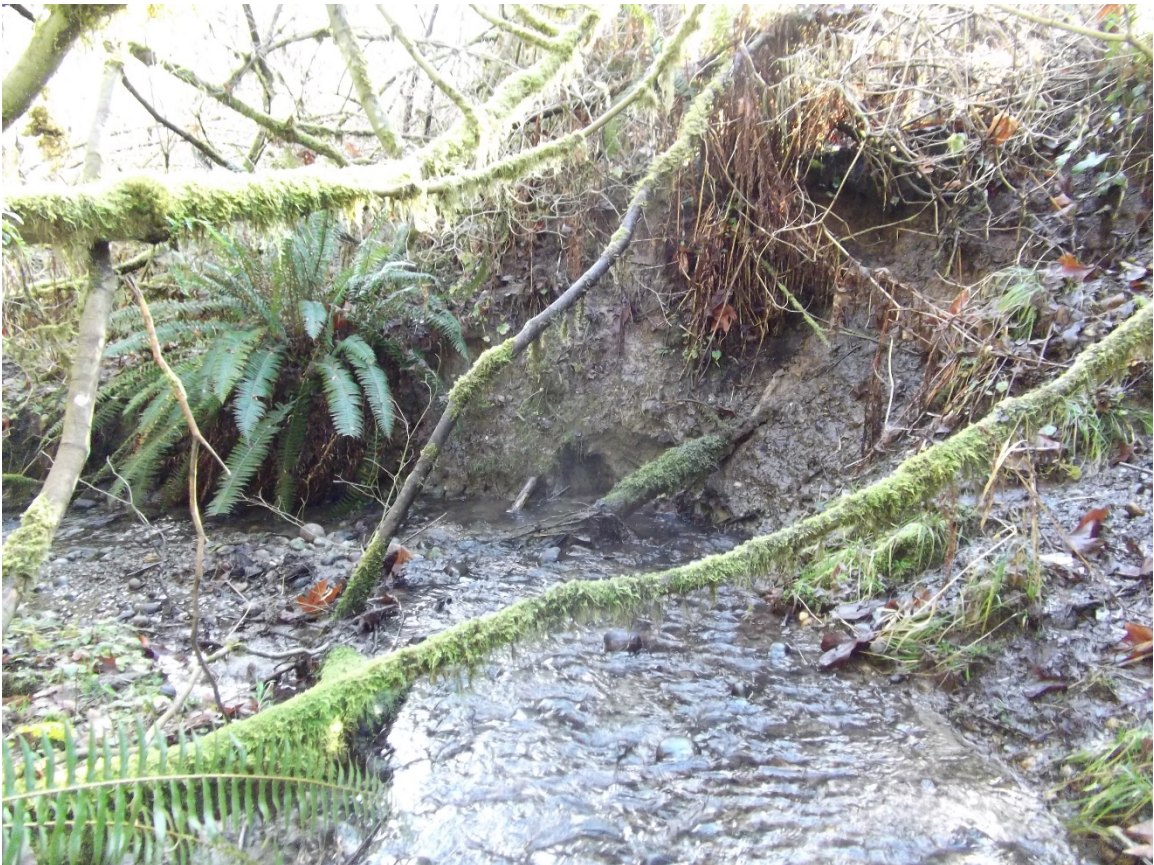
The unnamed tributary that receives flows from the site was visually inspected for signs of erosion and channel degradation that might be a cause for concern. The channel meanders through a heavily forested and wide valley floor. The channel is heavily vegetated with high grass and brush growing on both the channel sides and bottom.

Visual inspection identified few locations where the channel sides are incised or where topography and vegetation have created localized areas or plunge erosion.

The few locations of incision and erosion are minor (less than three vertical feet of exposed soils), and isolated to not more than a few feet from the creek edge. The creek, and all minor points of erosion, is a significant distance from the steeper valley side-slopes and pose no discernible threat to private property or public infrastructure. **The creek channel downstream of the site discharge should be considered stable.**

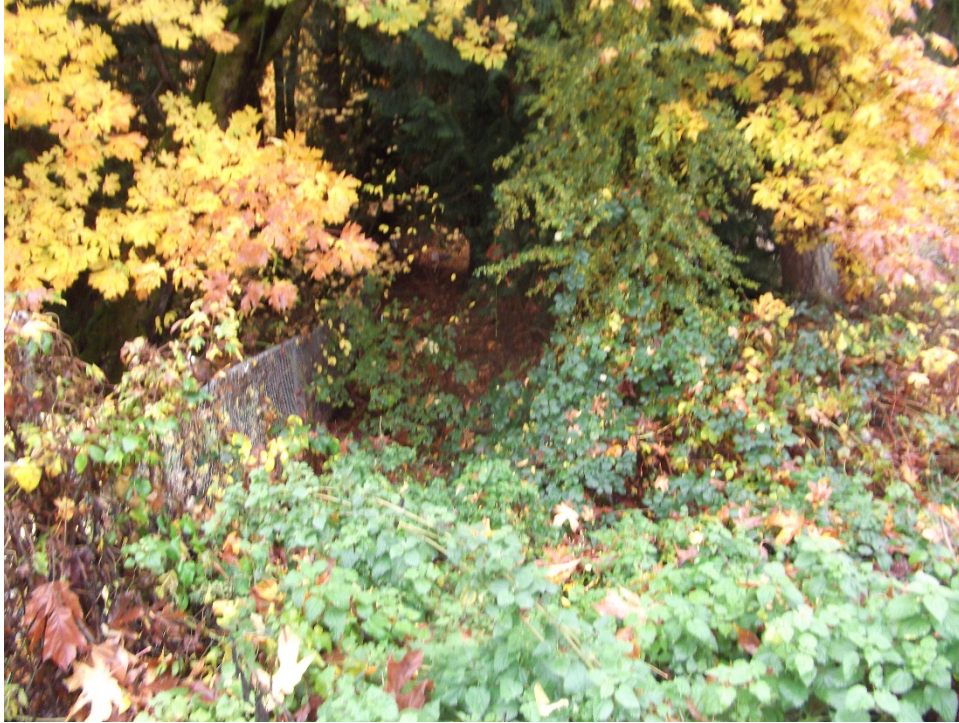
The natural drainage channel on the south side of NE 100th St. ❶

Stormwater onsite generally flows east towards an existing unnamed stream (see Figure 3.1, Downstream Analysis Map). Existing site flows drain overland across the eastern property boundary and deposit into this unnamed tributary that flows south from NE 100th St ①. Stormwater travels in this channel for approximately 1,400 feet before passing beyond the 0.25 mile boundary of analysis ②. Flows from the site eventually reach the Sammamish River via this unnamed tributary.

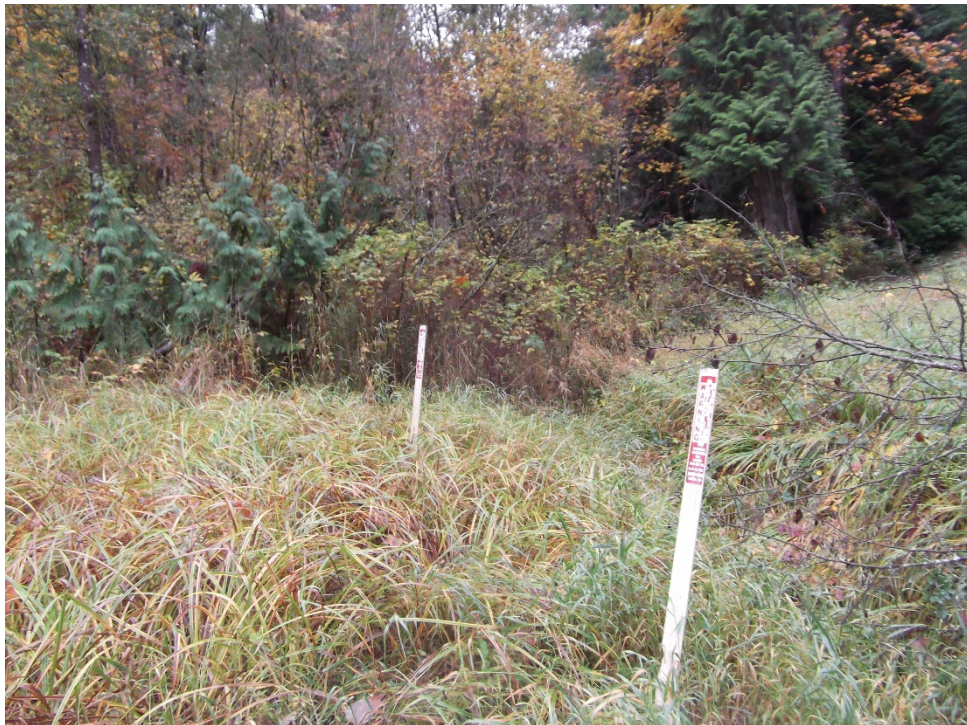
The channel, viewed from the power line easement, just beyond the quarter mile buffer. ❷

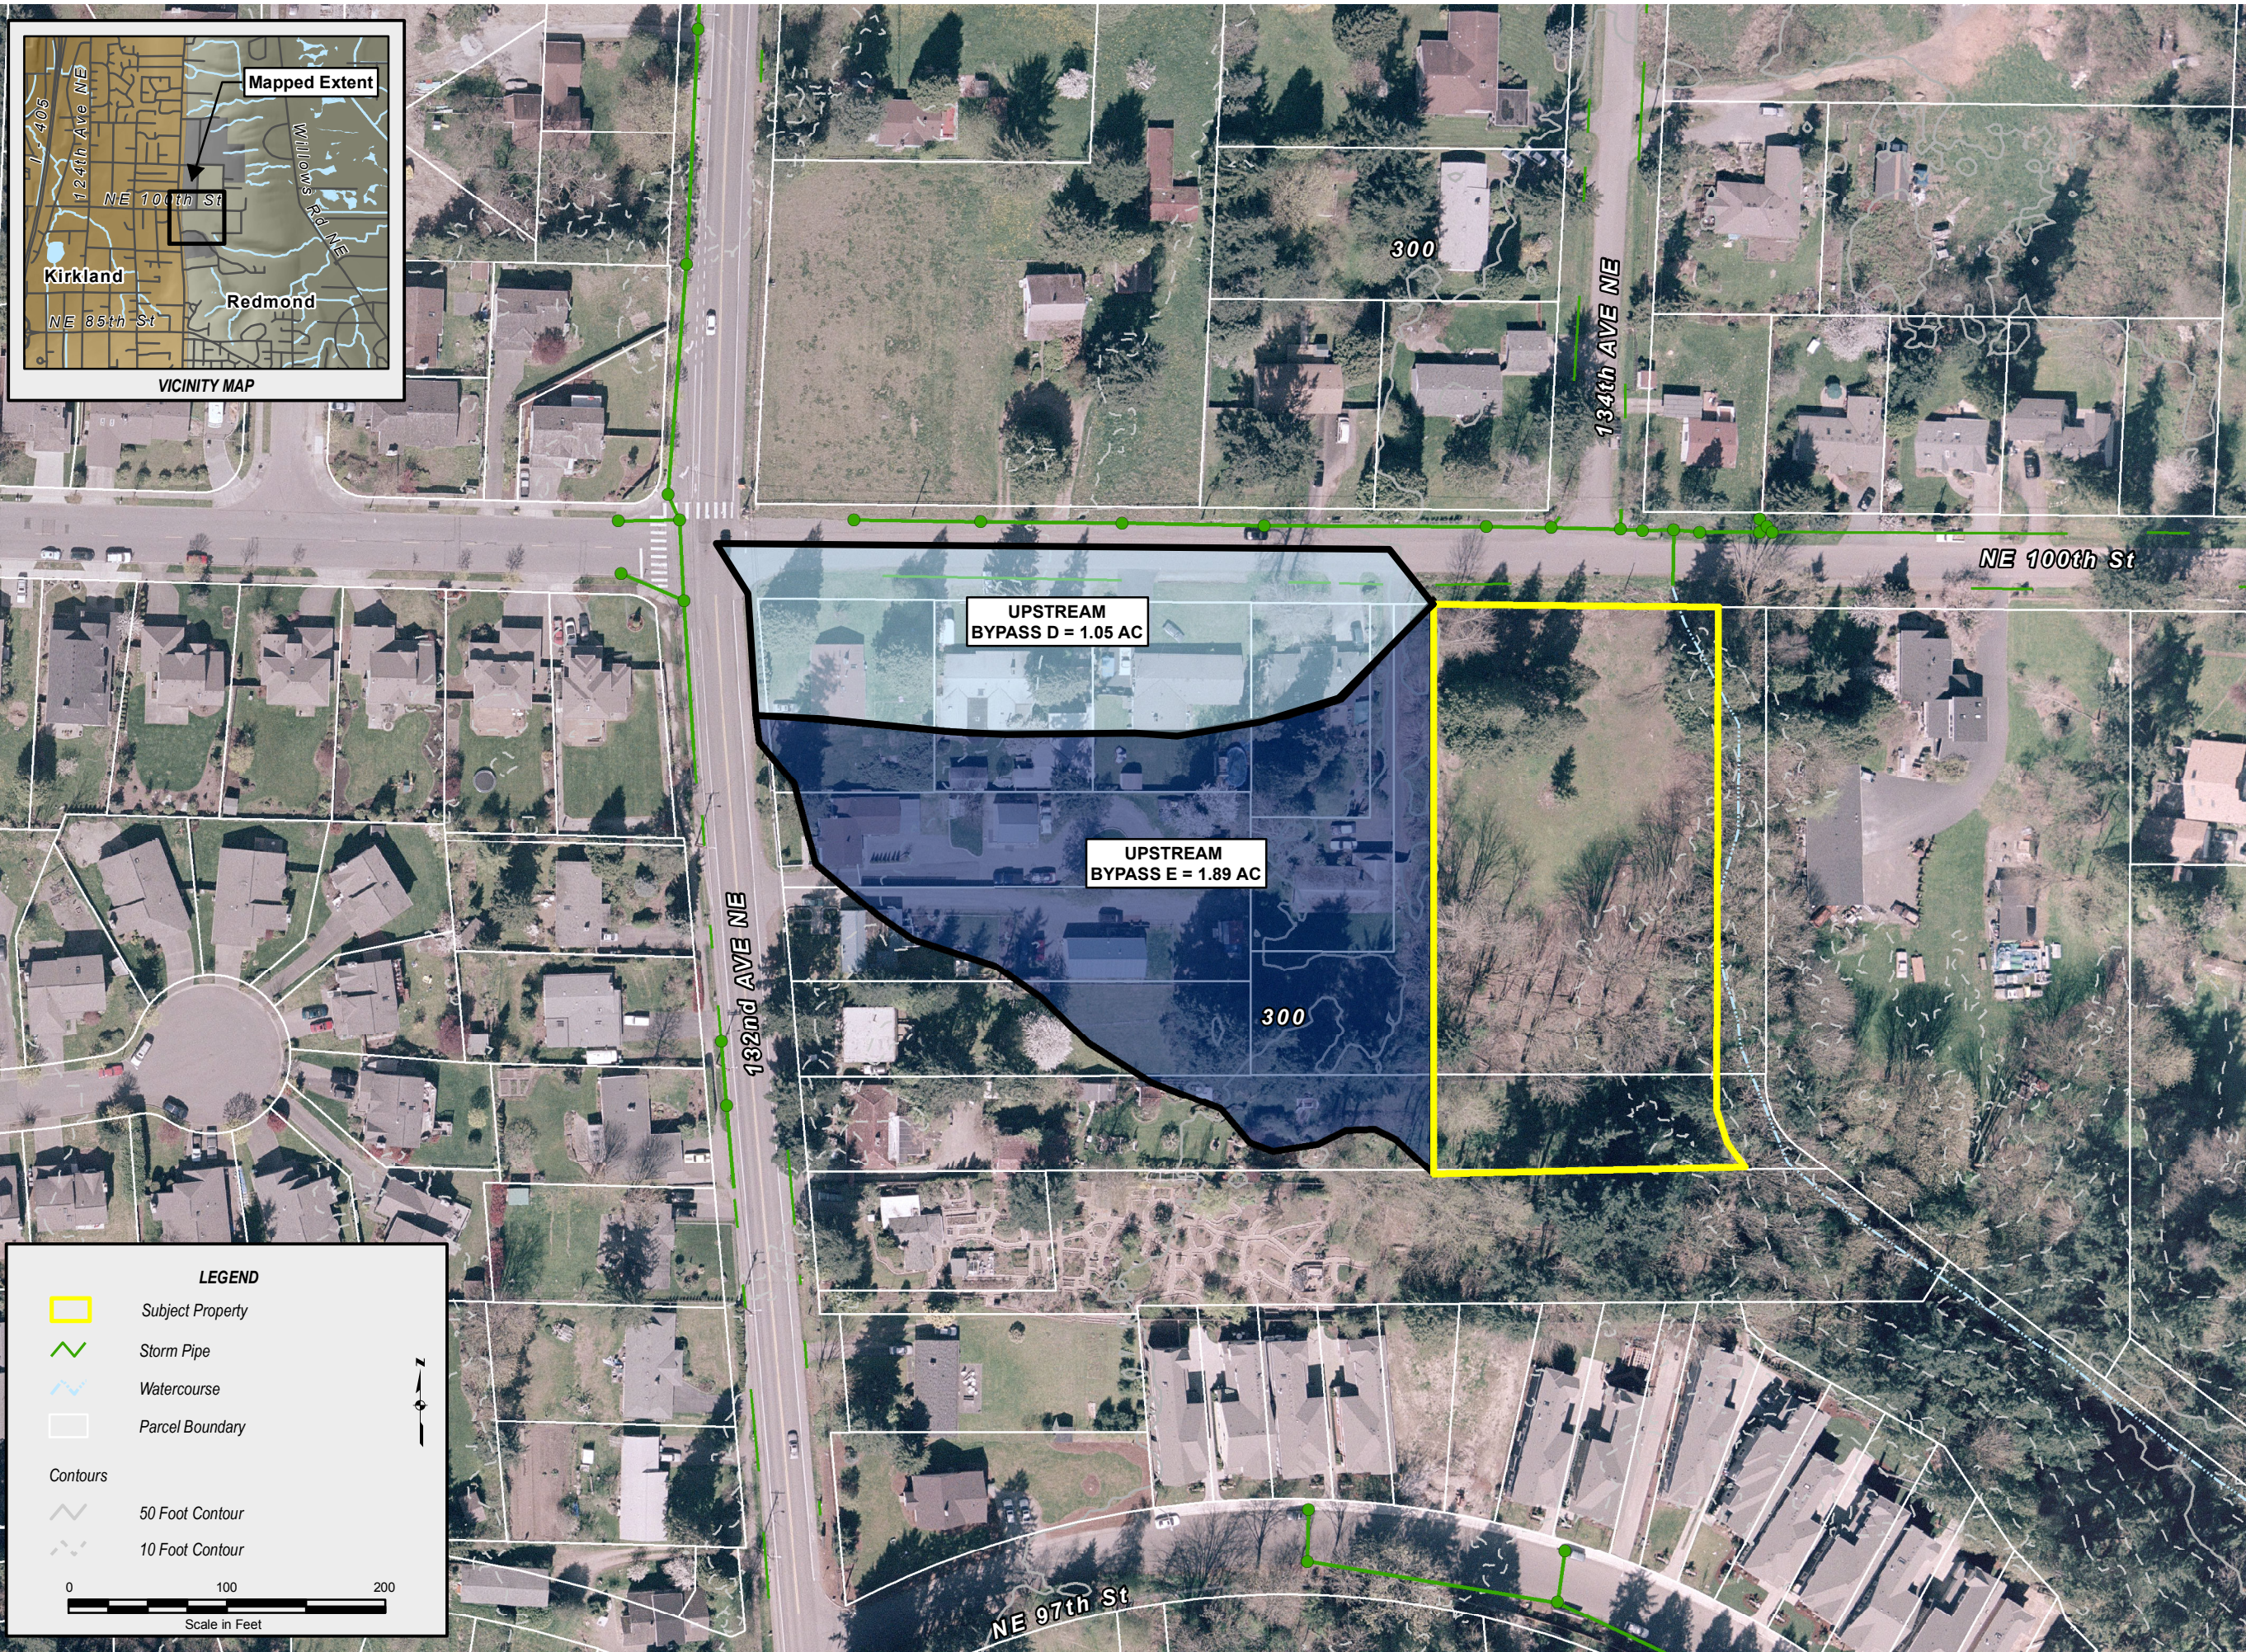
3.0

LEGEND

- Subject Property
- ~ Storm Pipe
- ~ Watercourse
- Parcel Boundary

There are two basins that are located upstream of the site, Upstream Bypass Basin D and Upstream Bypass Basin E. Both basins bypass the site in the developed condition and so are not considered for purposes of modeling. For visual representation of these upstream basins in the existing condition, see Figure 3.0, Upstream Analysis Map.

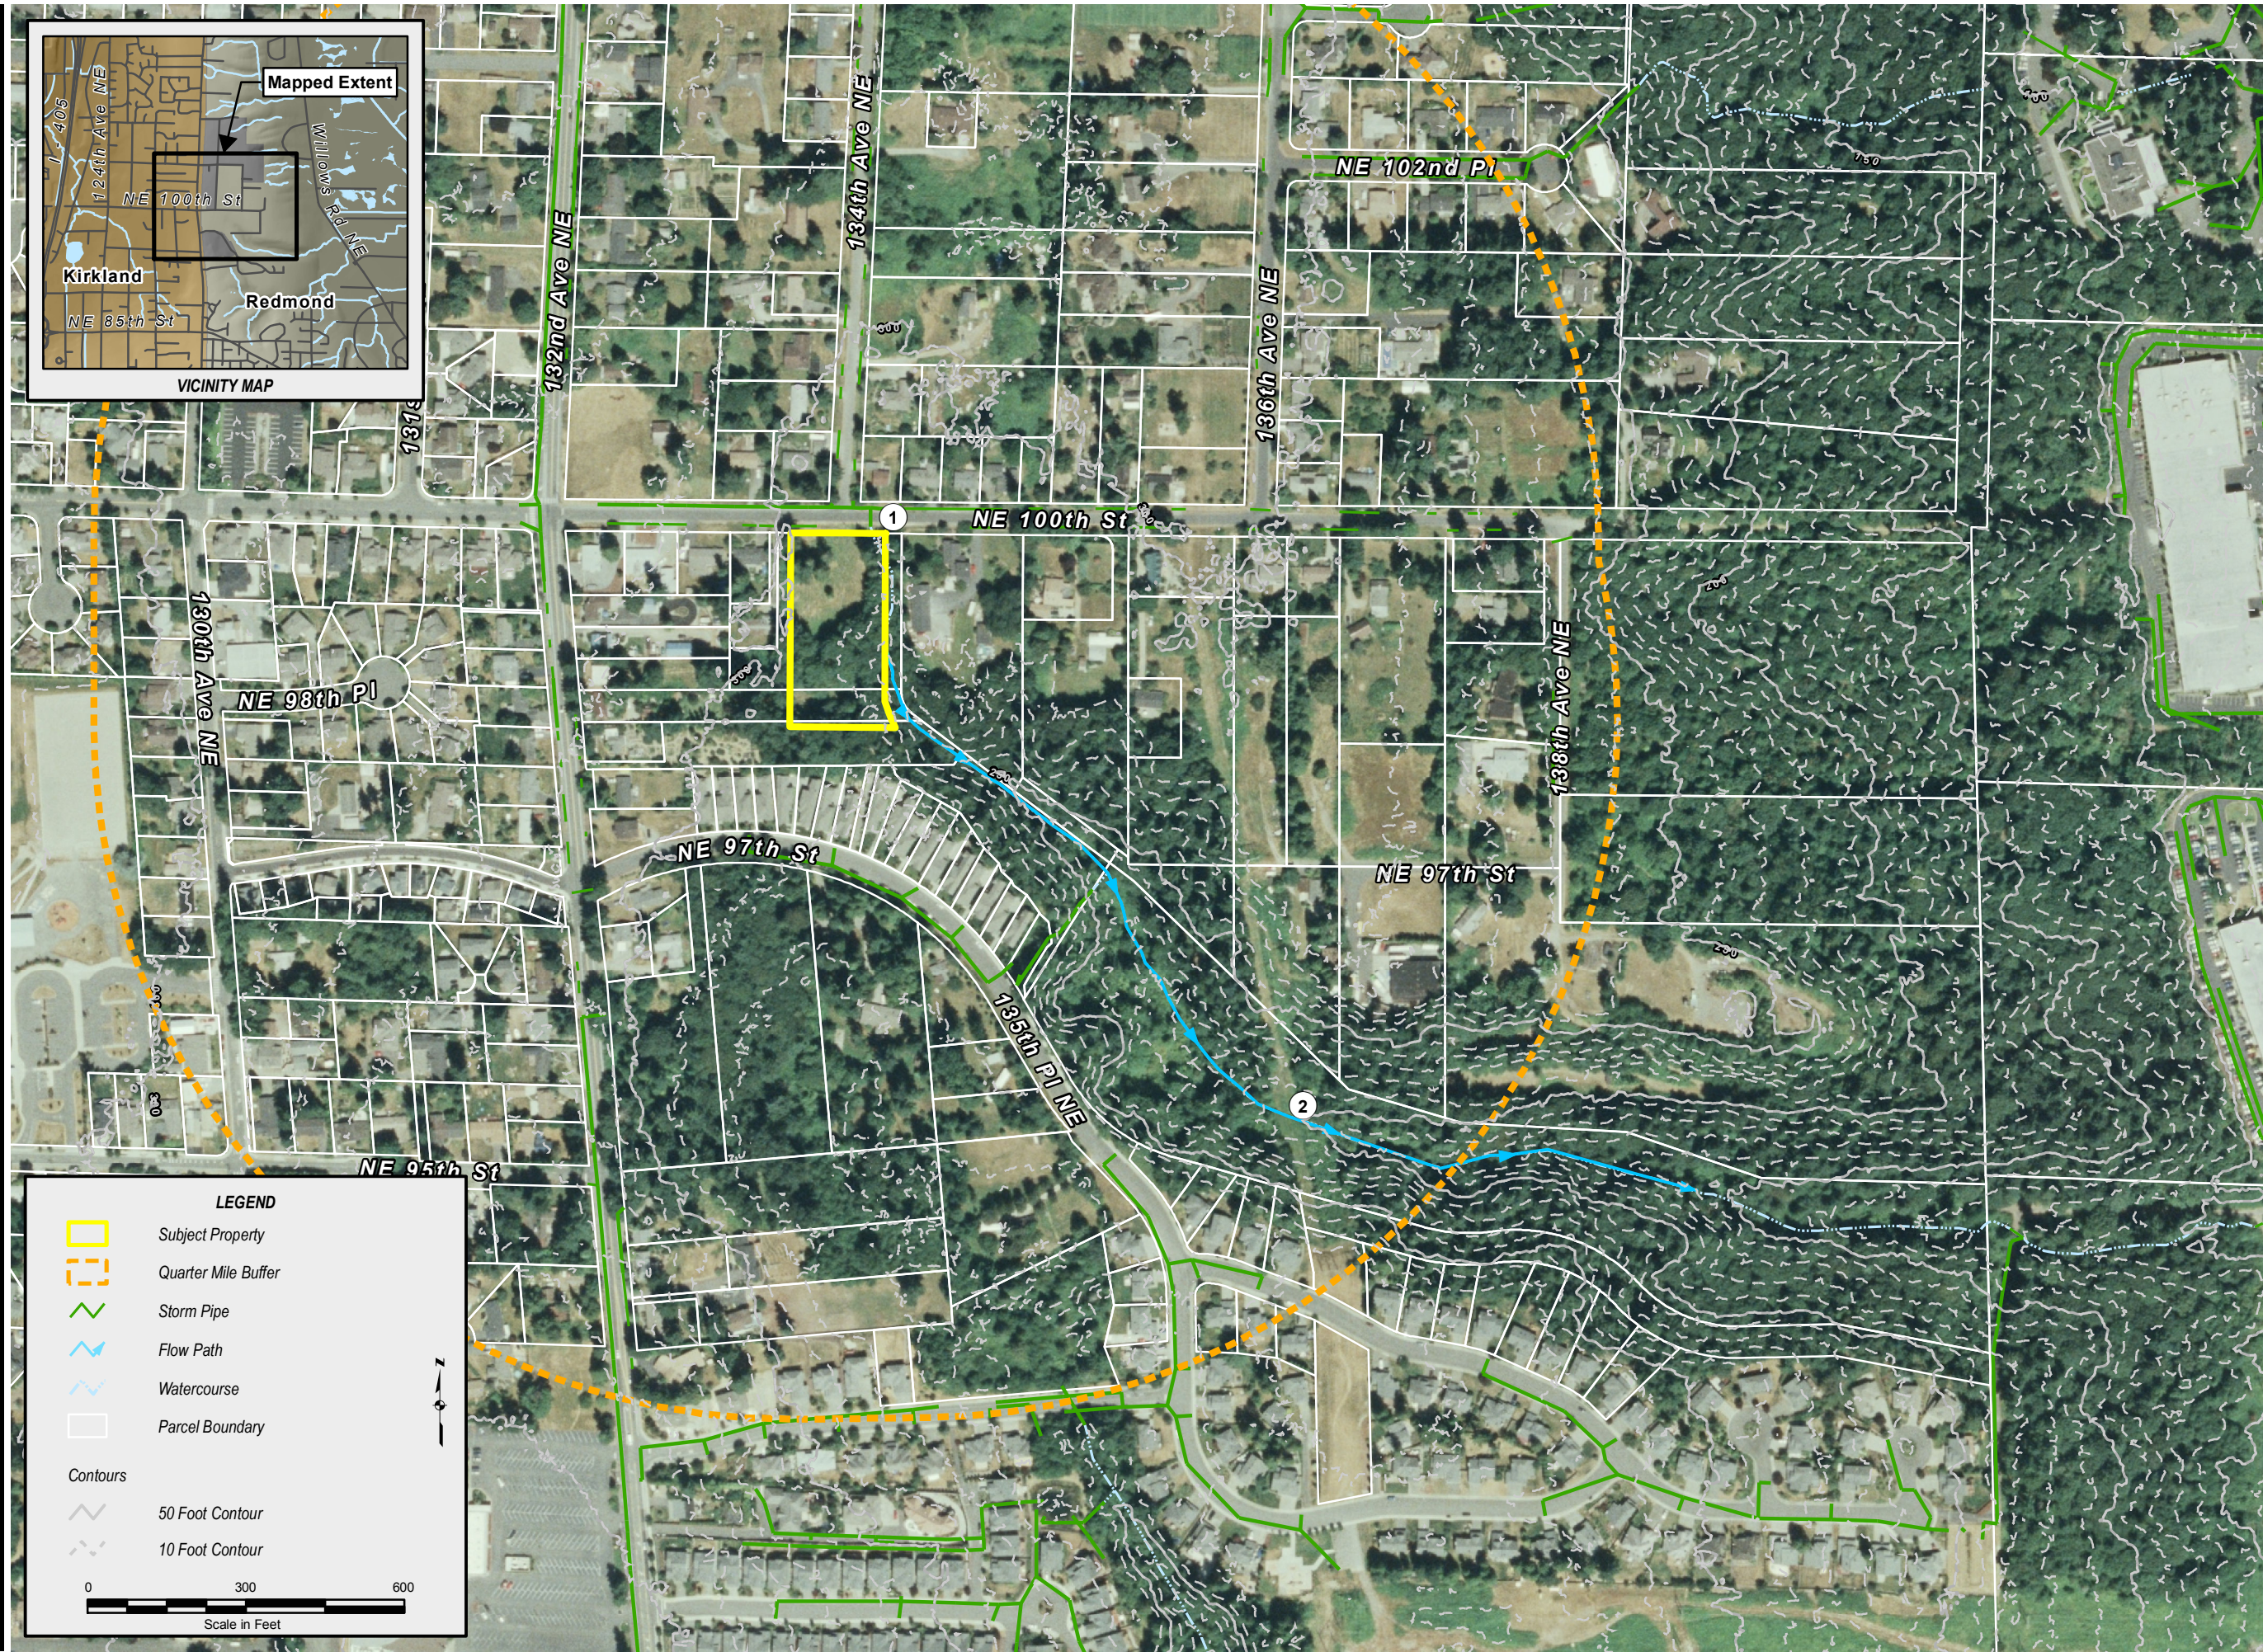
FIGURE:
3.1

LEGEND

- Subject Property
- Quarter Mile Buffer
- Storm Pipe
- Flow Path
- Watercourse
- Parcel Boundary

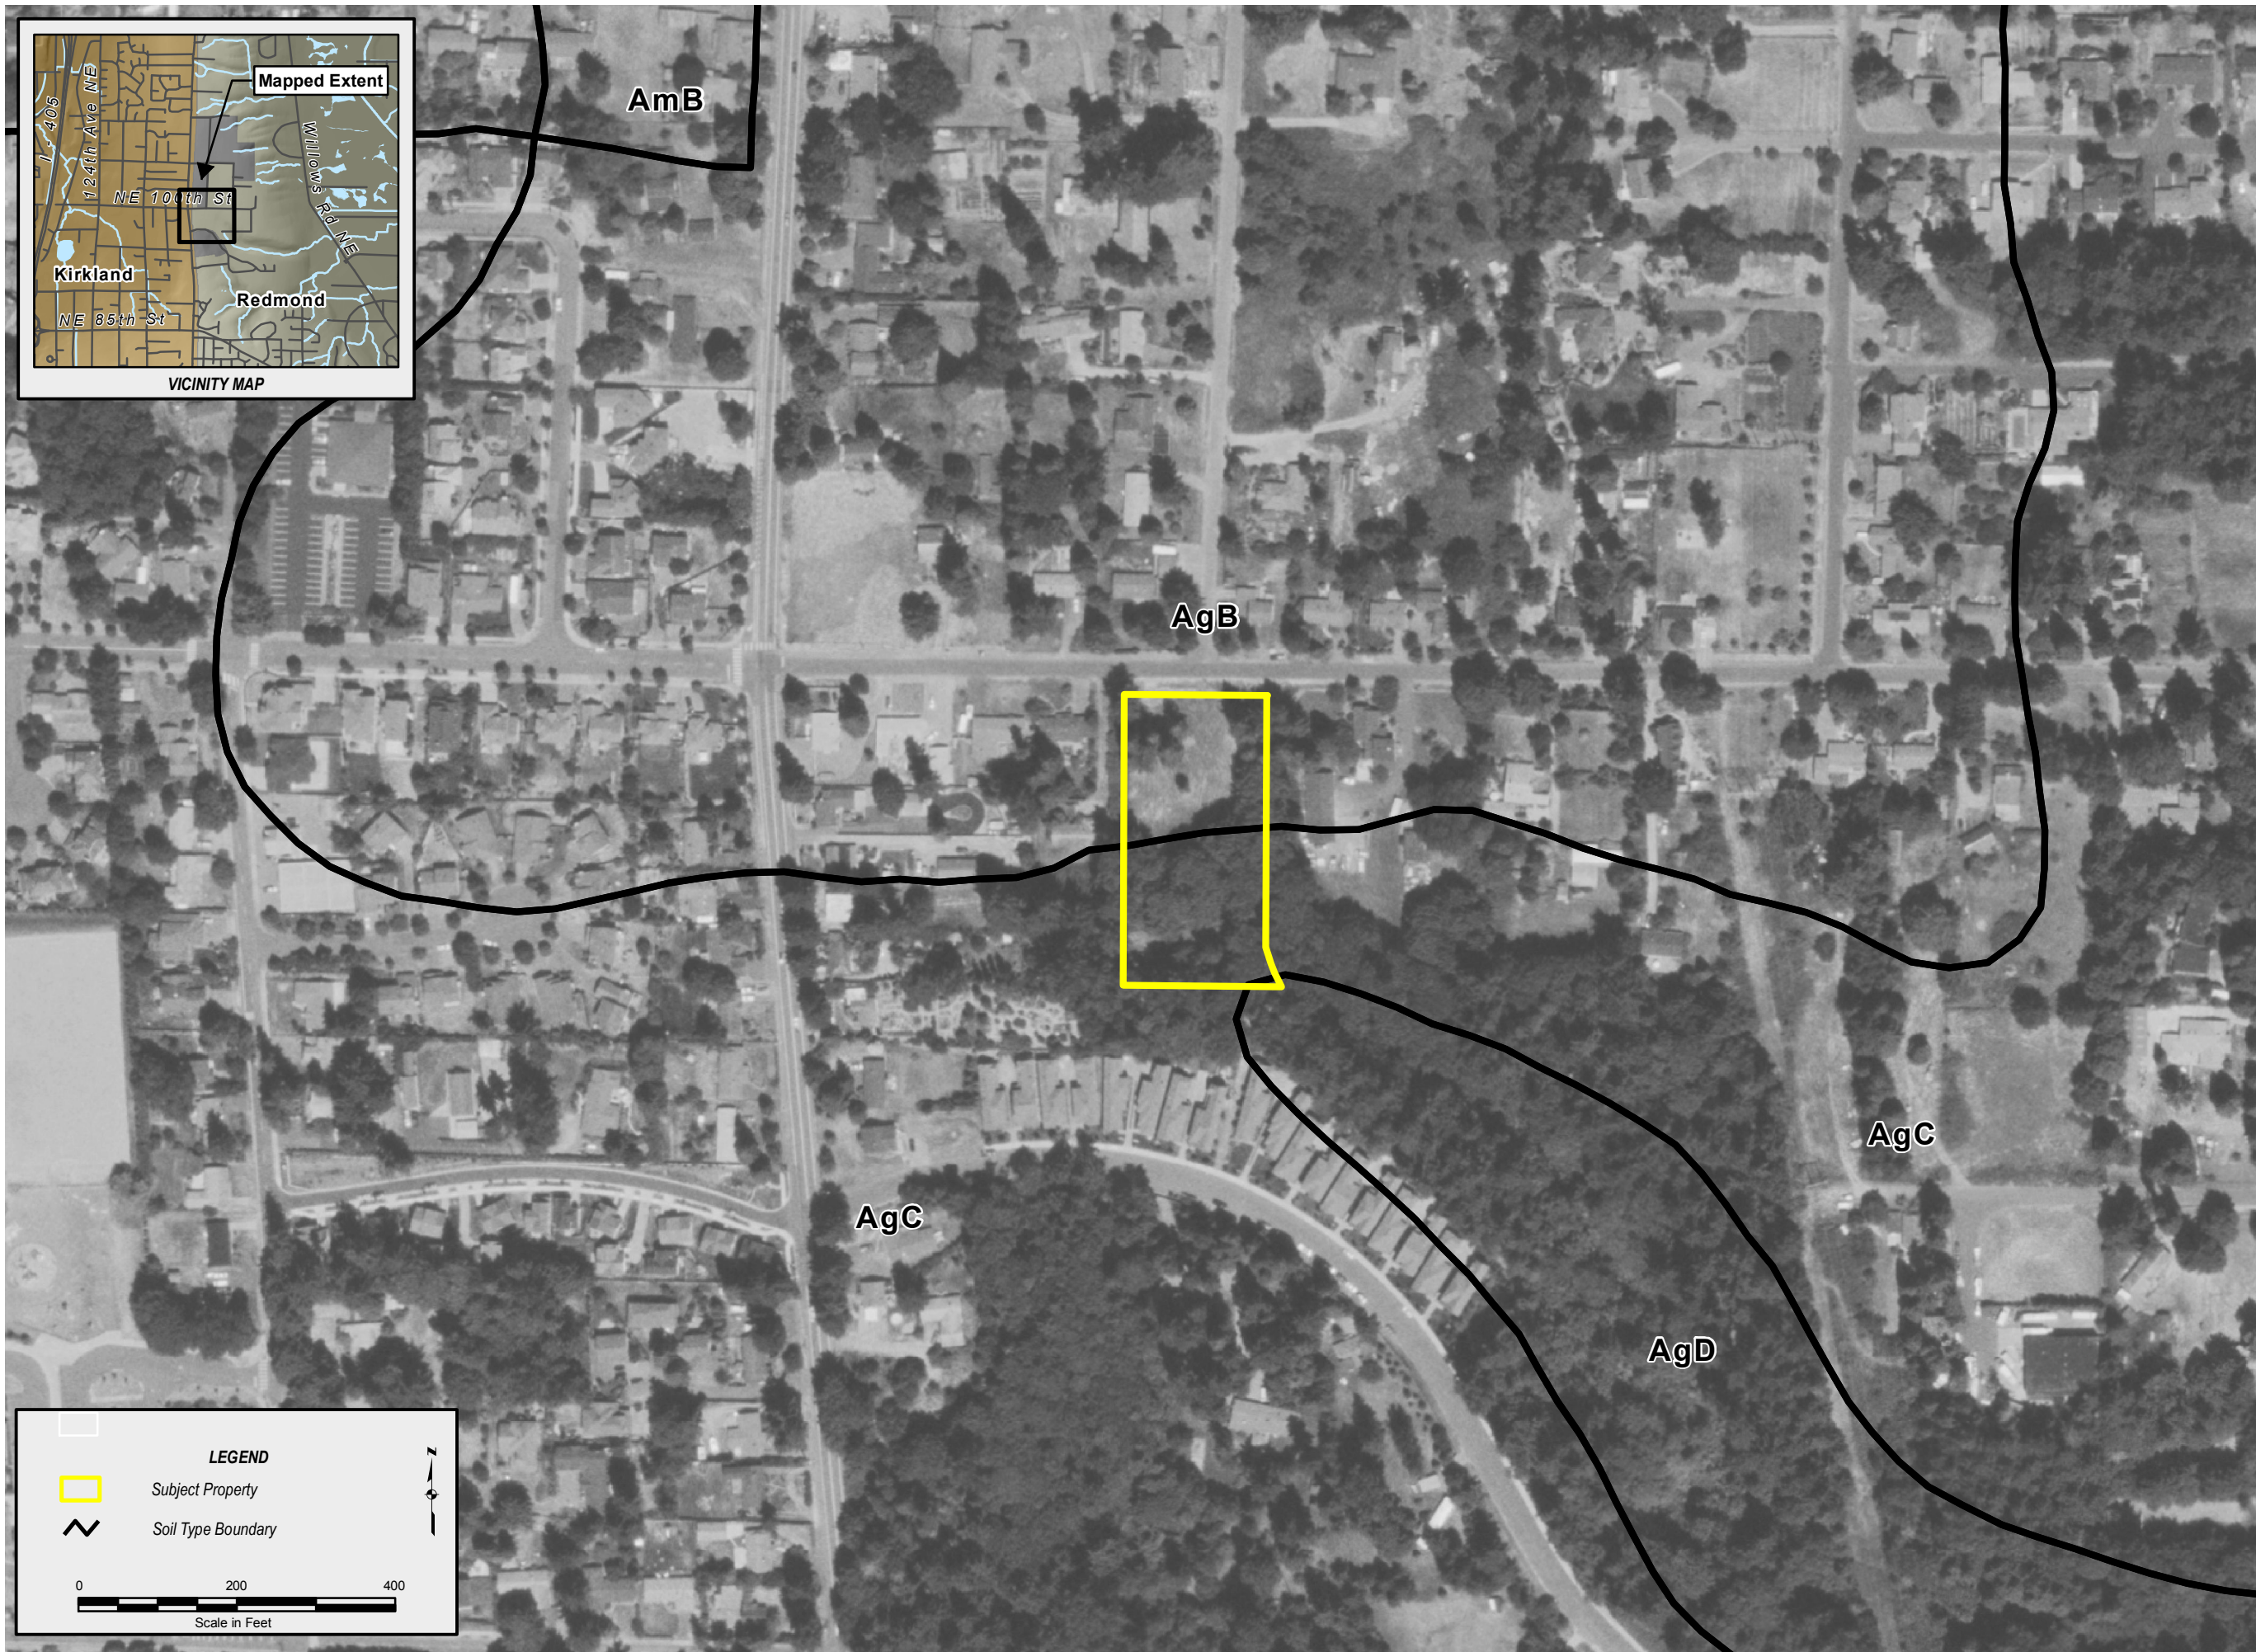
ELLSWORTH
KING COUNTY SOIL SURVEY

LEGEND

- Subject Property
- Soil Type Boundary
