**Preliminary
Drainage Report**

Ellsworth Residential Plat

July 2015

Job No: 13-171

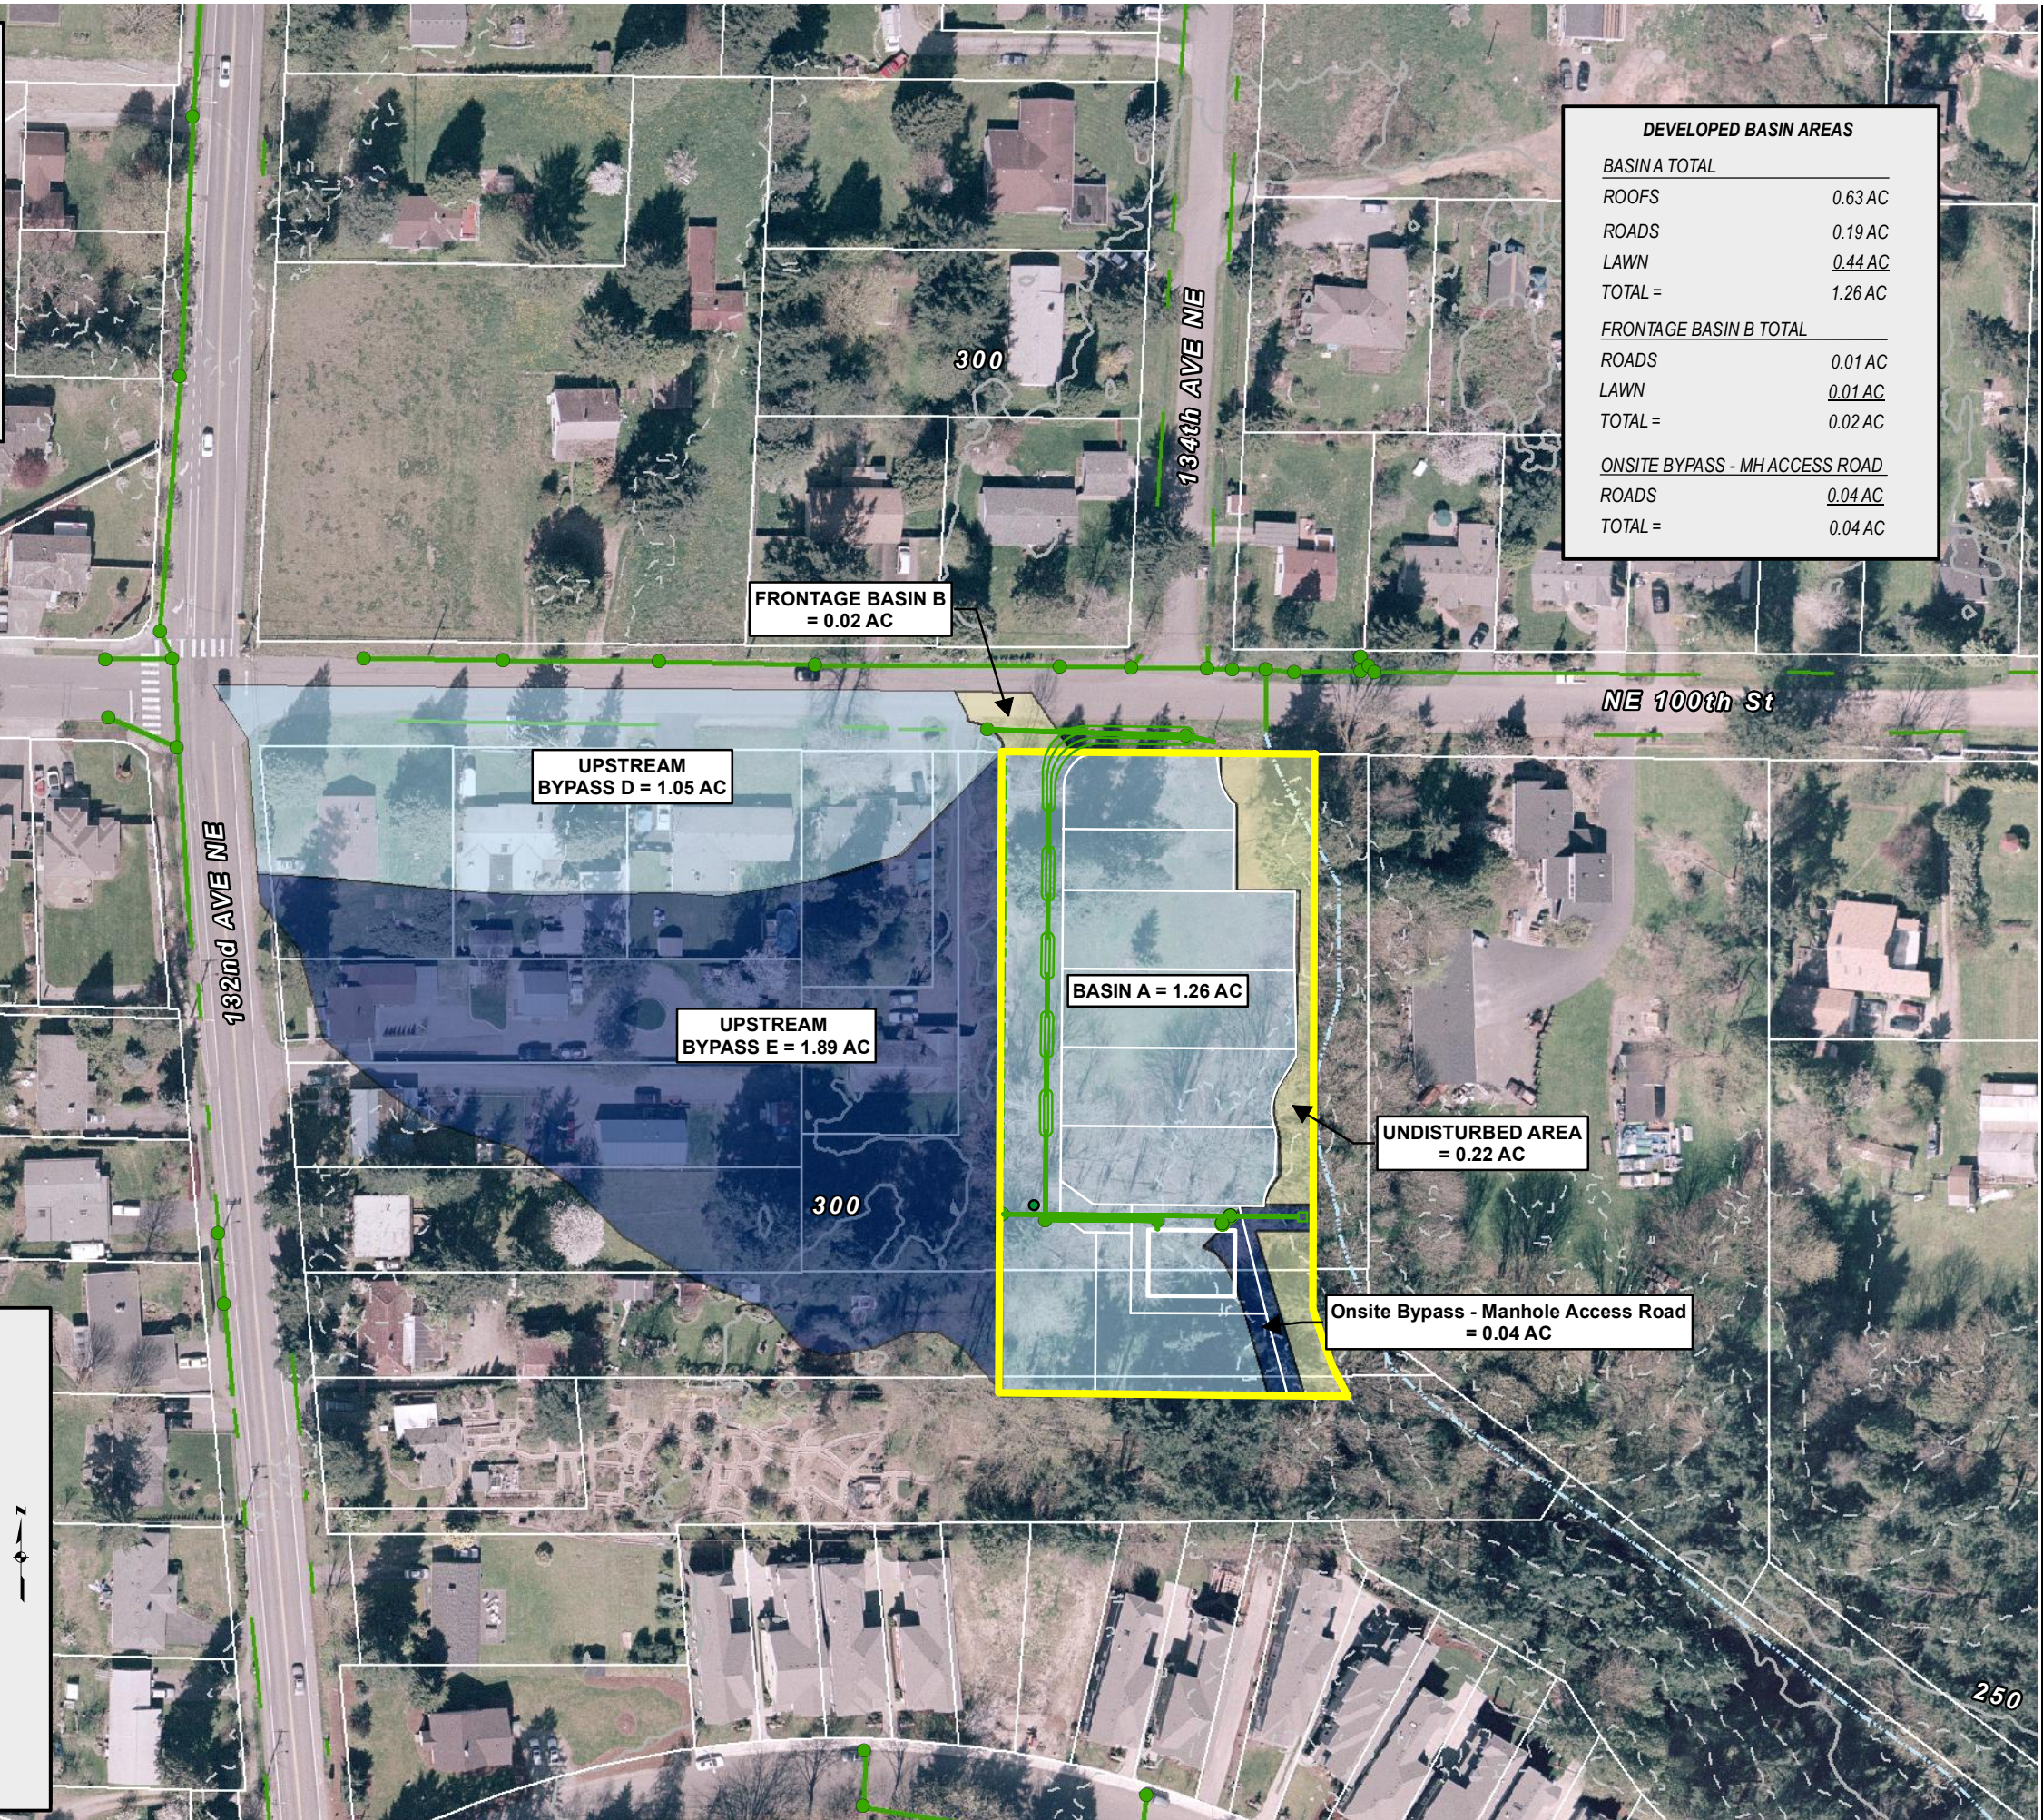
DEVELOPED BASIN AREAS	
BASIN A TOTAL	
ROOFS	0.63 AC
ROADS	0.19 AC
LAWN	0.44 AC
TOTAL =	1.26 AC
FRONTAGE BASIN B TOTAL	
ROADS	0.01 AC
LAWN	0.01 AC
TOTAL =	0.02 AC
ONSITE BYPASS - MH ACCESS ROAD	
ROADS	0.04 AC
TOTAL =	0.04 AC

The developed site and frontage area along NE 100th St is divided into 3 distinct basins for the purposes of collection, conveyance and modeling. Frontage Basin B and Basin A will be collected and conveyed to proposed on-site detention. Due to site topography, a manhole access road will bypass detention (Onsite Bypass - Manhole Access Road). In the developed condition, there remains an undisturbed area of 0.22 acres along the eastern property boundary, coincident with the existing creek and its buffer.

Basin A is approximately 1.26 acres. Flows are collected and conveyed via the proposed drainage system including catch basins, roof drains, storm drain pipe and roadside swales. In the developed condition, it has been modeled as follows:

Frontage Basin B is approximately 0.02 acres. Flows are collected into a roadside swale. In the developed condition, it has been modeled as follows:

Onsite Bypass - Manhole Access Road will bypass detention due to developed site topography. Runoff will be collected within the retaining wall foundation drain and will outlet into the site's natural discharge location on the southeast portion of the site. This bypass basin has been modeled as follows:

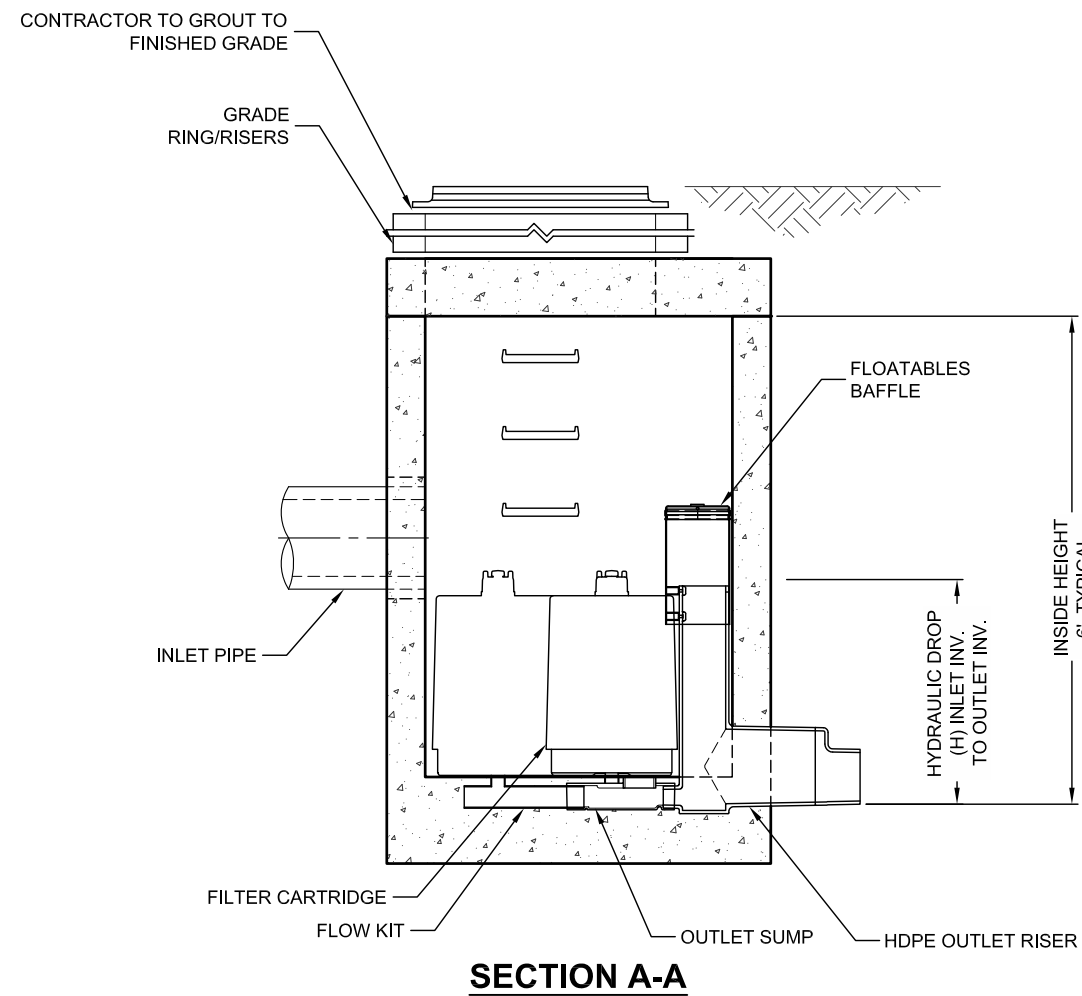
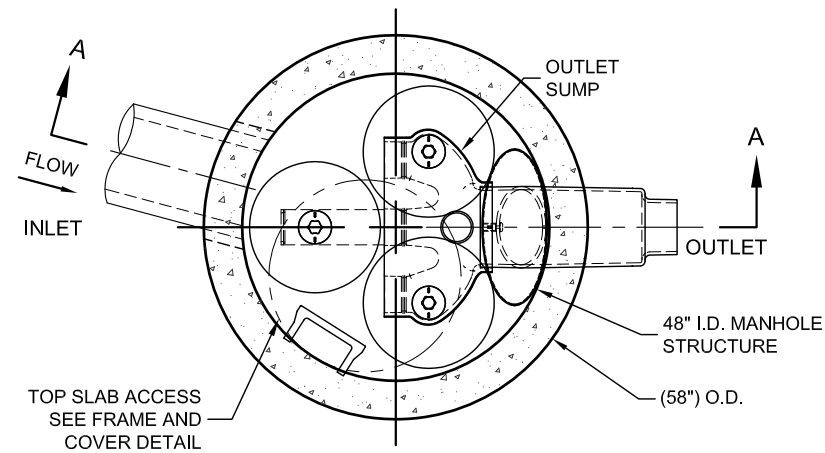
STORMFILTER DESIGN NOTES

STORMFILTER TREATMENT CAPACITY IS A FUNCTION OF THE CARTRIDGE SELECTION AND THE NUMBER OF CARTRIDGES. THE STANDARD MANHOLE STYLE IS SHOWN WITH THE MAXIMUM NUMBER OF CARTRIDGES (3). VOLUME SYSTEM IS ALSO AVAILABLE WITH MAXIMUM 3 CARTRIDGES. Ø48" MANHOLE STORMFILTER PEAK HYDRAULIC CAPACITY IS 1.0 CFS. IF THE SITE CONDITIONS EXCEED 1.0 CFS AN UPSTREAM BYPASS STRUCTURE IS REQUIRED.
