Edgewood East

City of Redmond, Washington

Preliminary Storm Drainage Report

Blueline Job No. 14-036

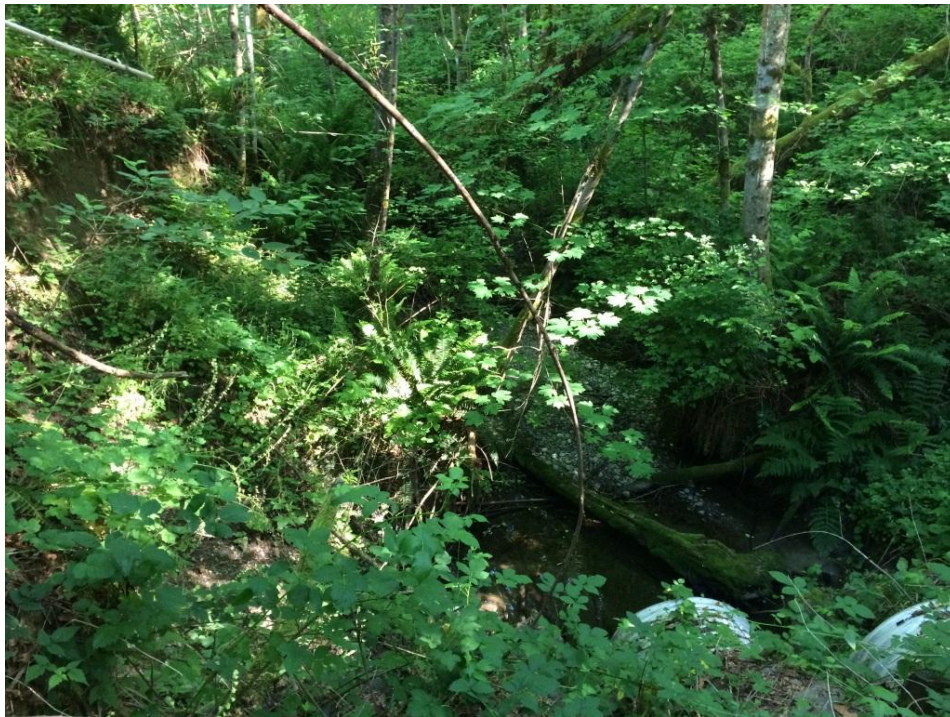
Photo 2: Facing southeast along stream within vegetated ravine (approx. 100-ft downstream of site). Outfall of twin culverts in bottom right of photo. Visible evidence of ravine erosion within 20-30 ft of stream, in upper left of photo.

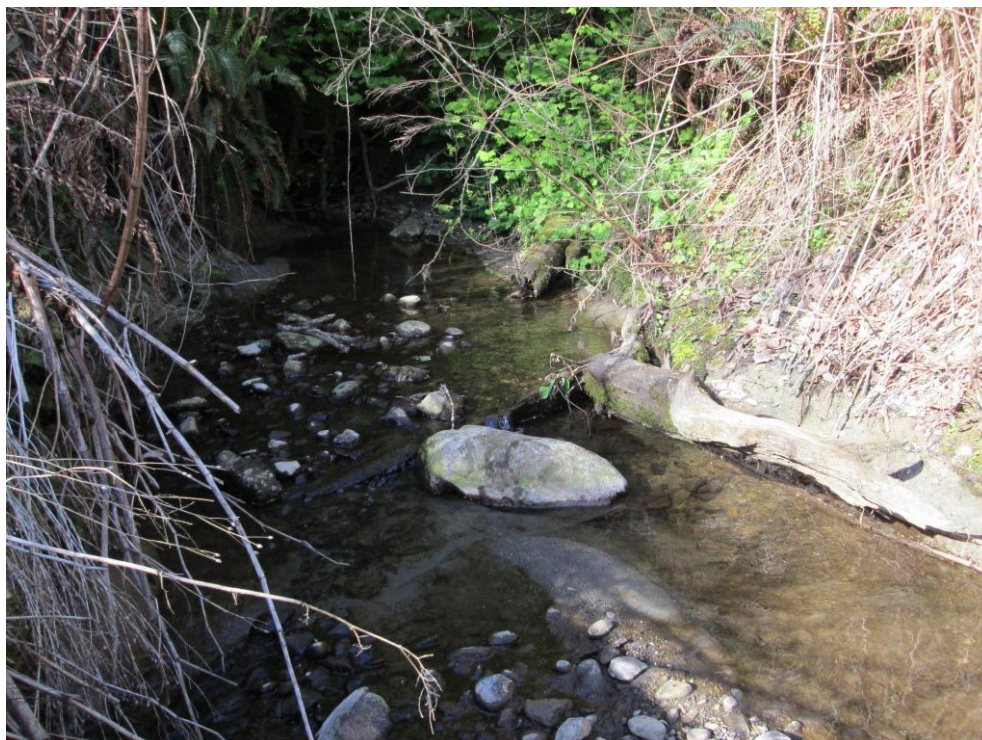
Photo3: Facing west along stream from inlet of box culvert which passes beneath 18th Ave NE.

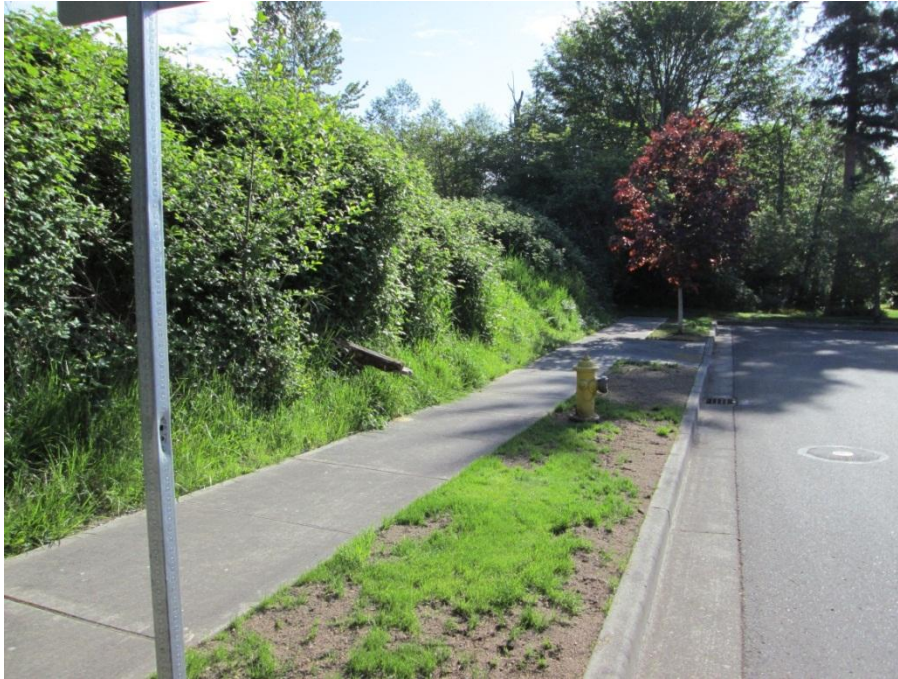
Photo 5: Facing east along southern boundary of site. Runoff from South Basin sheet flows into catch basins within NE 122nd St.

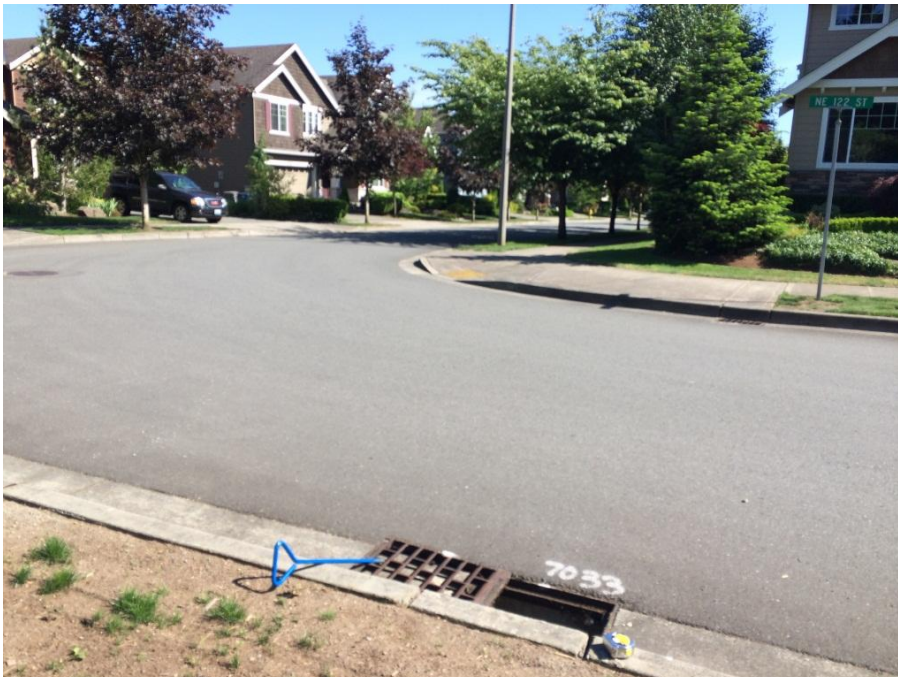
Photo 6: Facing southeast across NE 122nd St toward 178th PI NE from the southern boundary of the site. Runoff is conveyed south within 178th PI NE by 12" pipes.

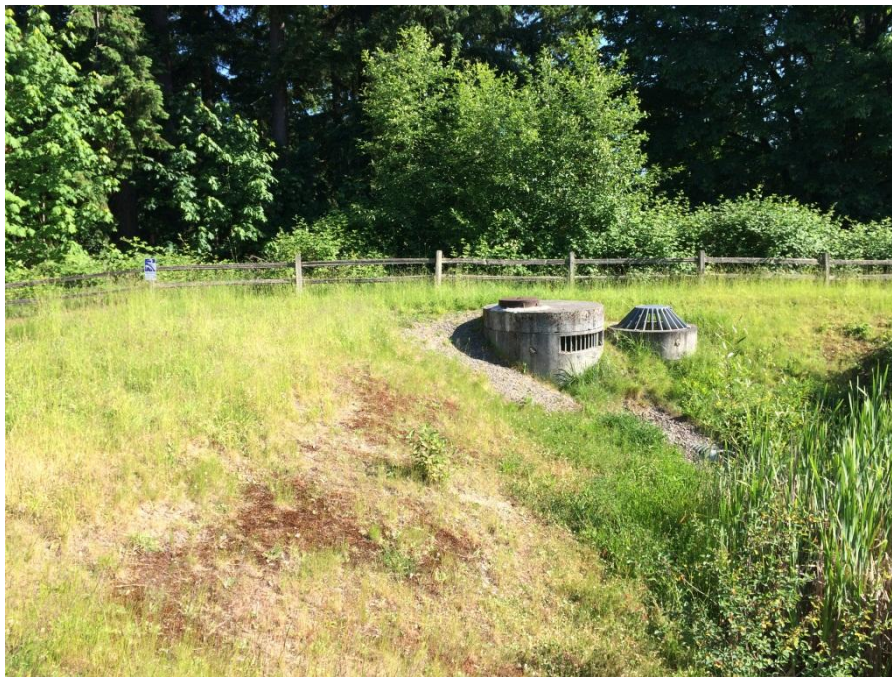
Photo 8: Facing southeast across Talora Aye pond toward overflow structures. Stream fencing in background.

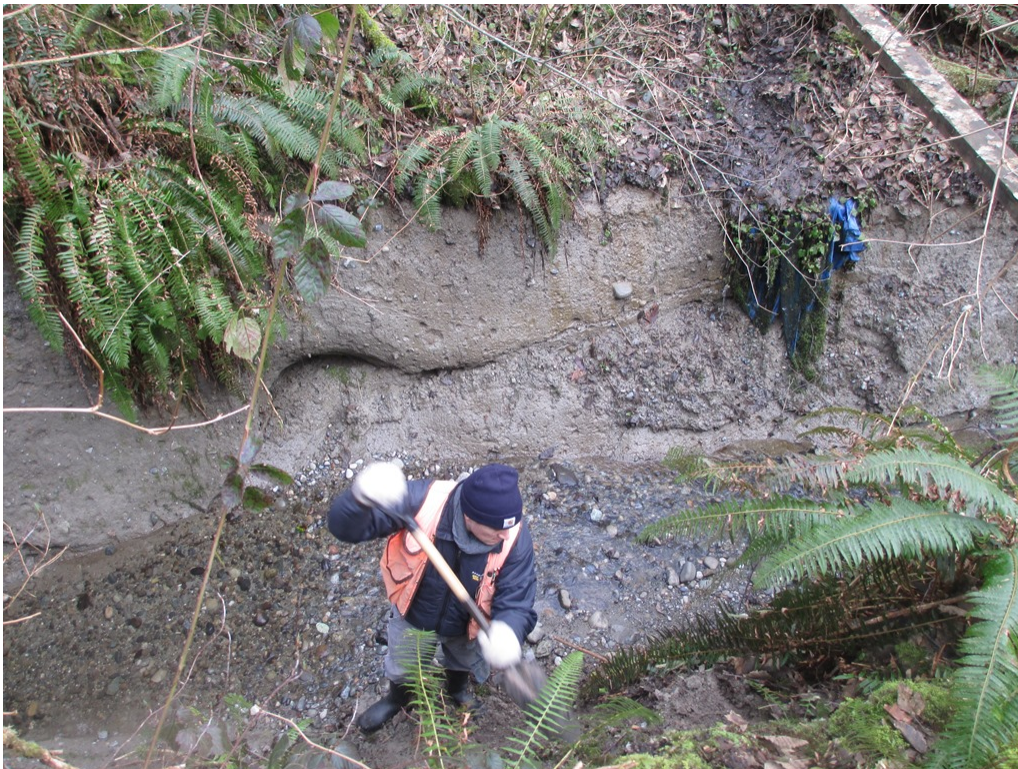
Photo 1. View of deeply incised channel in Stream A. February 4, 2014.

Stream banks in the northern portion of the site are the most incised on the site, with vertical bank walls approximately 15 feet in height (Photo 1). As the channel progresses through the property the banks are less incised (Photo 2). Stream substrate in the stream bed is primarily medium to small cobble, gravel, small gravel and sand; these substrate sizes have been graded by higher stream flows from large to small from the middle of the channel to the bed margins (Photo 3).

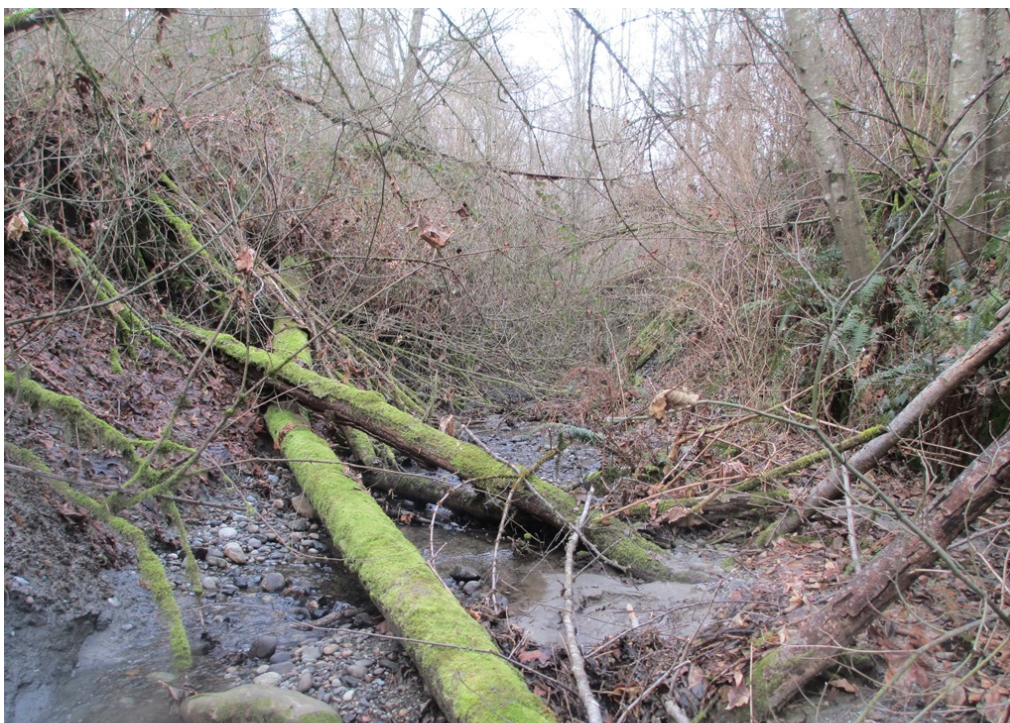
Photo 2. Less incised channel in Stream A as the stream passes through the site. February 4, 2014.

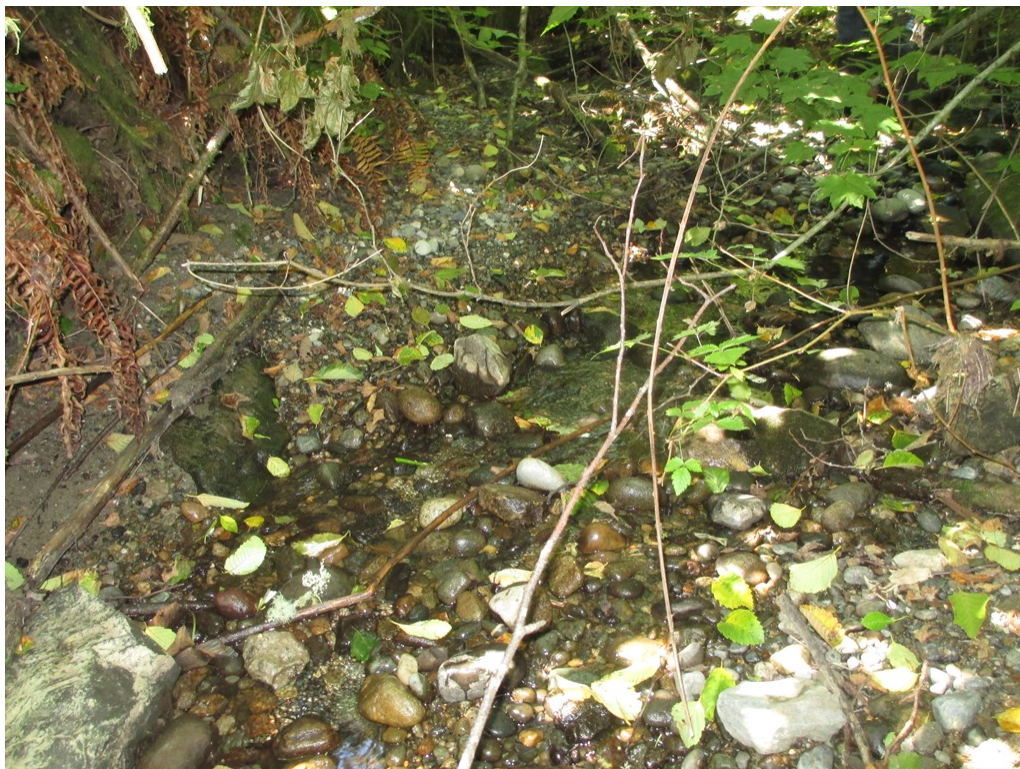
Photo 3. Typical stream bed substrate and flow observed at southern end of project site. July 14, 2014.
