Terrene at 132nd Ave NE Plat

City of Redmond, Washington

Preliminary Storm Drainage Report

Blueline Job No. 14-171

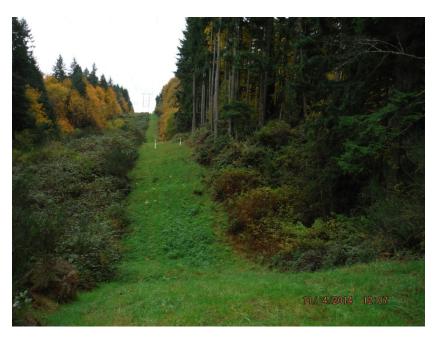
Photo 1: Looking south along Olympic Pipe Corridor

Flow split to the north moves northeasterly into a ravine onsite before reaching a path of short meadow grass of the Olympic Pipe Line Corridor (photo 1). Flow crosses the Olympic Pipe Corridor and exits thick forested cover (photo 2,3). Here flow continues to move easterly in the ravine to enter heavy brush and thick ground cover to the eastern boundary of the site (photo 4).

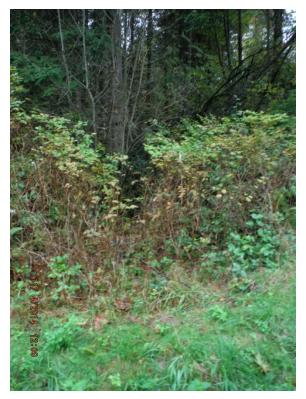
Photo 2: Looking west at edge of Olympic Pipe Corridor.

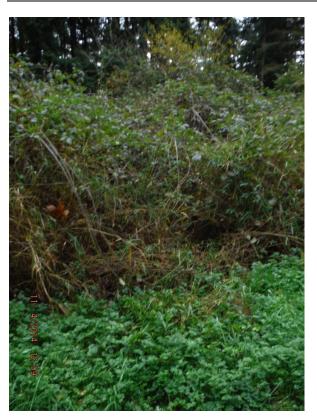
Photo 3: Looking east at edge of Olympic Pipe Corridor.

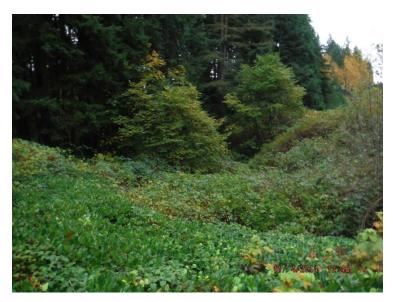
Photo 4: Looking southeast

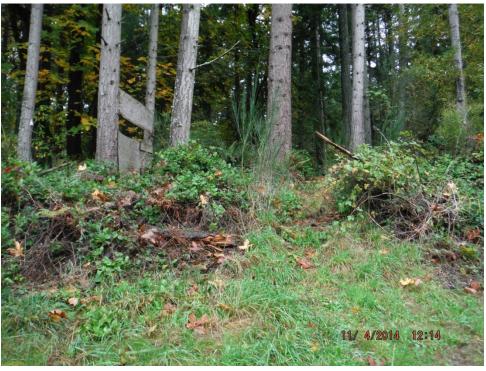
Photo 5: Looking west at edge of Olympic Pipe Corridor

Flow split to the south moves southeasterly along a gradual knob and slope and is conveyed south and east before reaching a path of short meadow grass of the Olympic Pipe Line Corridor. (photo 5,6). Flow continues to move easterly along the slope east and south to be caught by a flattening ravine and directed east over heavy brush and thick ground cover for up to the eastern boundary of the site. (photo 7).

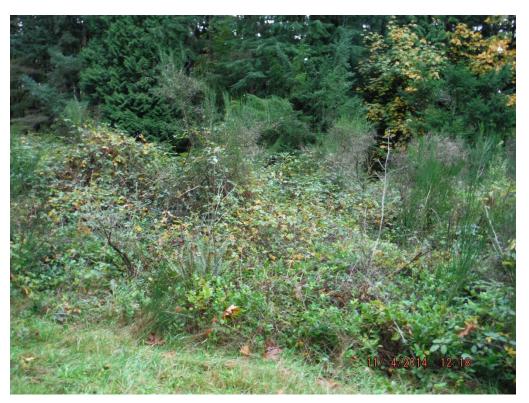
Photo 6: Looking east at edge of Olympic Pipe Corridor

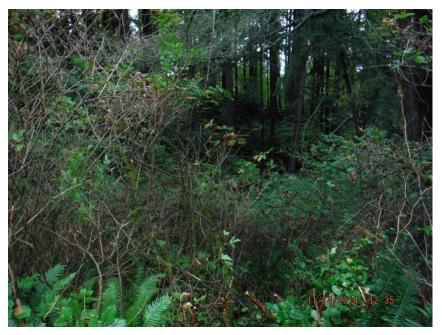
Photo 7: Looking northeast into ravine at edge of property line.

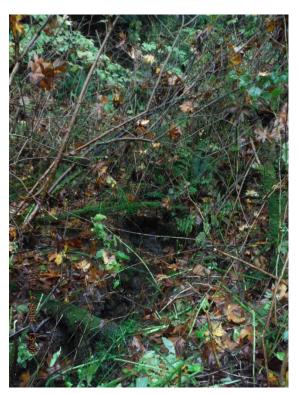
Photo 8: Looking east at unnamed stream (typical conditions)

Flows from the north and south continue through such conditions into a steeper and wider ravines moving to the southeast to discharge from the eastern boundary of the site and combine after an average of 557 feet. Runoff is then collected by a small stream (photo 8) Runoff is conveyed in open channel flow to the east in a small stream moving through dense foliage, ferns, tall grasses, and thick underbrush for approximately 874 feet. The offsite analysis was concluded at this point approximately ½ mile from the property.

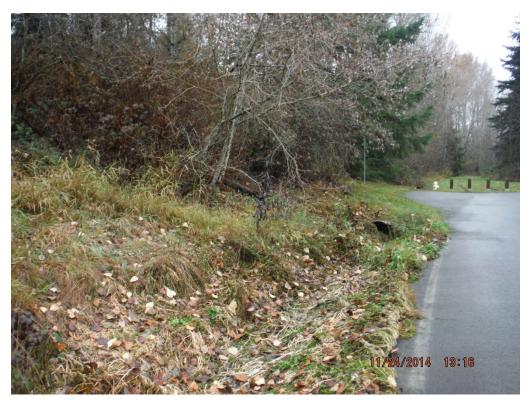
Photo 9: Looking north along west side of Aerojet access road at western boundary of the property approximately 1,100 feet north of the subject property.

A paved access road on Aerojet's campus, approximately 1,200 feet in length, parallels the western boundary of the Aerojet's property beginning at *Point A* and ending at *Point B*. A significant ridge / berm extends, as far as could be reasonably seen, down the western border of the property. (photos 9-14) There is a ditch with steady open channel flow free of debris directly west of the access road that conveys runoff south from the ridge to the west (photos 9-14). Flow is conveyed east under the access road via a 48-inch culvert (photo 14). Runoff discharges the culvert and is conveyed east into a ravine on the Aerojet campus (photo 15).

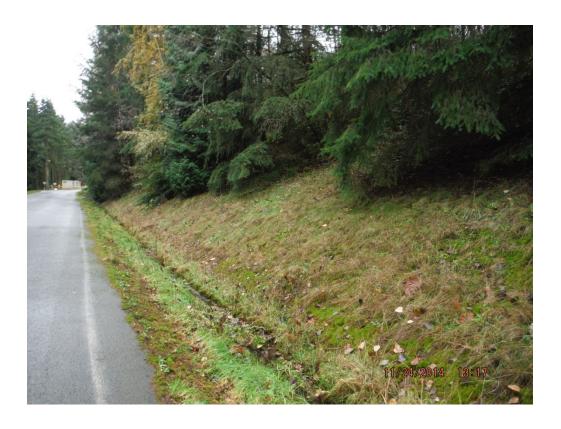
Photo 10: Looking south along west side of Aerojet access road at western boundary of the property.

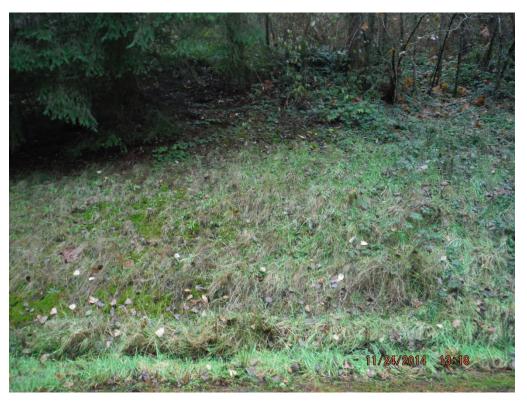
Photo 11: Looking west at slope of ridge west of ditch and access road on Aerojet's campus.

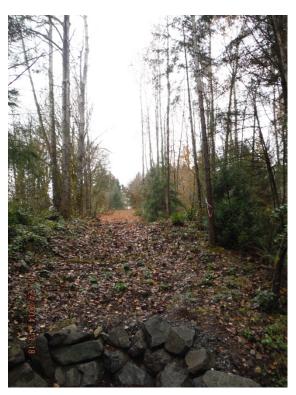
Photo 12: Looking west at slope of ridge to the west of ditch and access road on Aerojet's campus. In the distance you can see the power lines of the Olympic Pipeline Corridor (see following picture for close-up).

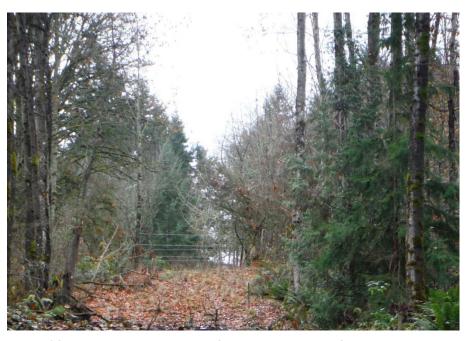
Photo 13: Looking west at slope of ridge to the west of ditch and access road on Aerojet's campus. See bottom third of photo for power lines of the Olympic Pipeline Corridor.

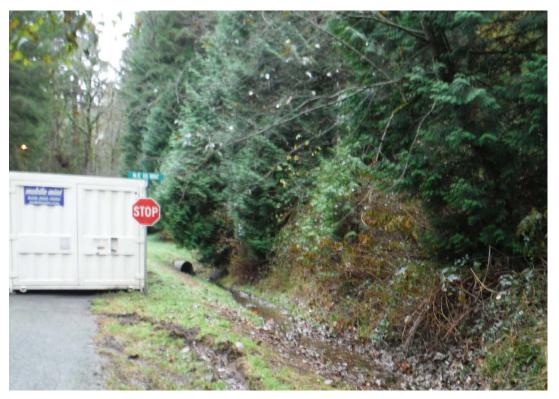
Photo 14: Looking south along west side of Aerojet access road at western boundary of the property.

48-inch culvert middle of photo and just to the right.

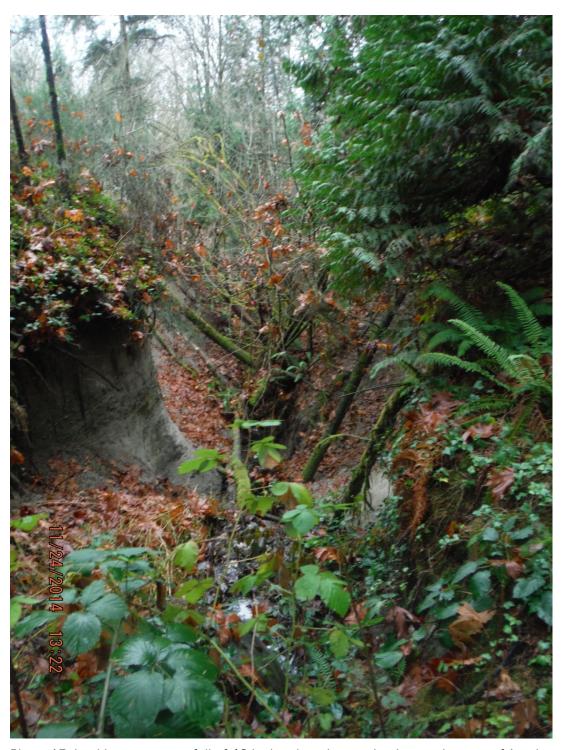
Photo 15: Looking east at outfall of 48-inch culvert into ravine just to the east of Aerojet access road. Culvert is located in the bottom middle of the picture.
