May 11, 2015

Re: TPN: 252605-9023; 6.89 acres

EDGEWOOD EAST TREE PRESERVATION PLAN

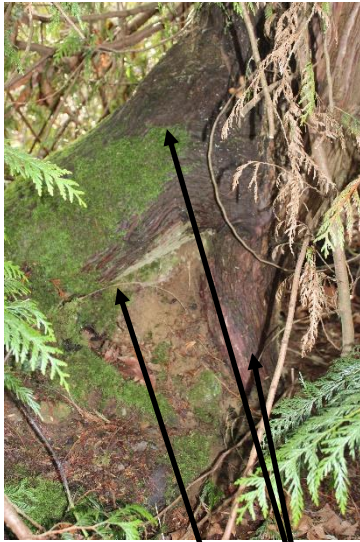
1

#7253 Nurse tree, exposed roots, self-corrected lean

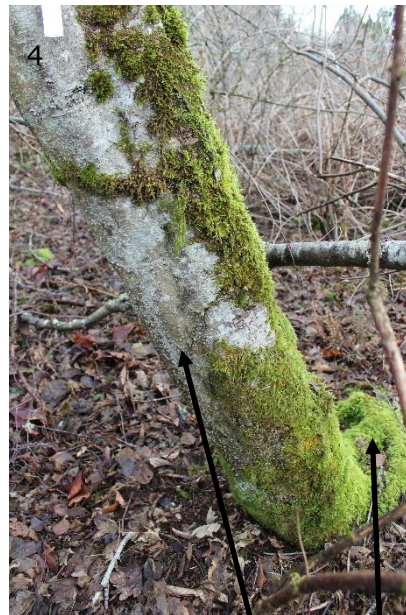
#7224 Red alder, previous dead leader, falling to west

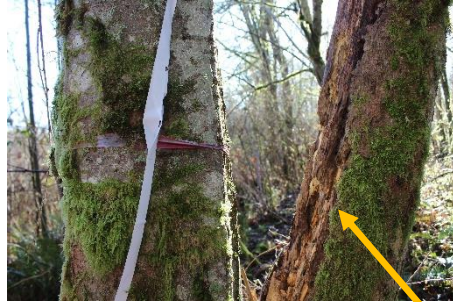
26

7598 Red alder: Co dom leaders, carpenter ants, pileated woodpecker, mostly dead

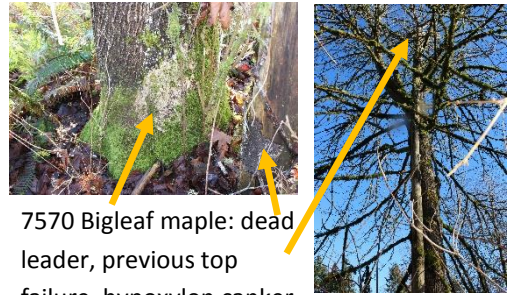
34

7570 Bigleaf maple: dead leader, previous top failure, hypoxylon canker

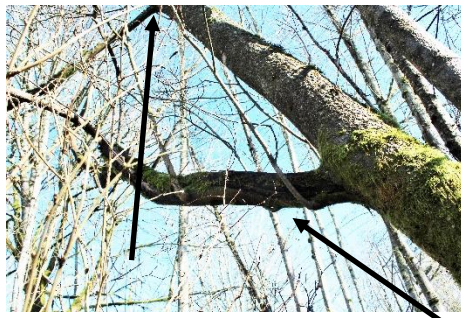
41

7299: Red alder: Large scaffold with underside decay, previous top loss, exposed roots, with decay, dead branches at base

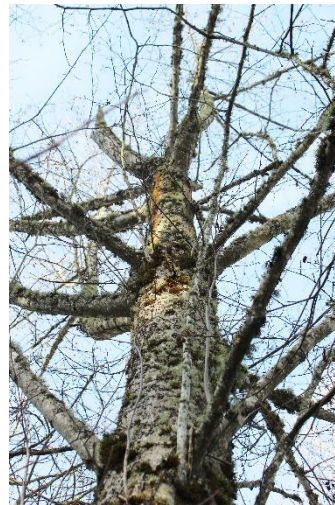
45

8001 Red alder: dead

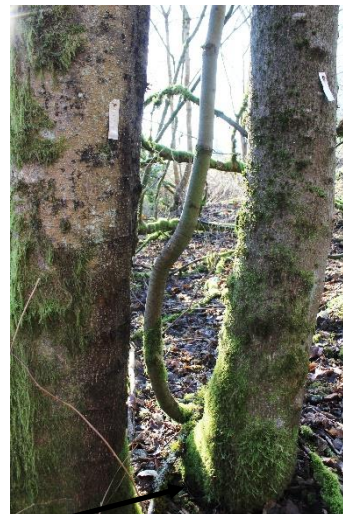
7331, 7330 Red alder, decay, dead wood, hangers, decay at rot crown

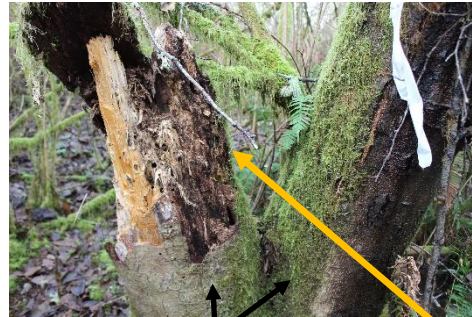
48

7745 Red alder: Co-dom leaders, decay, carpenter ants, pileated woodpecker

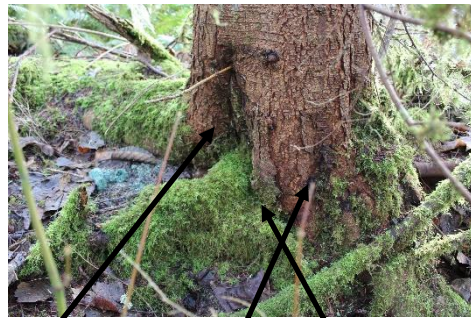
50

7634 Hemlock: Hemlock, nurse tree, decay, perennial canker, in standing water

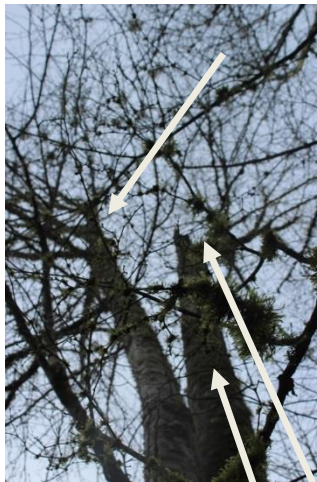
8224 Red alder, broken tops, carpenter ants, pileated woodpecker

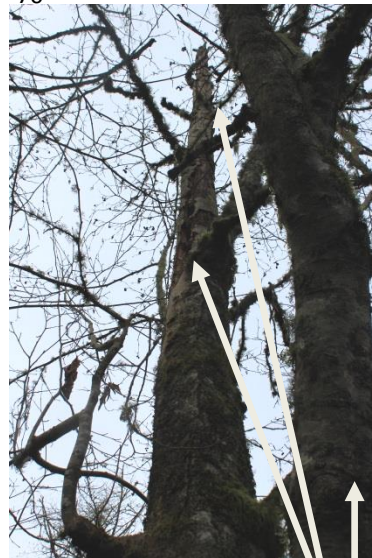
70

7742 Red alder: Co-dom, or e dead, pileated woodpecker

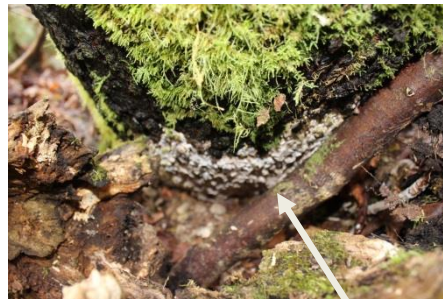
8232 Bigleaf maple: Hypoxylon Canker, decay at root crown, previous failure @ root crown

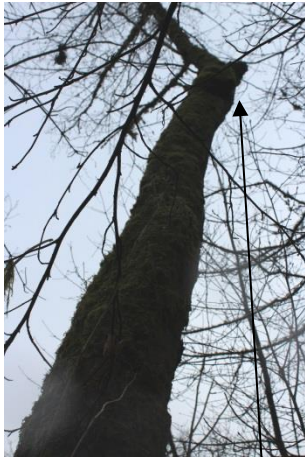
77

7749 Red alder: Dead, pileated woodpecker

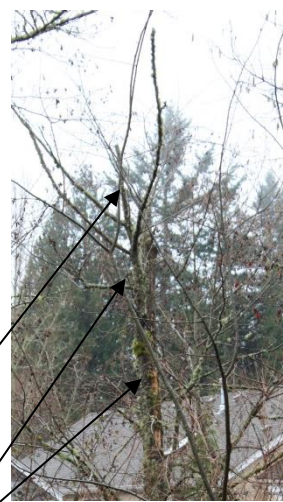
7218 Red alder: dead top, decay, pileated woodpecker

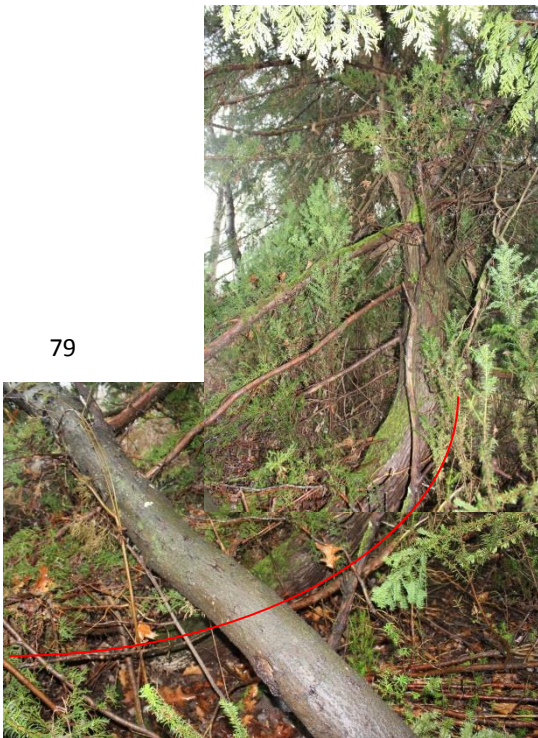
79

7367 Yew: fallen to west

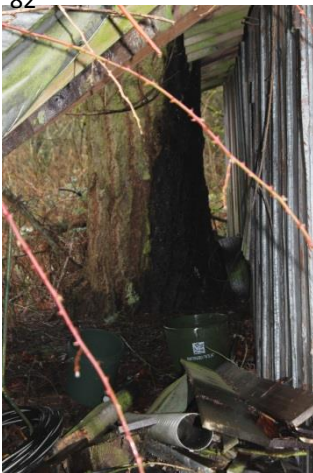
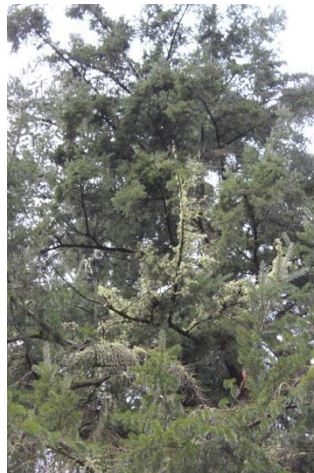
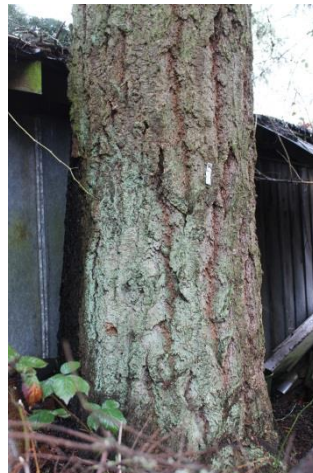
82

7290 Douglas fir: growing against a large outbuilding. Birdholes in trunk abnormal vertical cracks, previous top failure, dead wood
